Debris Flow Summary, Haypress Fire, 2017

Natalie Cabrera, Acting Forest Geologist

February 7, 2018

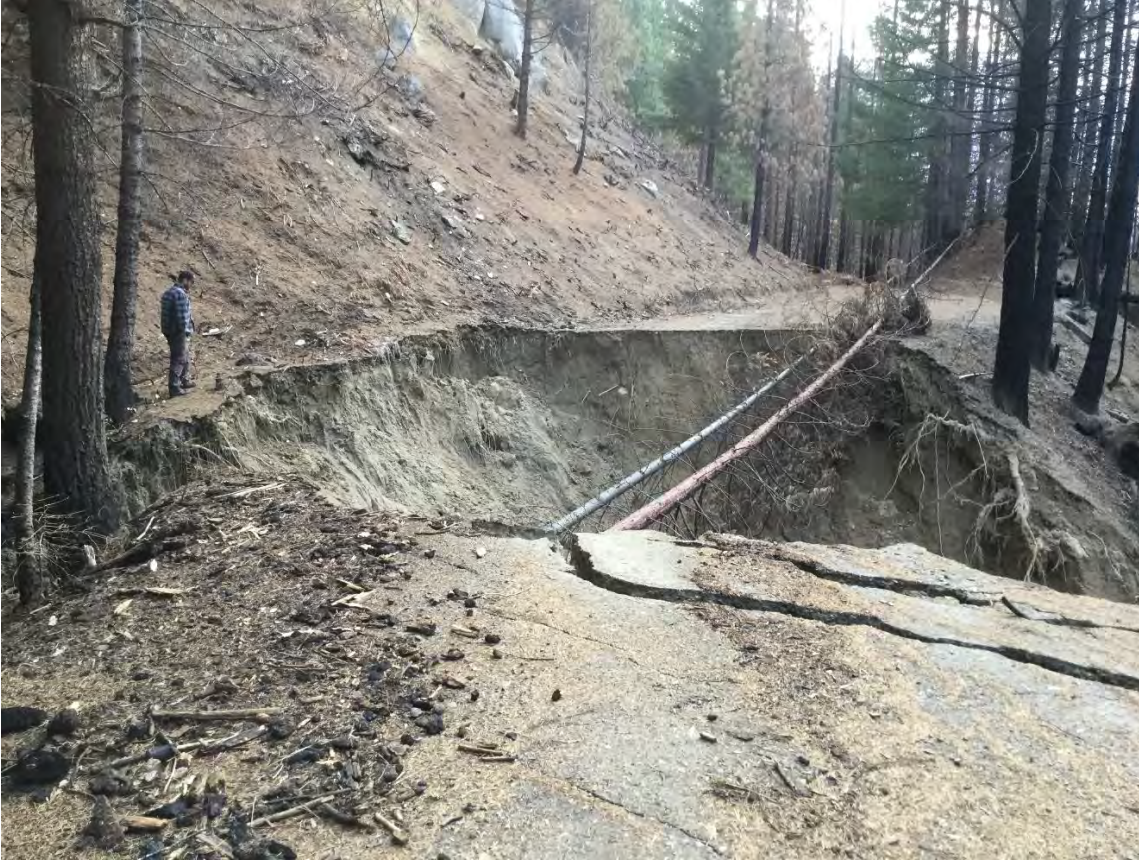
The initial surface erosion, inlet basin, and fill failure volumes were measured in the field. The channel scour volume between roads was estimated by visual examination of dimensions visible from each road, and length measured from a map. The road failure on 15N17 was about 55 feet wide and about 30 feet deep on average.

Figure 1. 15N17 failure viewed from right side (if facing downhill).

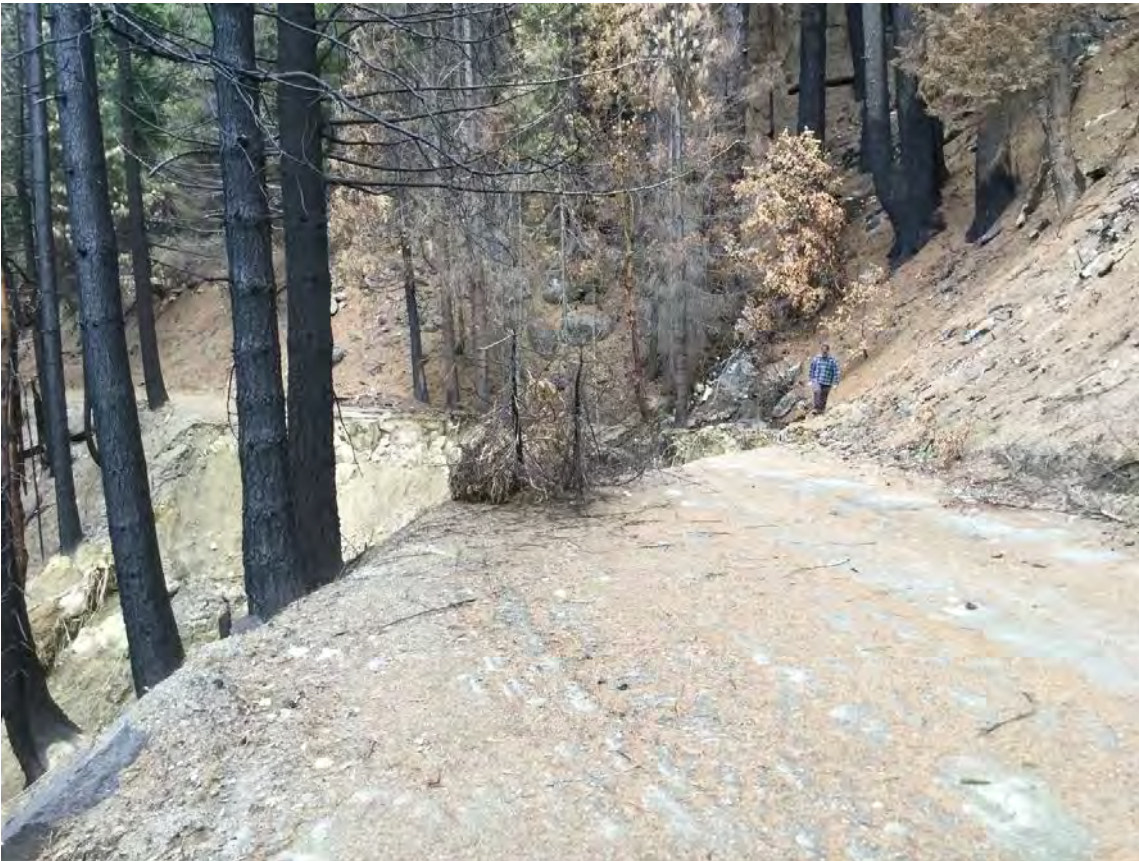
Figure 2. 15N17 failure viewed from left side (if facing downhill).

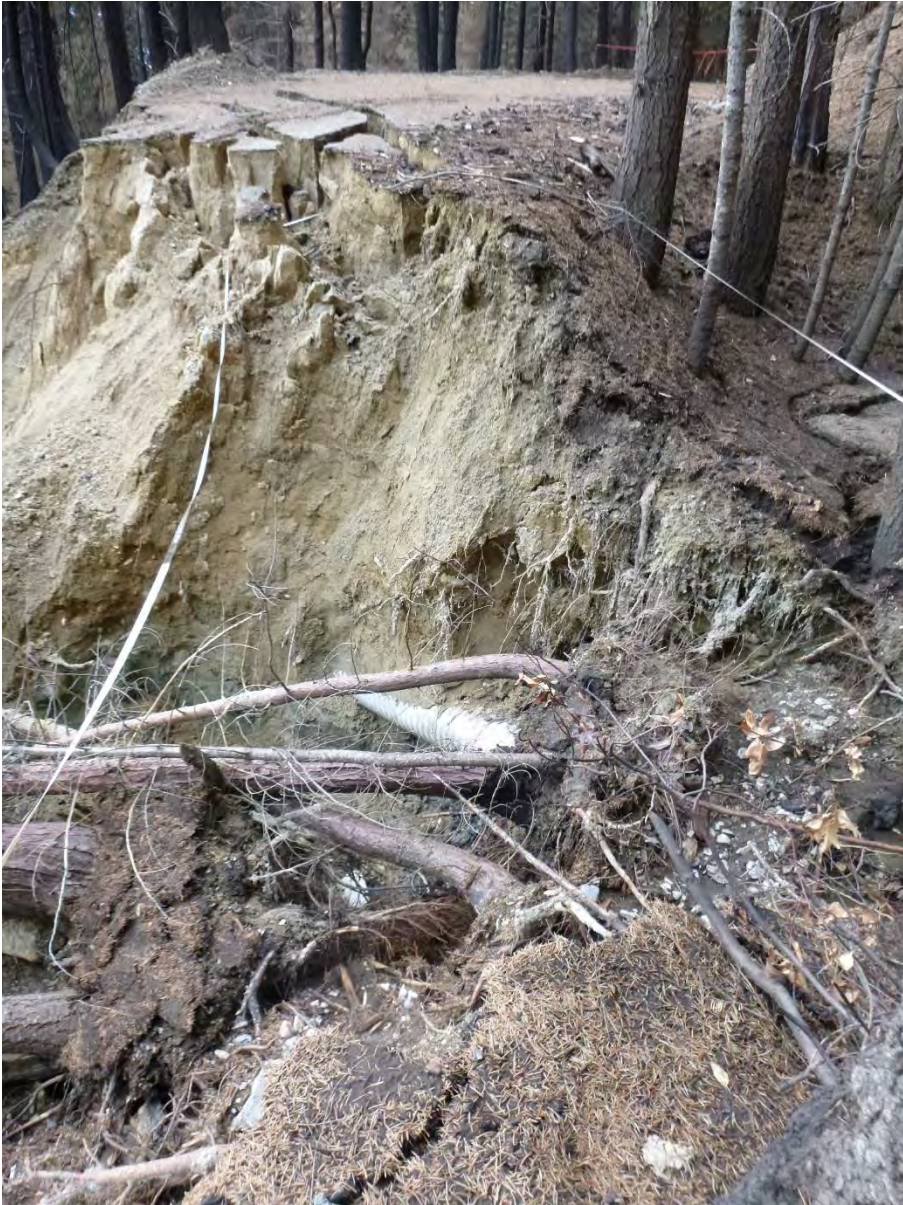
The eroded volume that reached the inlet basin easily overwhelmed the basin capacity. Photos below show the buried culvert is about 1.5-2 feet lower than the deposited sediment. Using the known location of the inlet and photos of the inlet basin prior to the debris flow, it was estimated that the former basin volume capacity was about 33 yd³. The 150 yd³ of sediment, in addition to the volume of water that carried the sediment, far outpaced the capacity of the inlet basin and 18 inch diameter culvert inlet. The pipe was installed with a drastic skew to the right, and with an inadequate low gradient slope, but regardless of these poor installation conditions, the inlet would have plugged. In two other debris flows that occurred in September (see below), the inlets were rapidly overwhelmed at such a rate that no material was observed within the pipe itself. The material rapidly fills the basin overtopping the inlet without much flow or sediment actually passing into the pipe itself. I believe the same mechanism was at work on this debris flow. Only an excavation of the buried inlet will definitively reveal the fact of this case. The professional assessment of this geologist/hydrologist is that the conditions created by the fire allowed for accelerated surface erosion that rapidly buried the pipe inlet with sediment.

Figure 3. View of right scarp near top of 15N17 failure showing in place culvert with buried inlet. Inlet is roughly to the right (as viewing photo) of the base of downed trees about 1.5-2 feet below surface of deposited sediment.

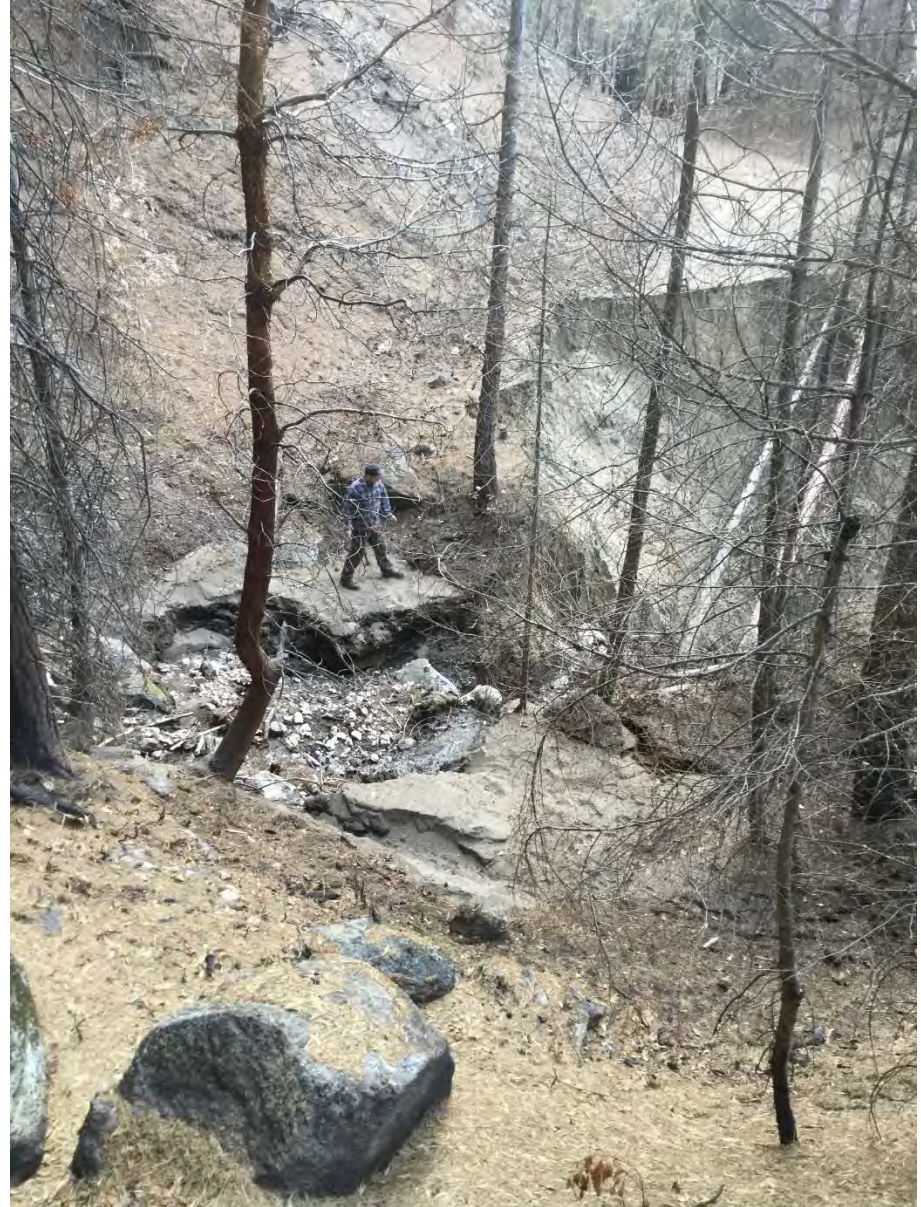
Figure 4. Overview of sediment filled inlet basin.

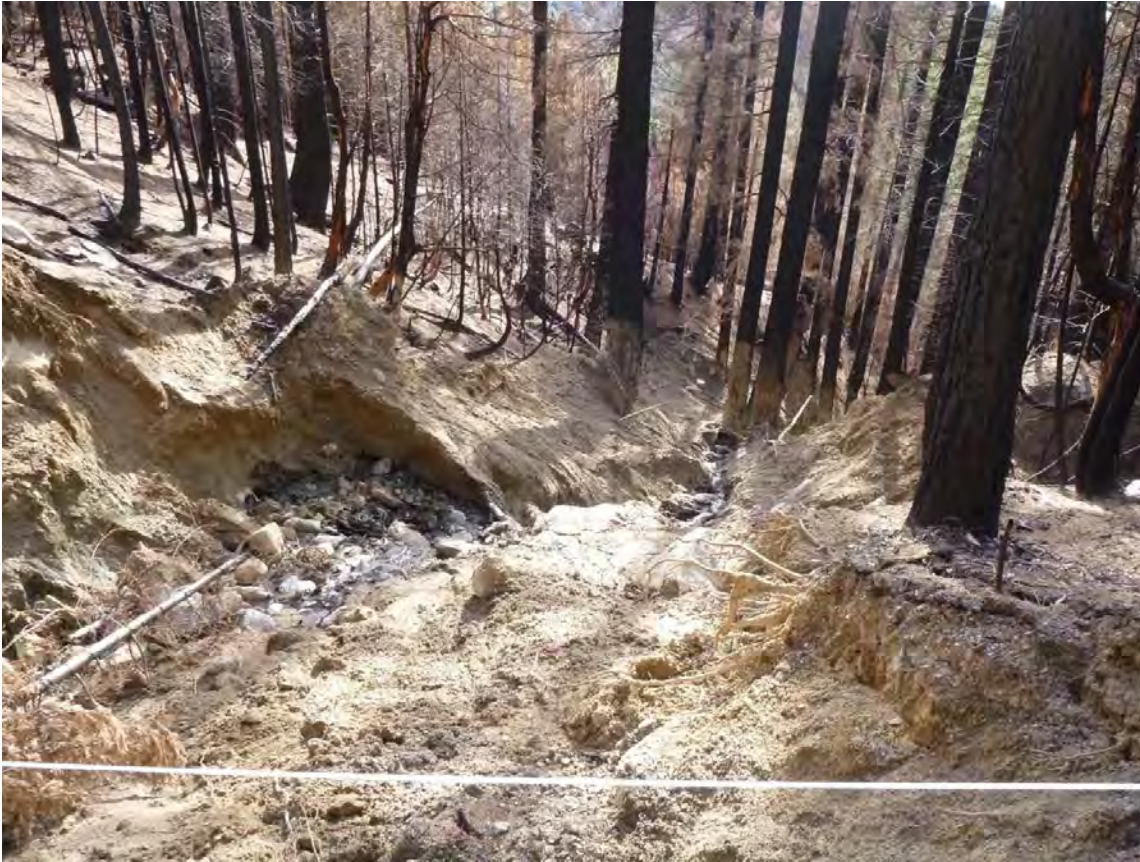
Figure 5. View looking downslope just below 15N17 failure showing scoured channel and mud stained trees.

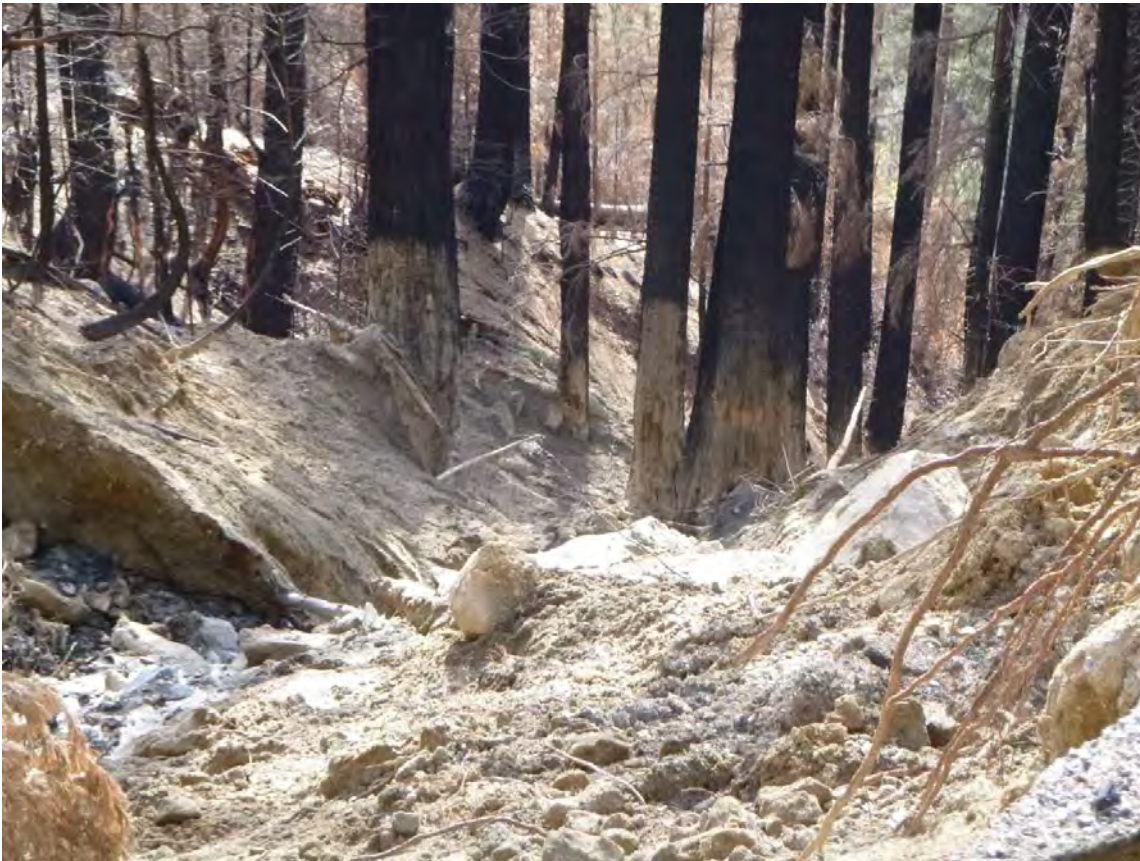
Figure 6. Close up of same trees as in Figure 5. Mud stains are about 5-15 feet high.

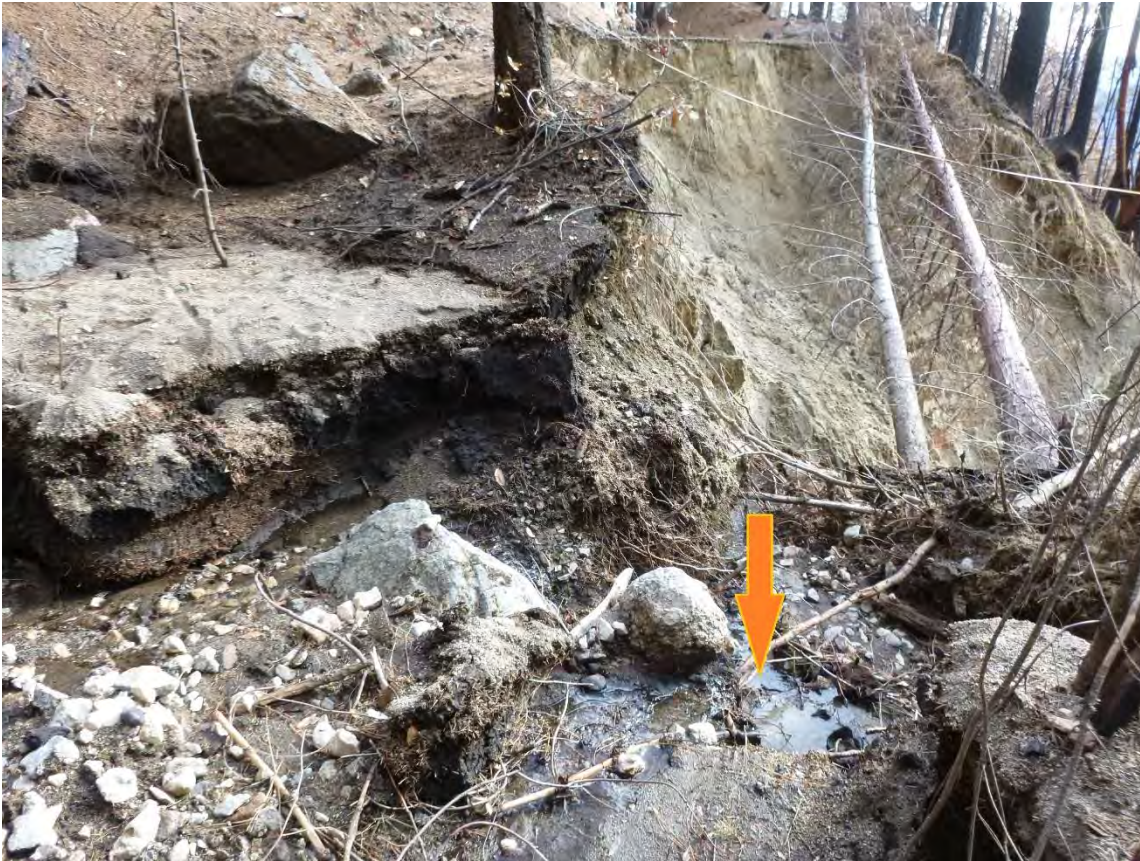
Figure 7. Close up of downstream end of 15N17 inlet basin showing stratigraphy with needles at base, then sand, then mud toward right that deposited while basin was full of water. Inlet is about 1.5-2 feet below arrow head.

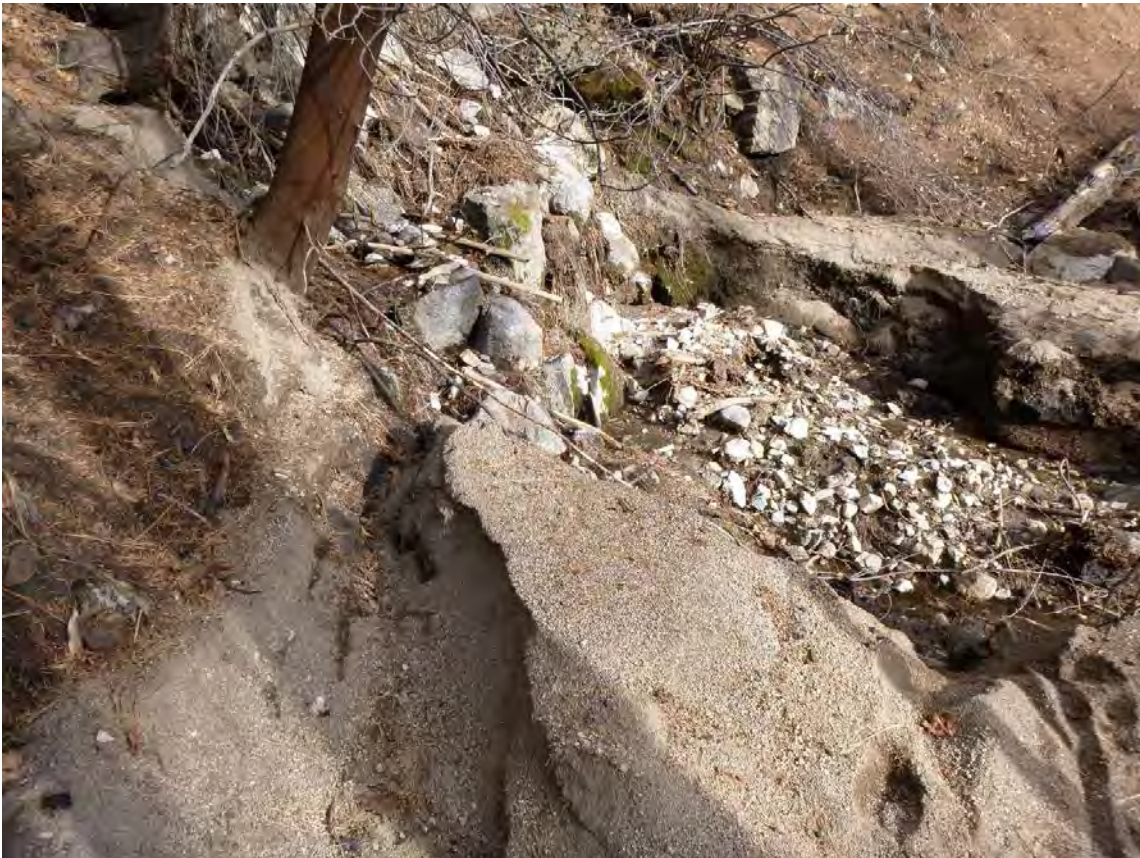
Figure 8. Close up of upstream end of 15N17 inlet basin showing 4 ft. height of sand deposition against boulder bank.

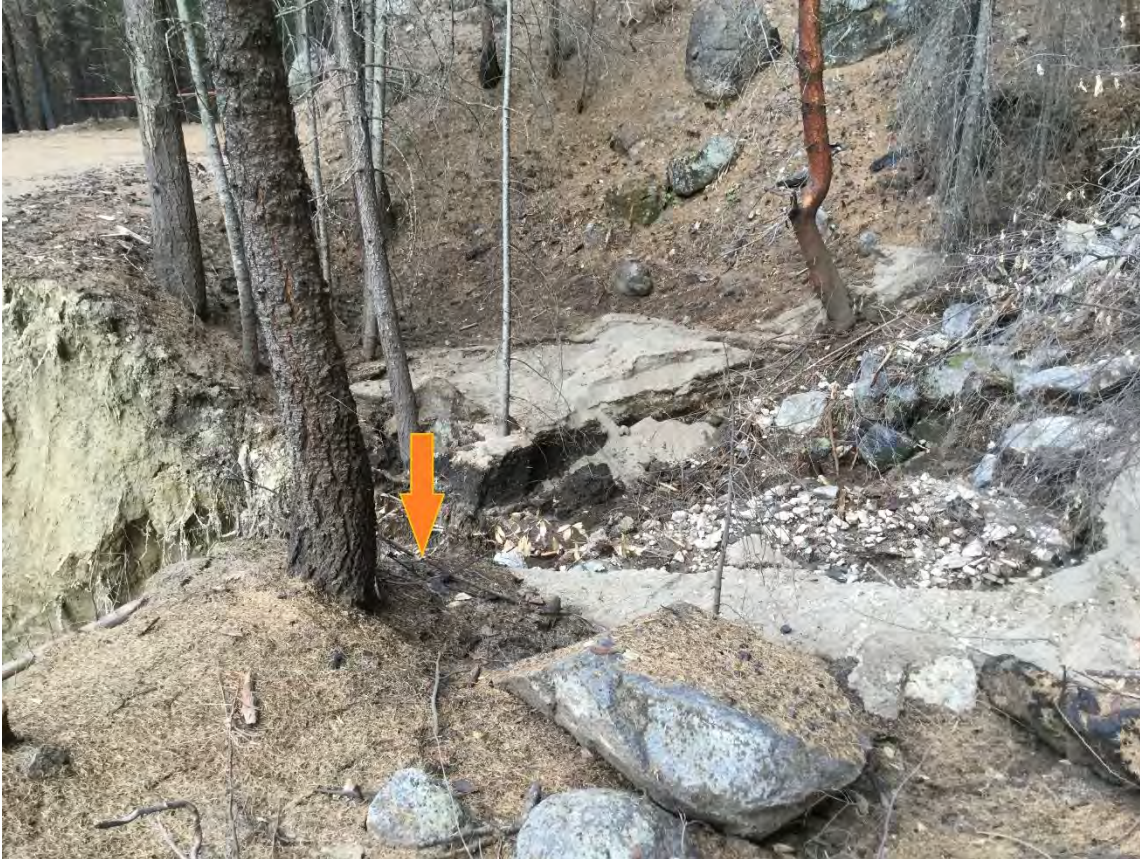
Figure 9. Overview of 15N17 inlet basin showing 4 ft. height of sand deposition against boulder bank, and 2 ft. height of sand deposition towards downstream edge. Buried inlet lies 1.5-2 feet below surface at notch through center just downstream of two small trees on right bank (arrow points to present surface).

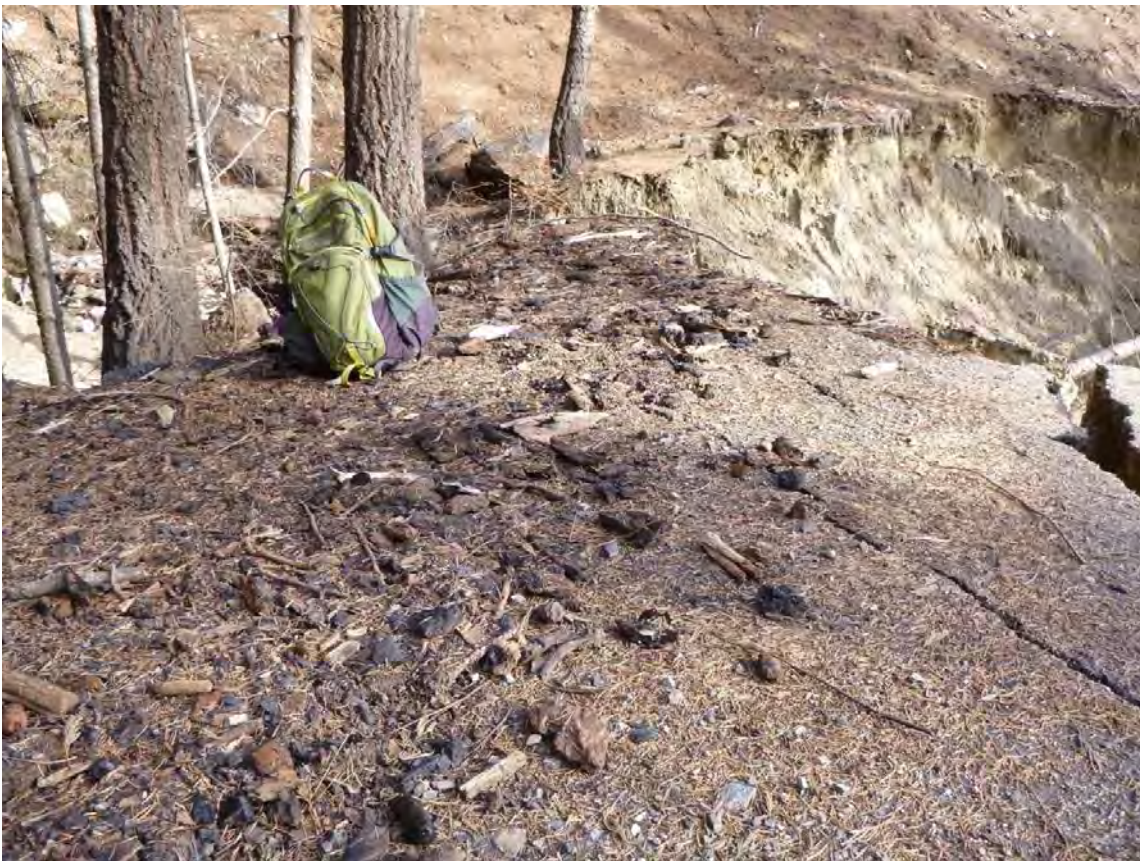
Figure 10. Right side (if looking downslope) of 15N17 road surface showing rafted debris from overtopped, water filled Inlet basin.

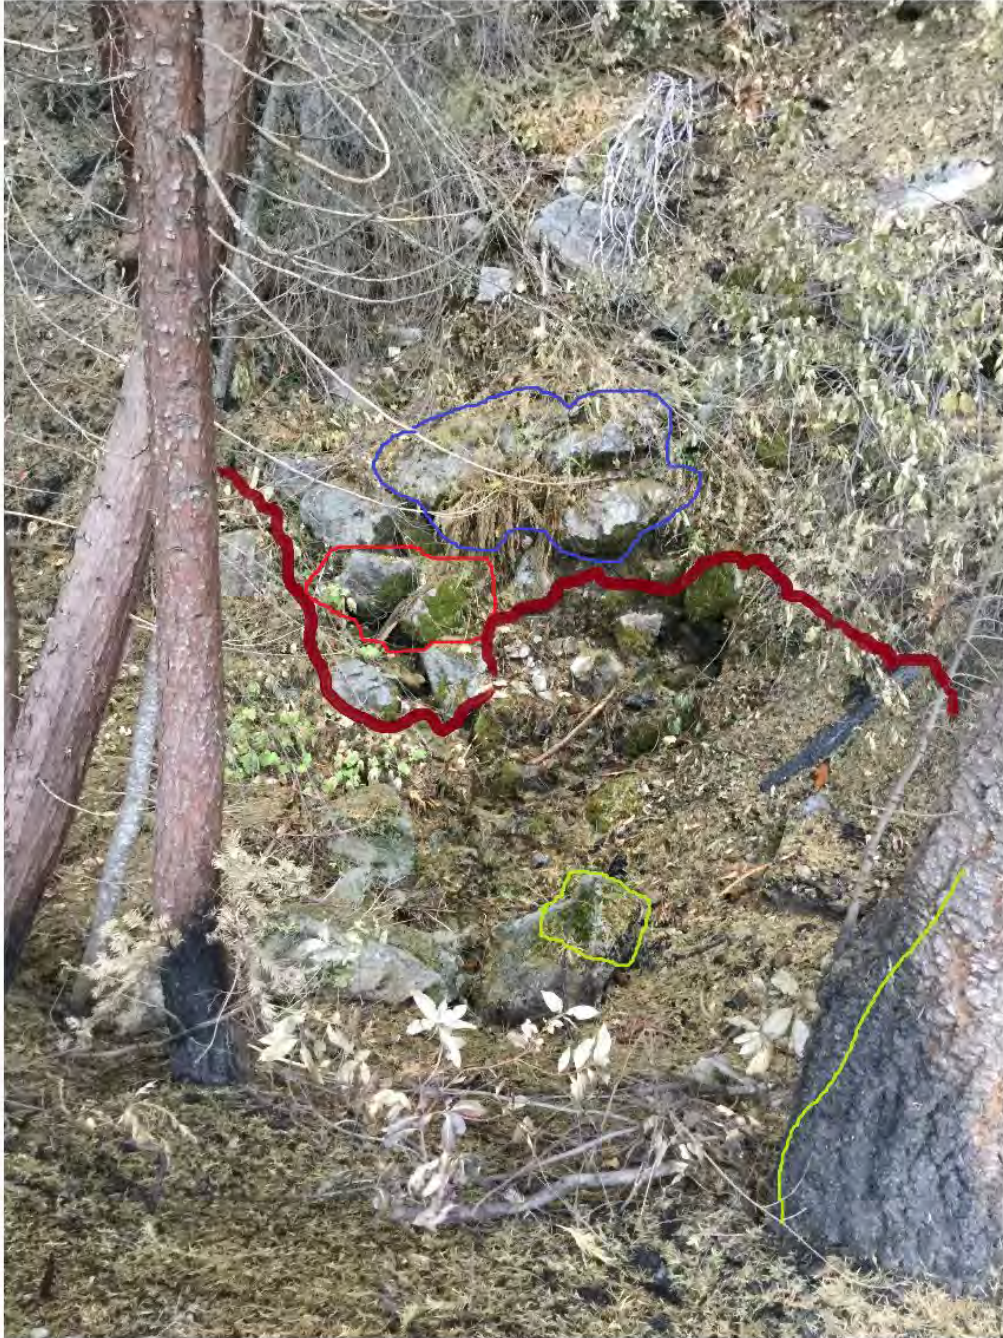
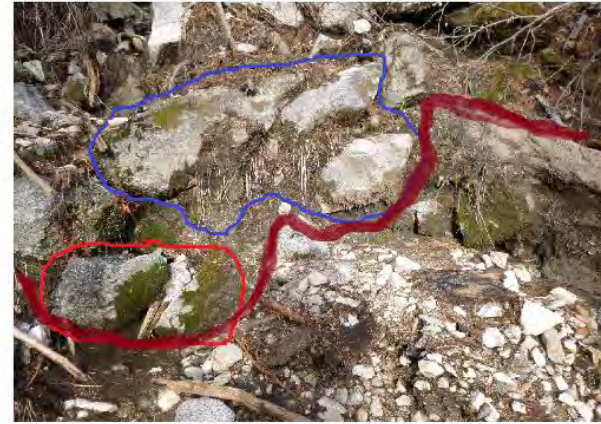
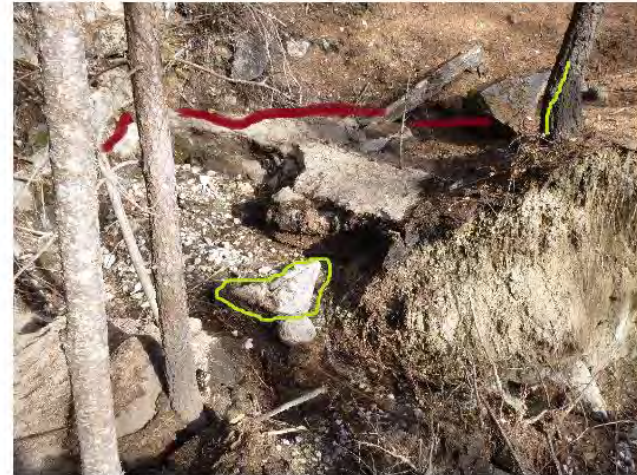
Figure 11. Left is looking upstream at boulder head of inlet basin before debris flow (Sept. 2017 during fire activity). Photos on the right were taken after the debris flow. Colors match analogous landmarks, and the dark red line shows level of sediment deposition. The inlet is about 1-2 feet downstream, and about 1.5-2 feet below the green circled boulder.

= sediment deposition level

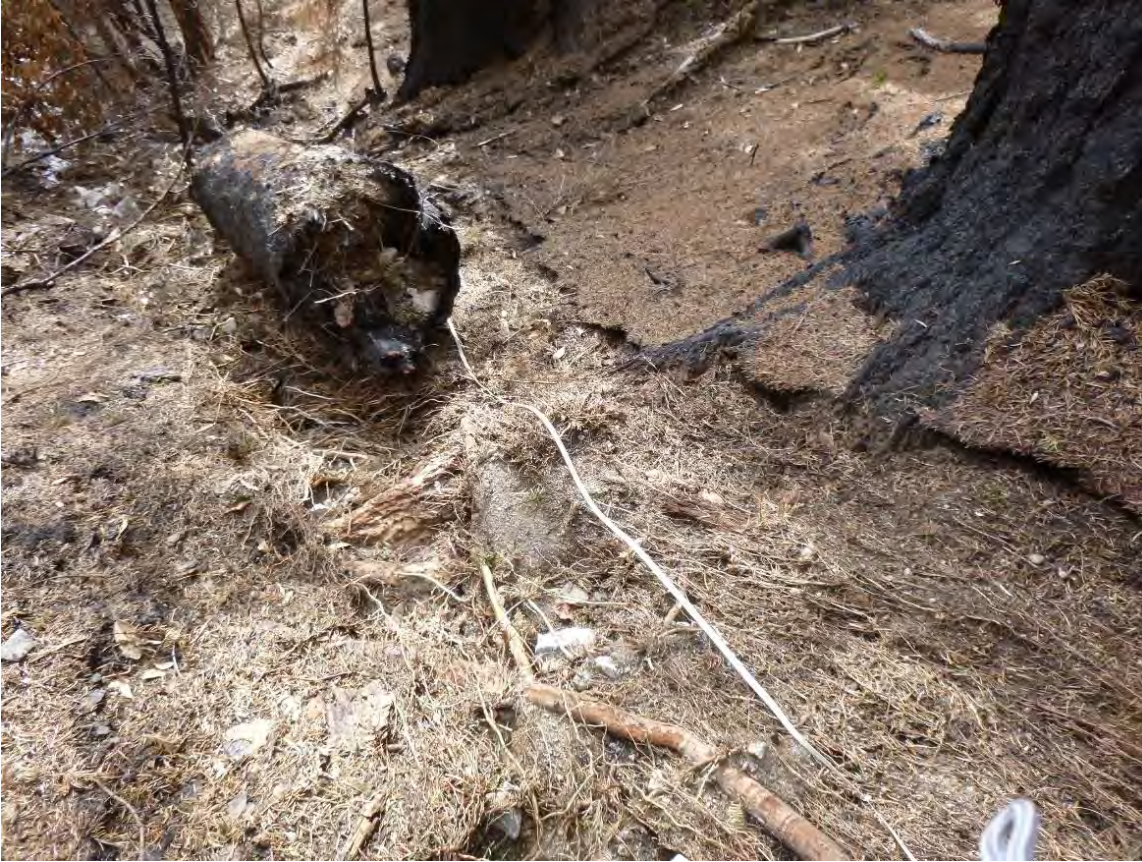
Figure 12. Channel and bank erosion about 100 feet above 15N17.

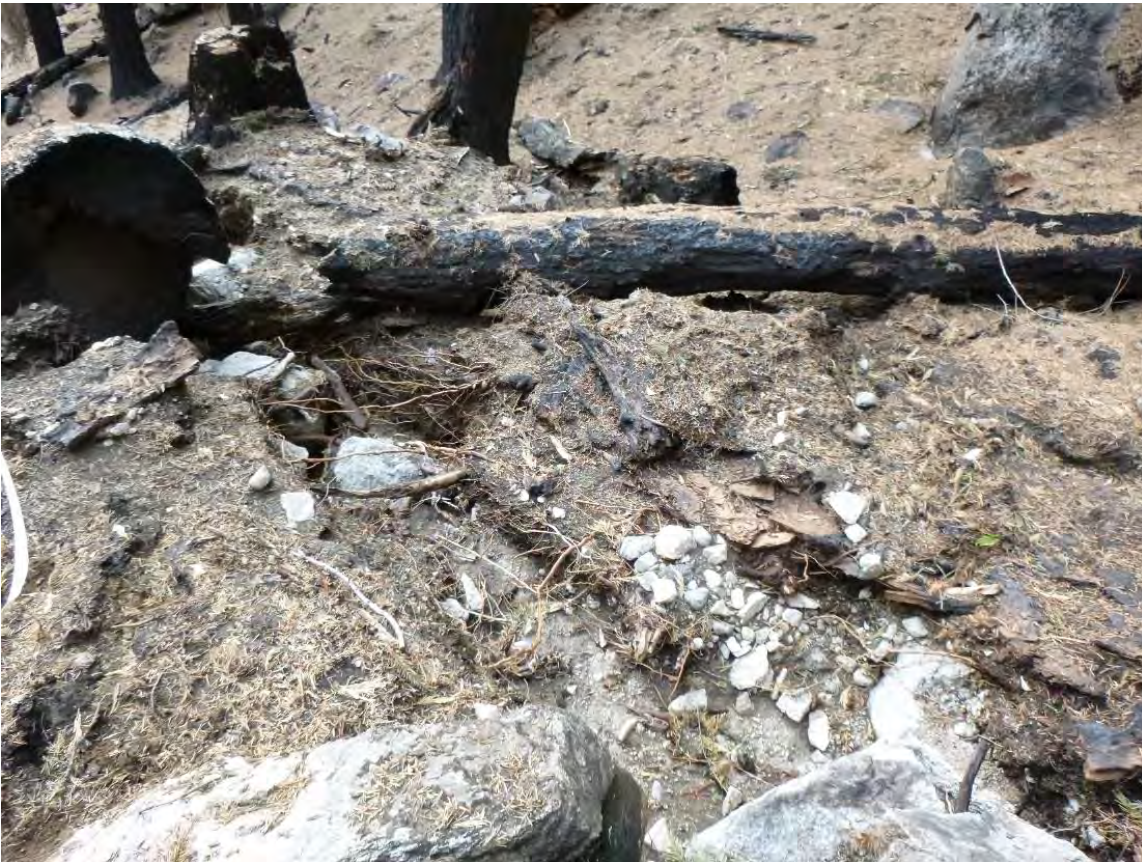
Figure 13. Channel and bank erosion above 15N17.

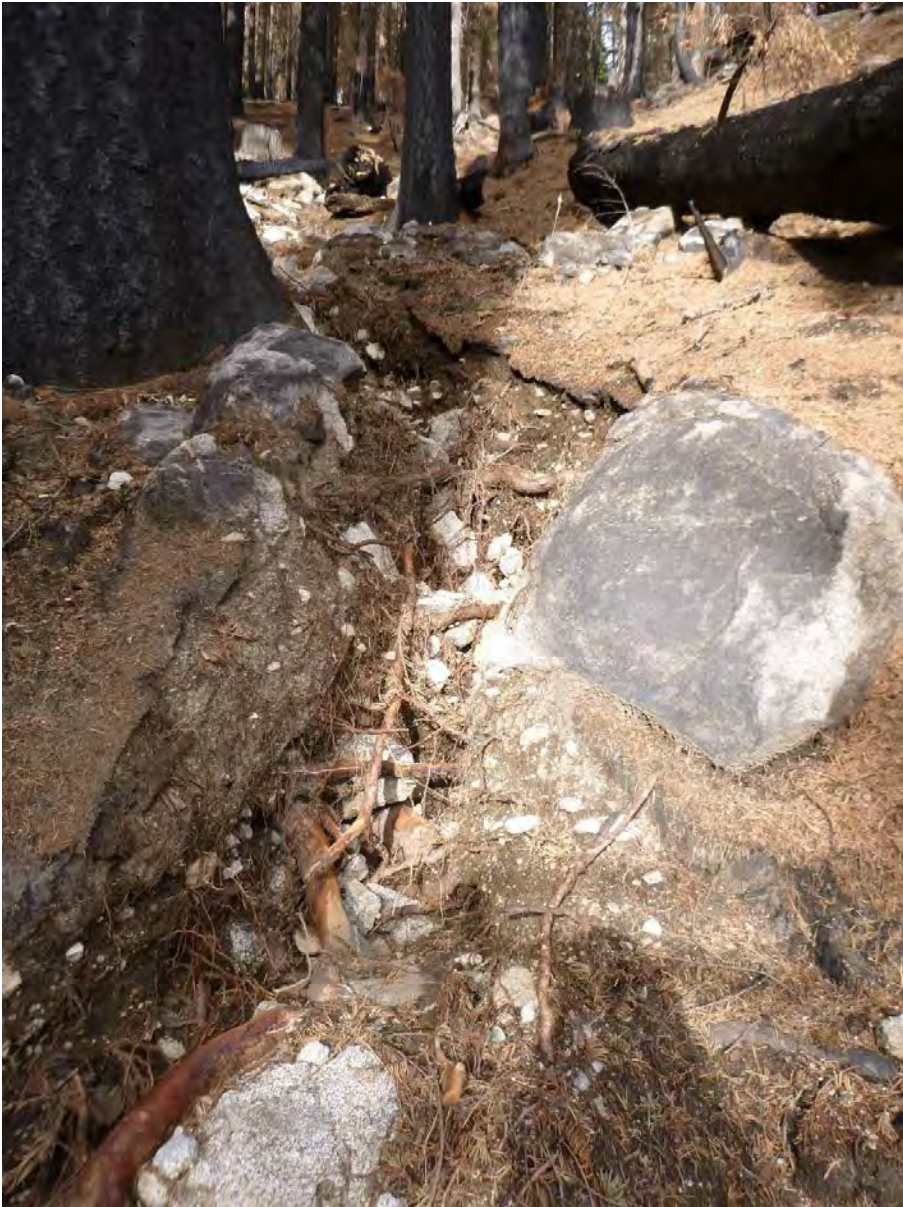
Figure 14. Channel and bank erosion within 100 feet above 15N17.

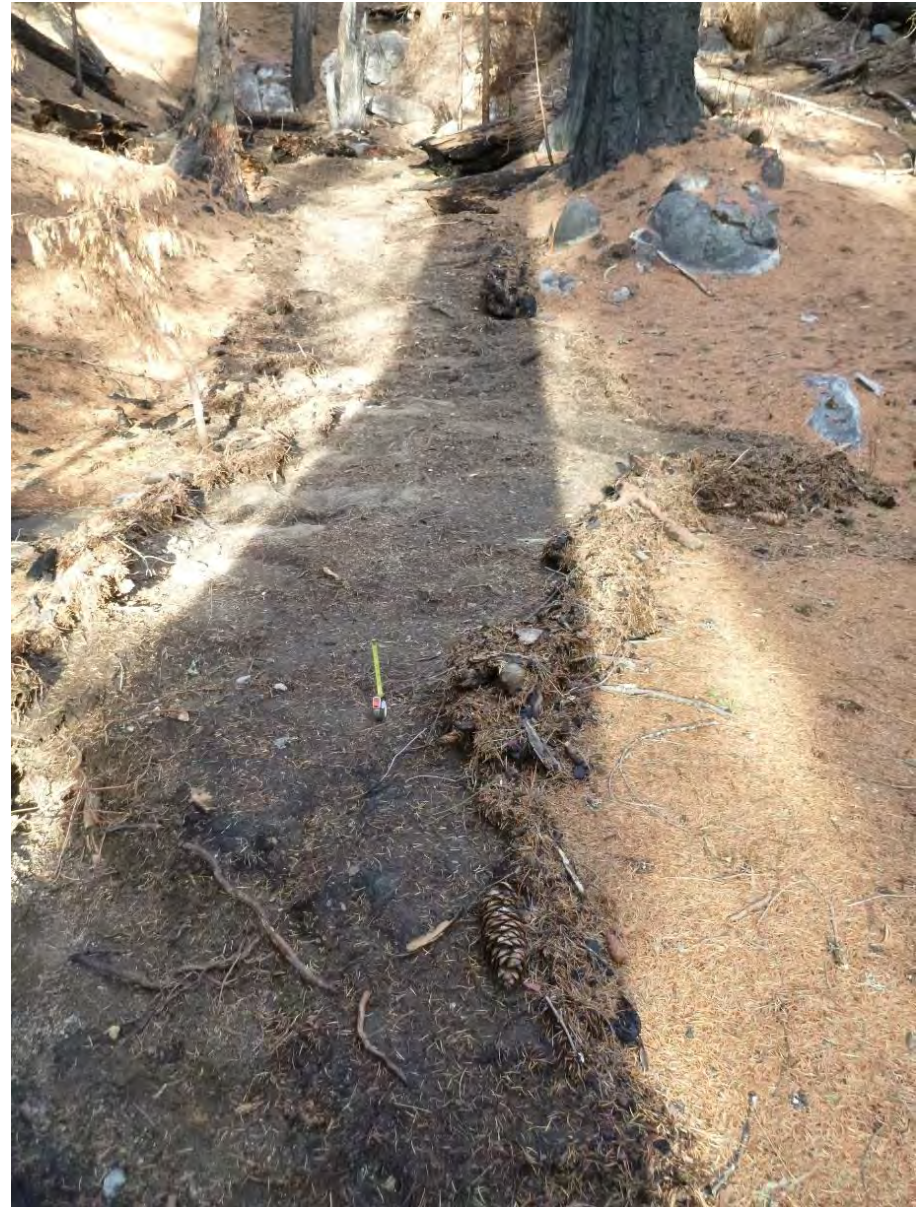
Figure 15. Sheetwash erosion and 1 ft. high needle cast levees about midslope between 15N17 and saddle below Irving Mountain, above defined channel.

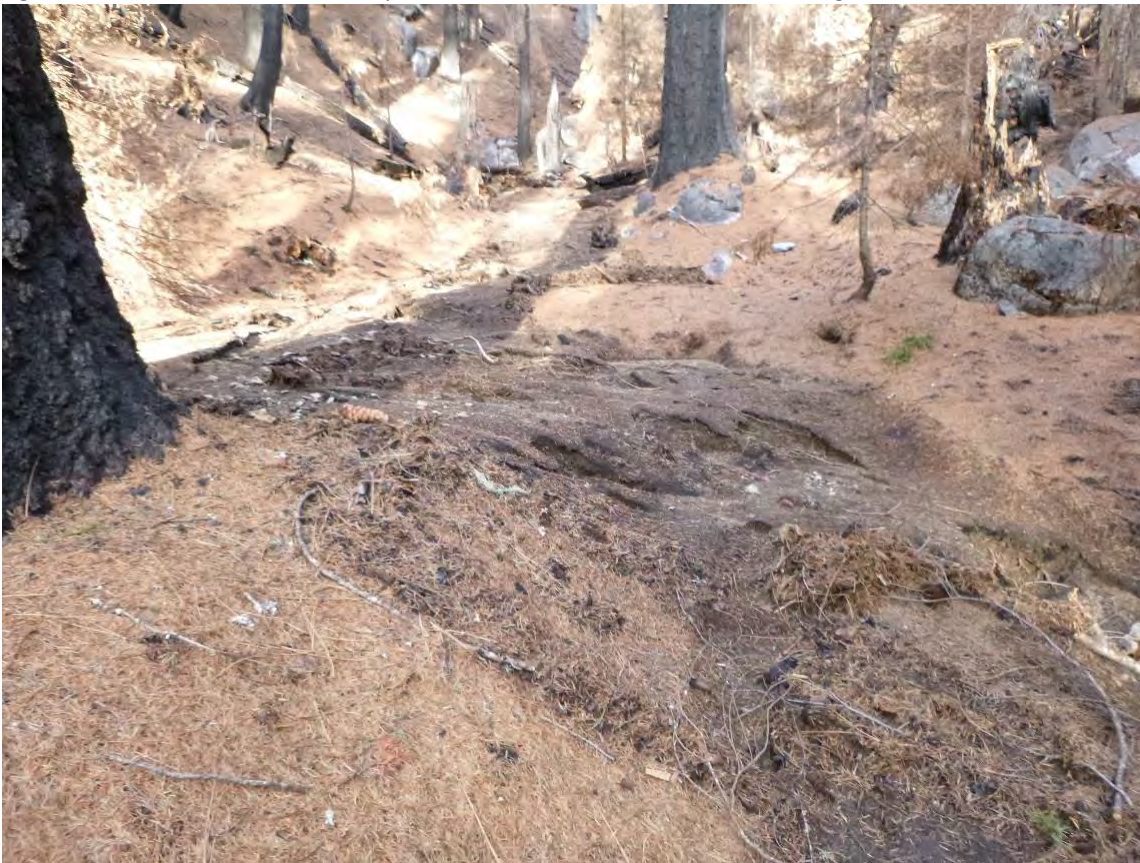
Figure 16. Sheetwash erosion at midslope between 15N17 and the saddle below Irving Mountain.

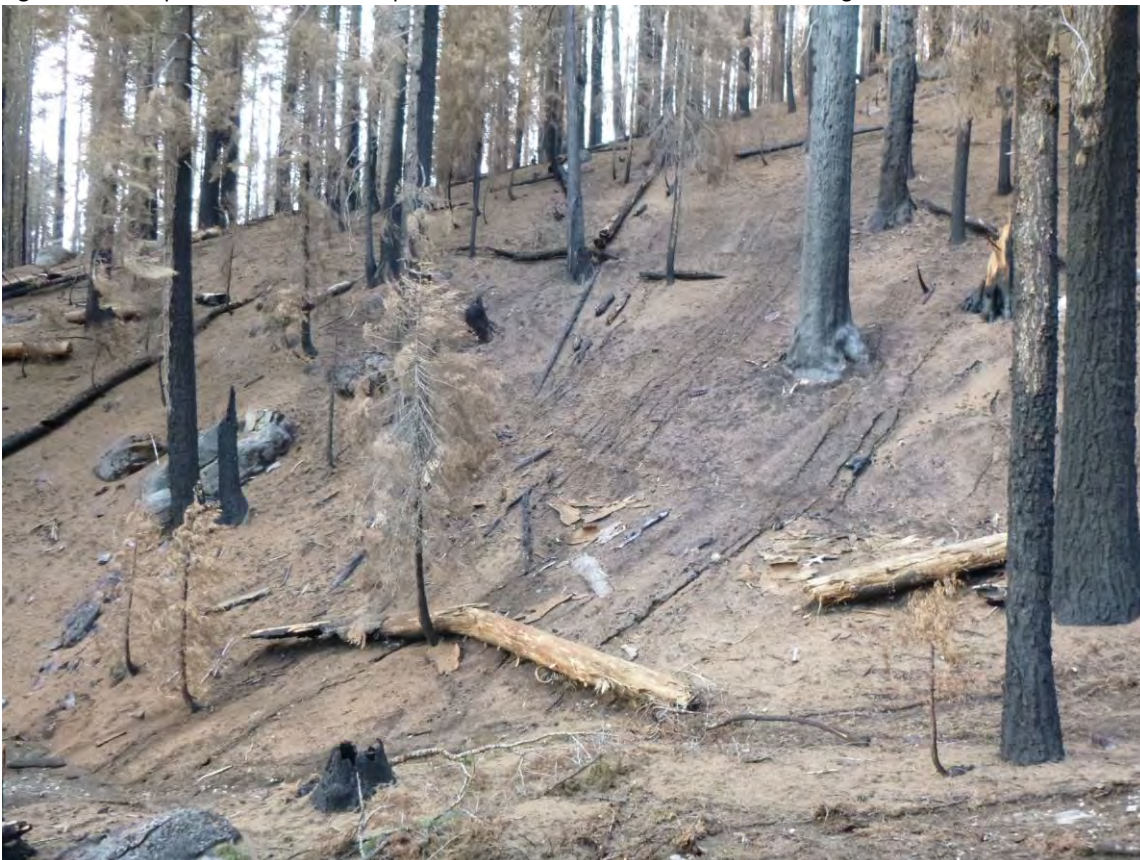
Figure 16. Hillslope rill erosion at midslope between 15N17 and the saddle below Irving Mountain.

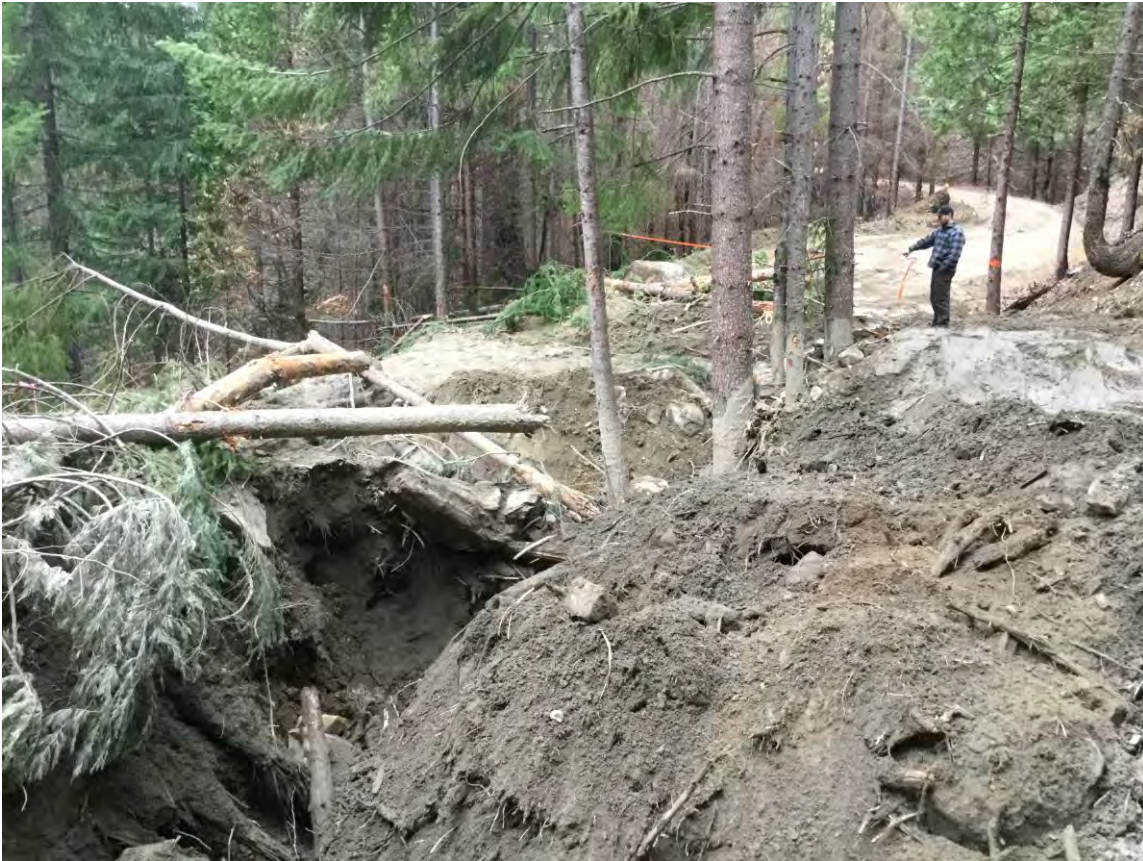
Figure 18. 13N11 buried by failed debris post repair to restore flow.

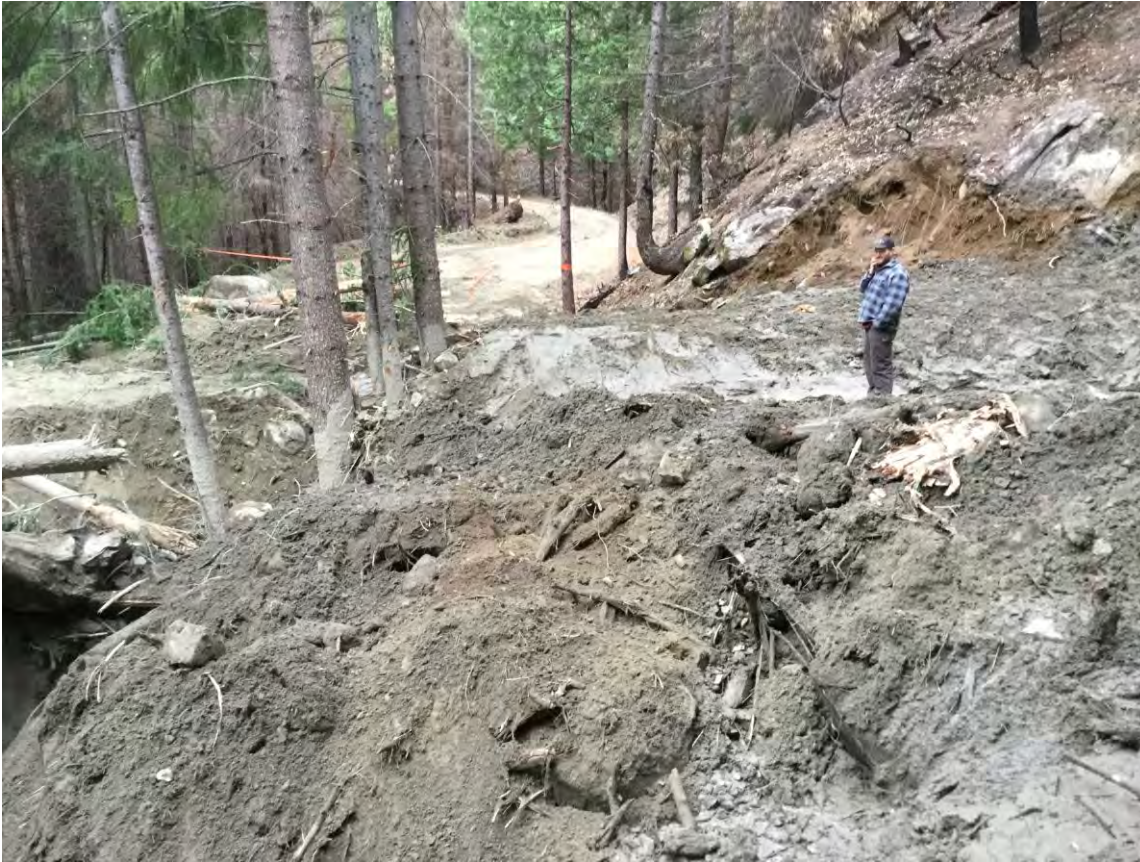
Figure 19. 13N11 buried by failed debris post repair to restore flow.

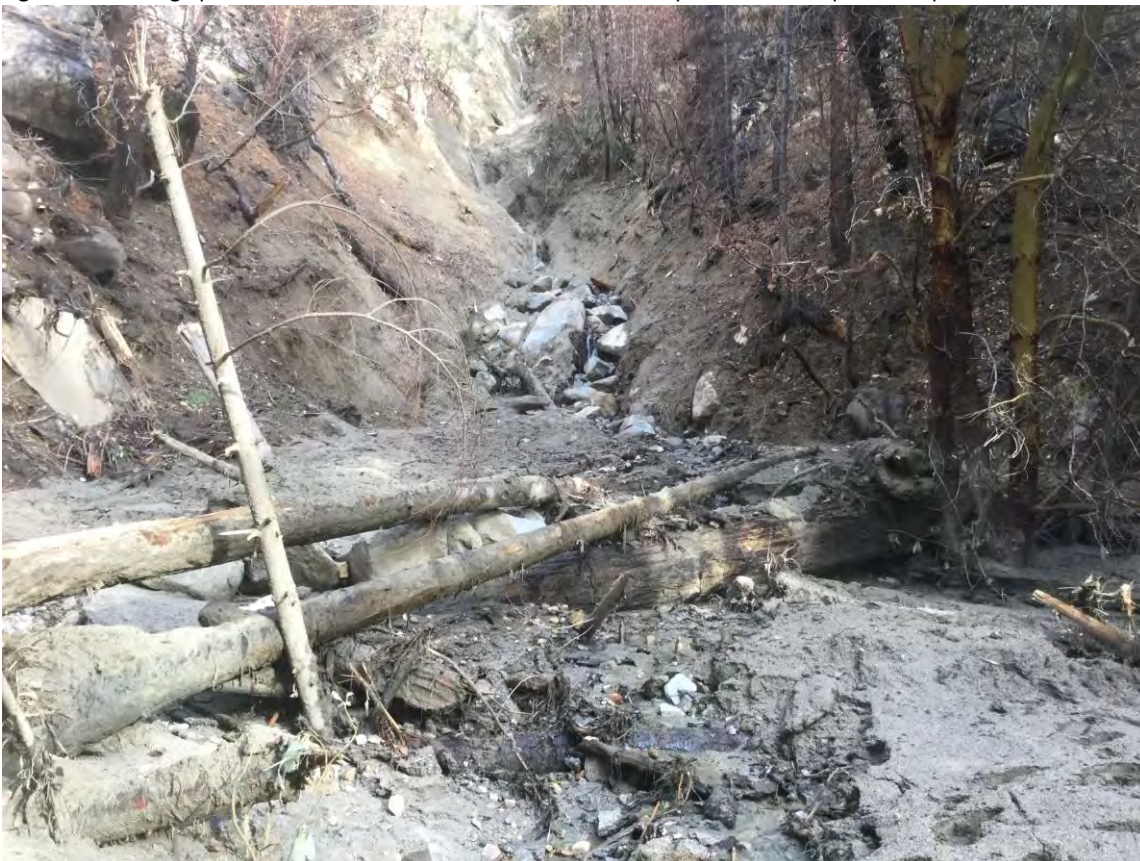
Figure 20. Looking upstream at eroded channel from 13N11. Taken by Adam Dresser prior to repair.

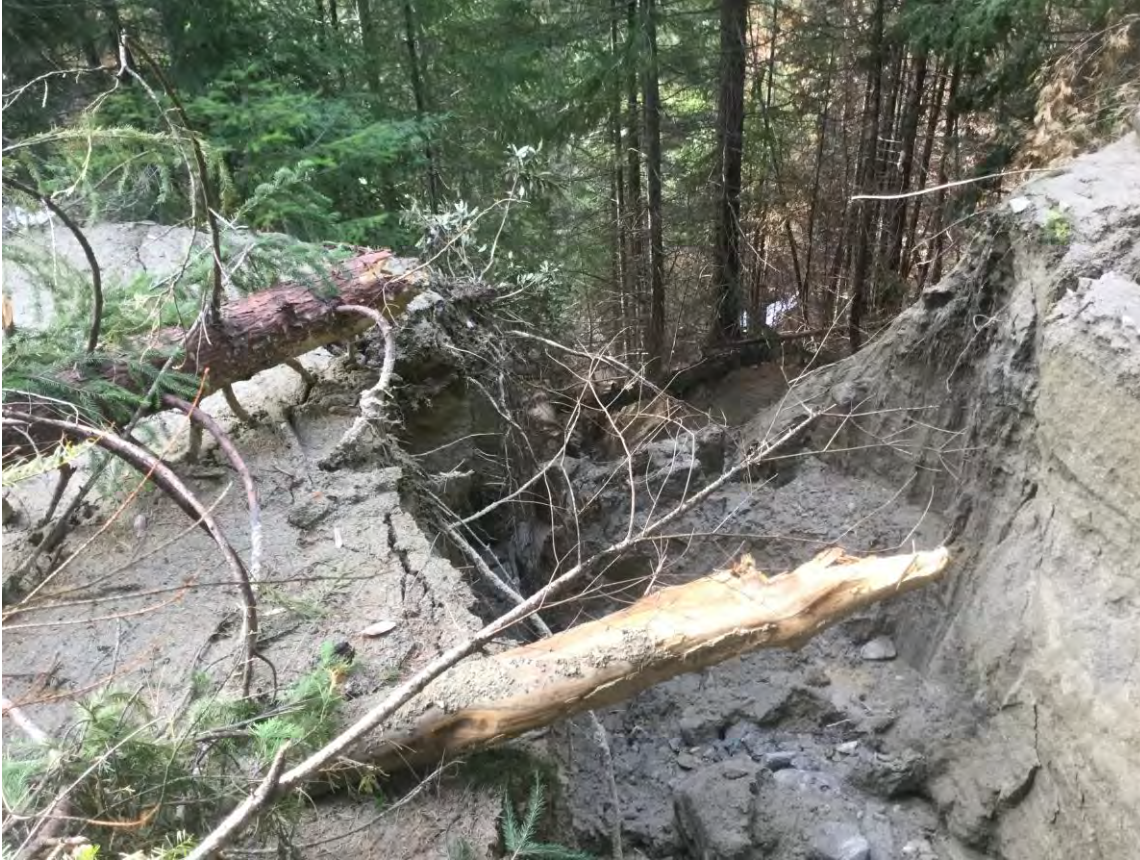
Figure 22. Looking downstream at gully through centerline of fill on 13N11. Taken by Adam Dresser prior to repair.
