Debris Flow Summary, Haypress Fire, 2017

Natalie Cabrera, Acting Forest Geologist

February 7, 2018

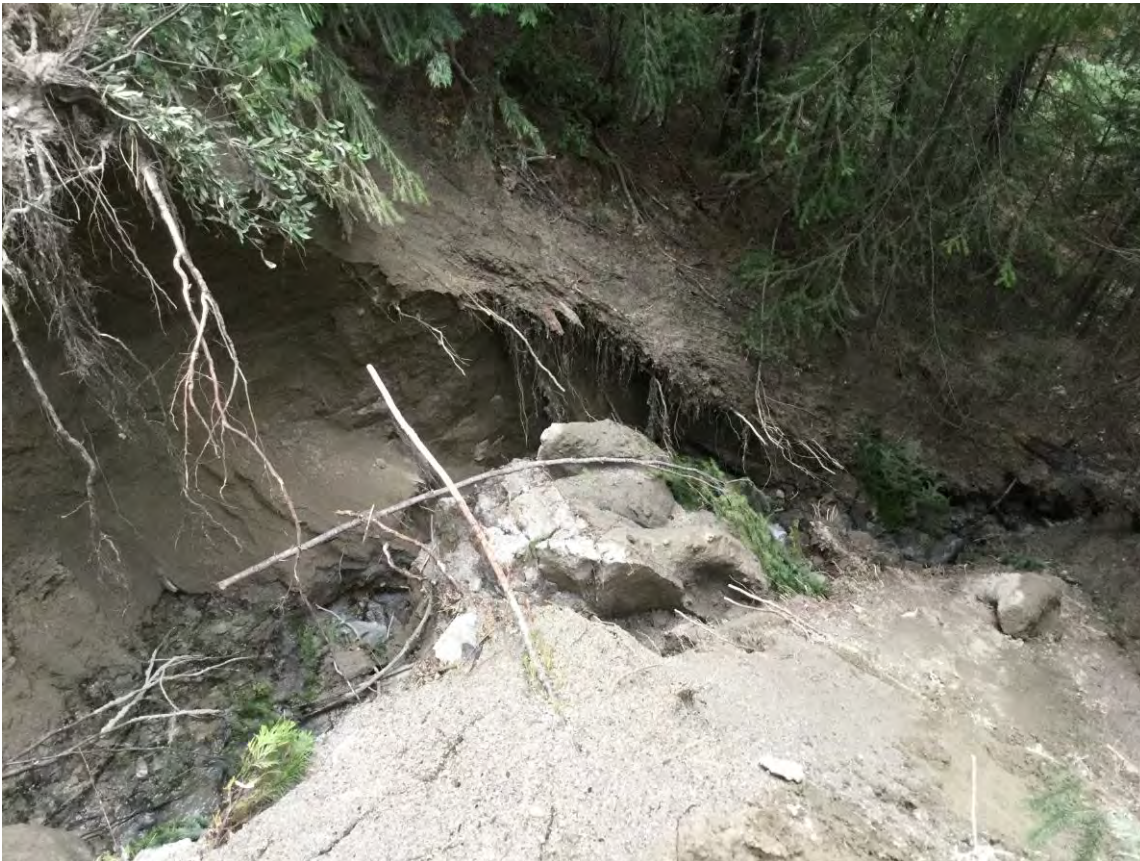
Figure 23. Looking downstream at lower end of gully and base of 13N11 fill.

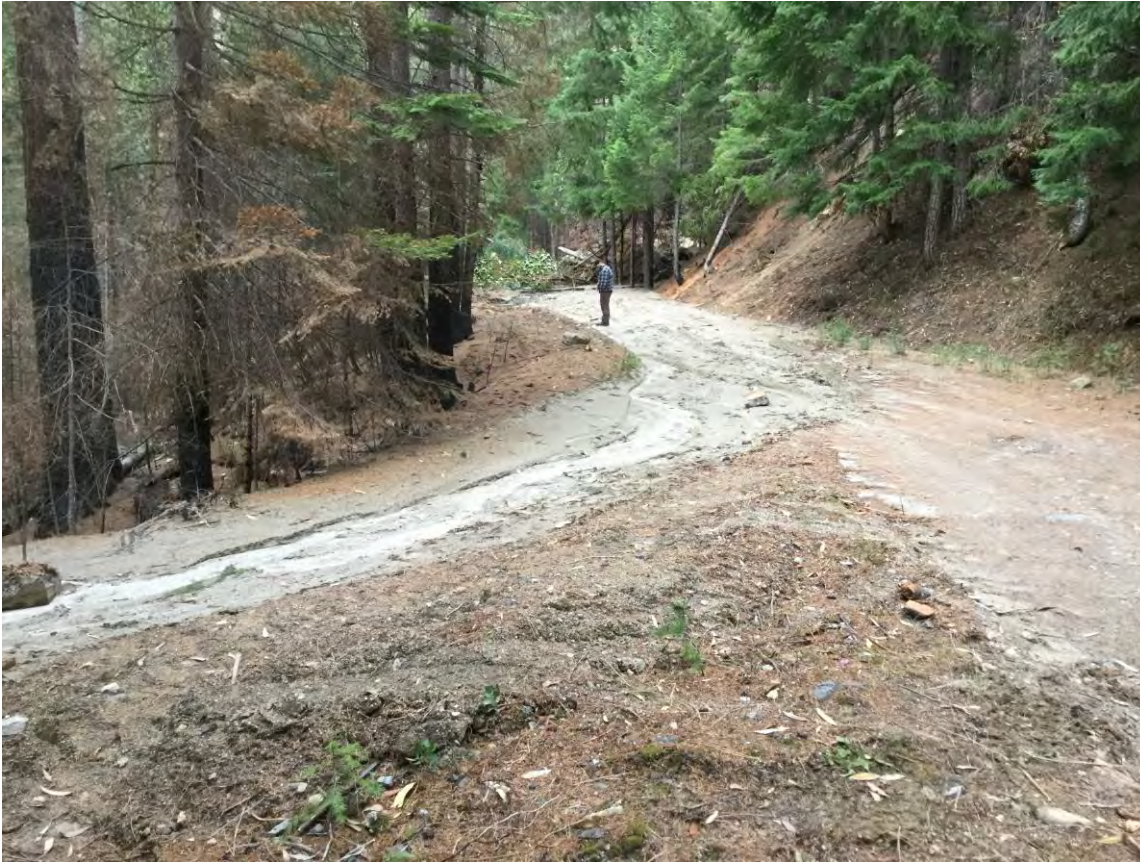
Figure 24. Looking right (if facing downhill) at diverted flow and sediment from debris flow on 13N11.

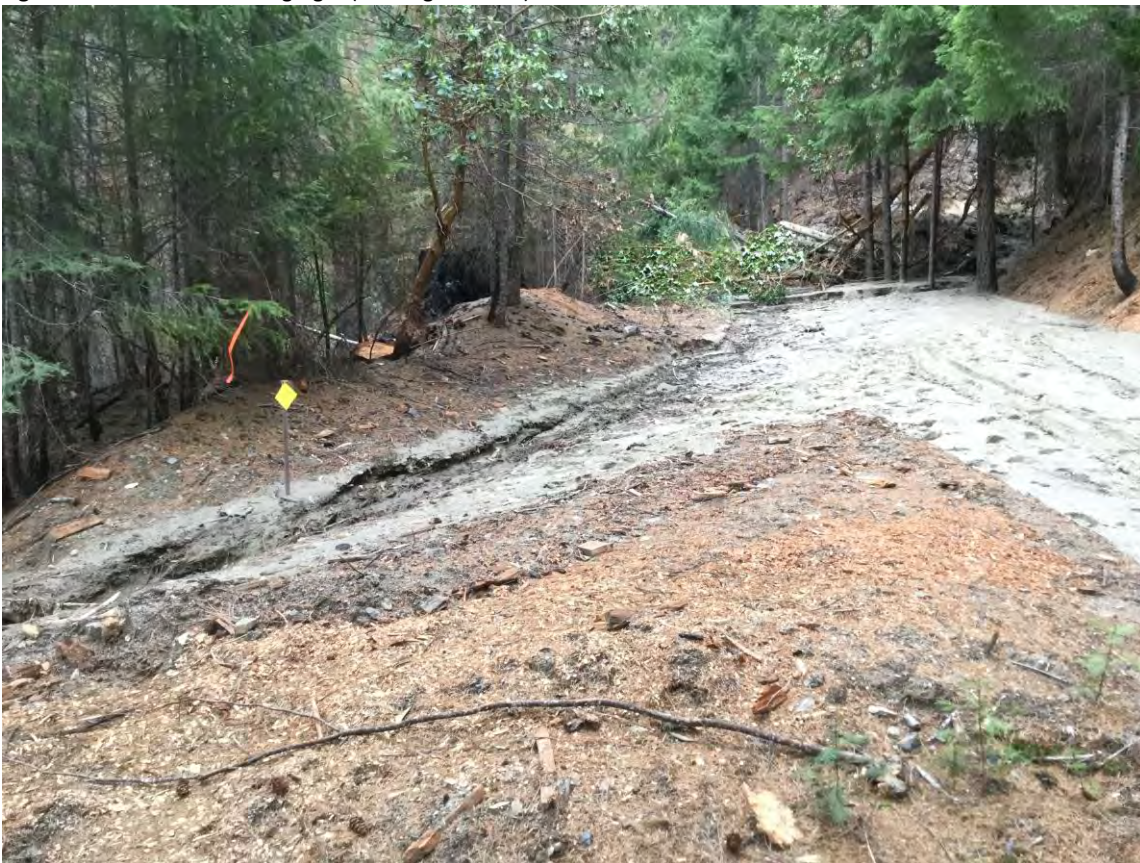
Figure 25. Closer view looking right (if facing downhill) at diverted flow and sediment from debris flow on 13N11.

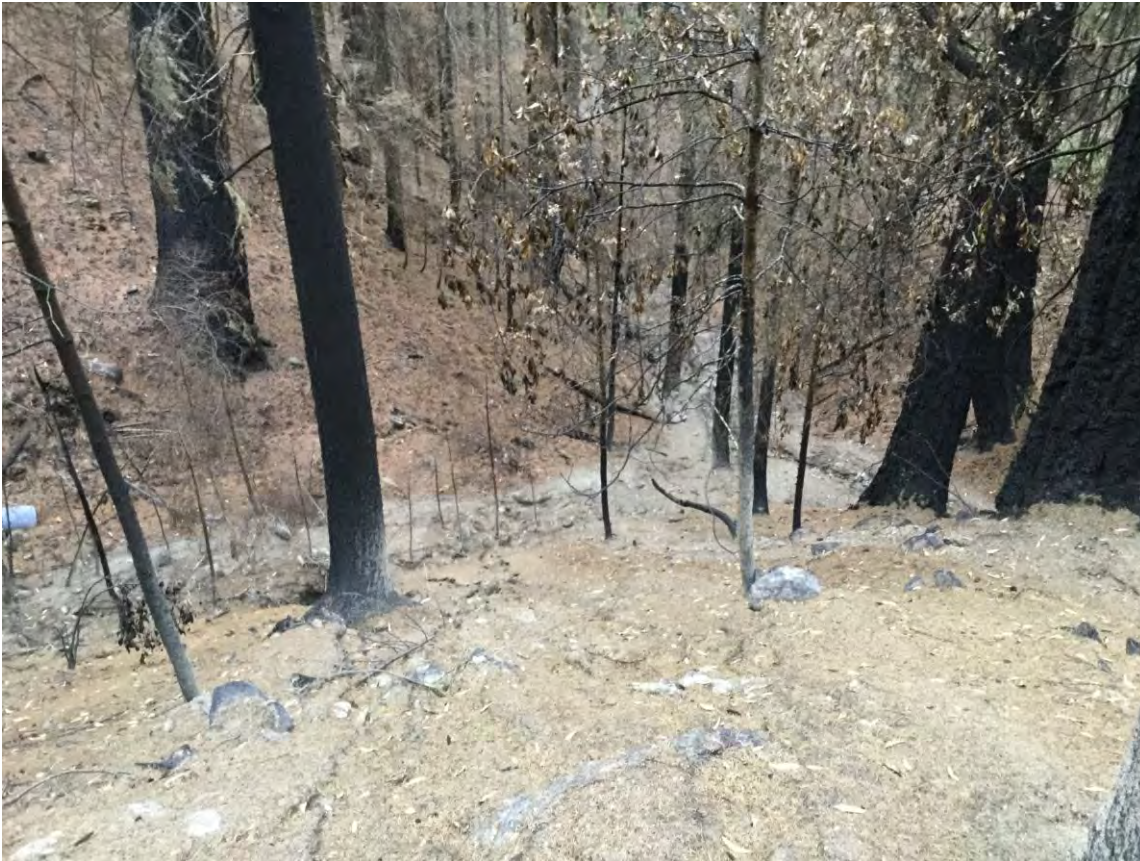
Figure 26. Looking downslope from 13N11 to confluence of channels about 100 feet below road that received debris flow material. Hillslope is also rilled and eroded.
