REACTIVATION OF DEEP-SEATED LANDSLIDES IN NORTHWESTERN CALIFORNIA AFTER WILDFIRES IN 2006 AND 2008 EP13D-0878

Abstract

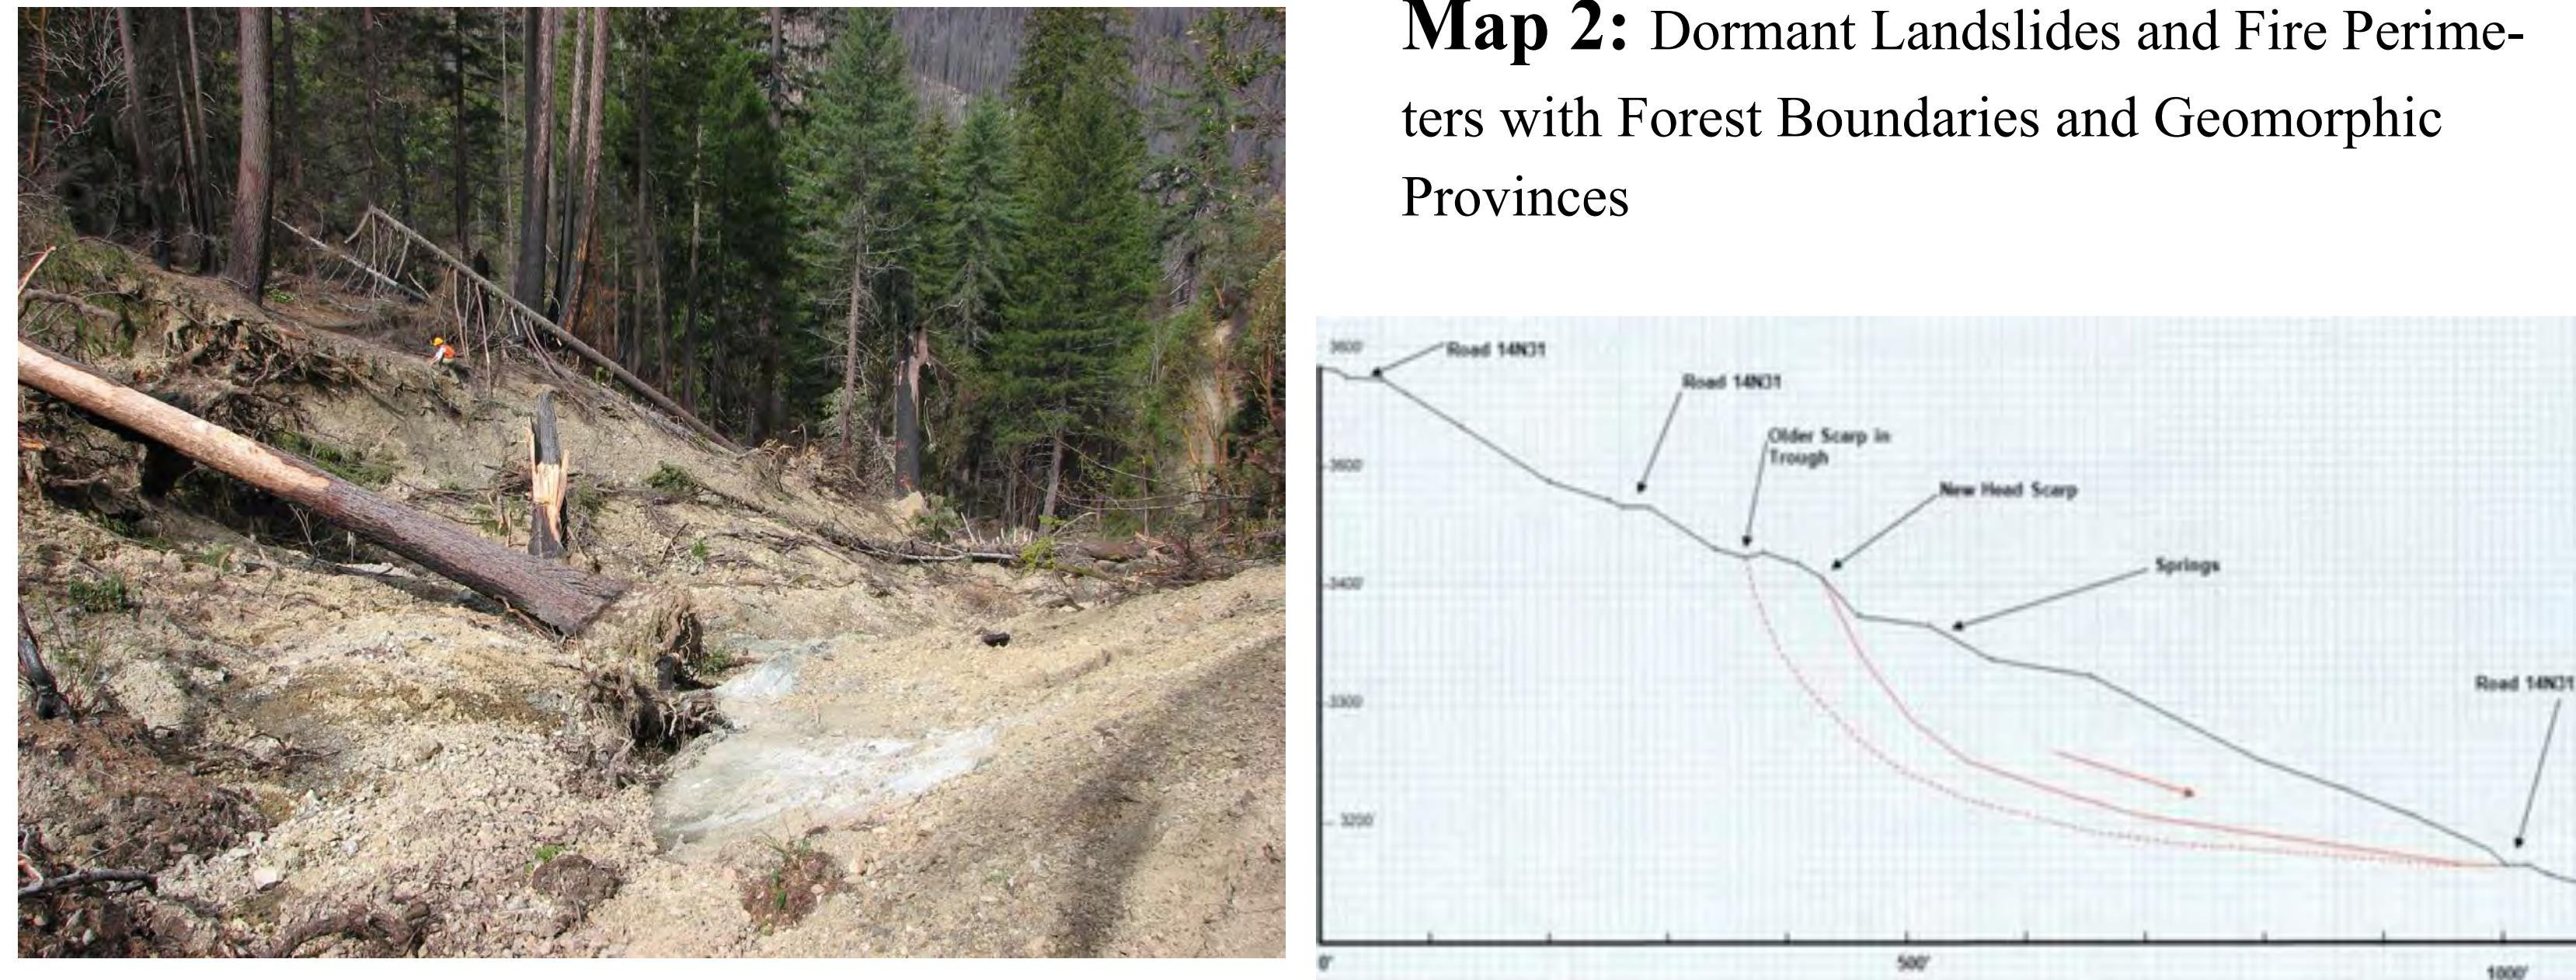
Siskiyou Fire - Slide #2 has rotational translational and earthflow components, and is about 200' wide here. View downhill to the west.

Siskiyou #2 - Activated winter 2009-2010, 15 foot scarps at head, and earthflow in lower portion (blocked road). Very minor movement in 2010-2011, and 2011-2012 (earthflow creep at toe, but little change to the head scarp);

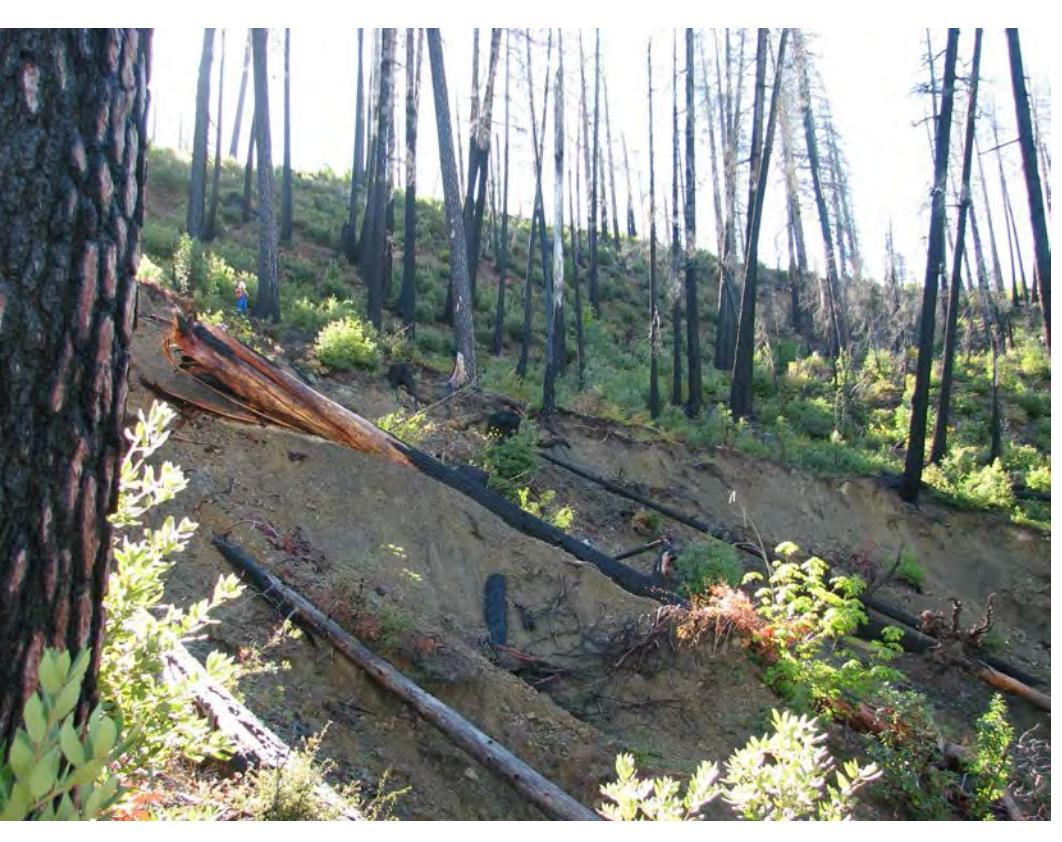
translational landslide.

Siskiyou Fire- #1, debris slide Panther Fire - #6, activated toe Trough Fire - #7, road segment Iron Basin Fire - #9, trees on body about 150 feet wide at toe of of rotational/translational land- (100 ' wide) damaged by rota- of large rotational/translational/ rotational/ slide (raw area in center about 250 tional/translational slide complex. earthflow complex killed by fire. Slide is about 2 miles long and $\frac{1}{4}$ mile wide at photo location.

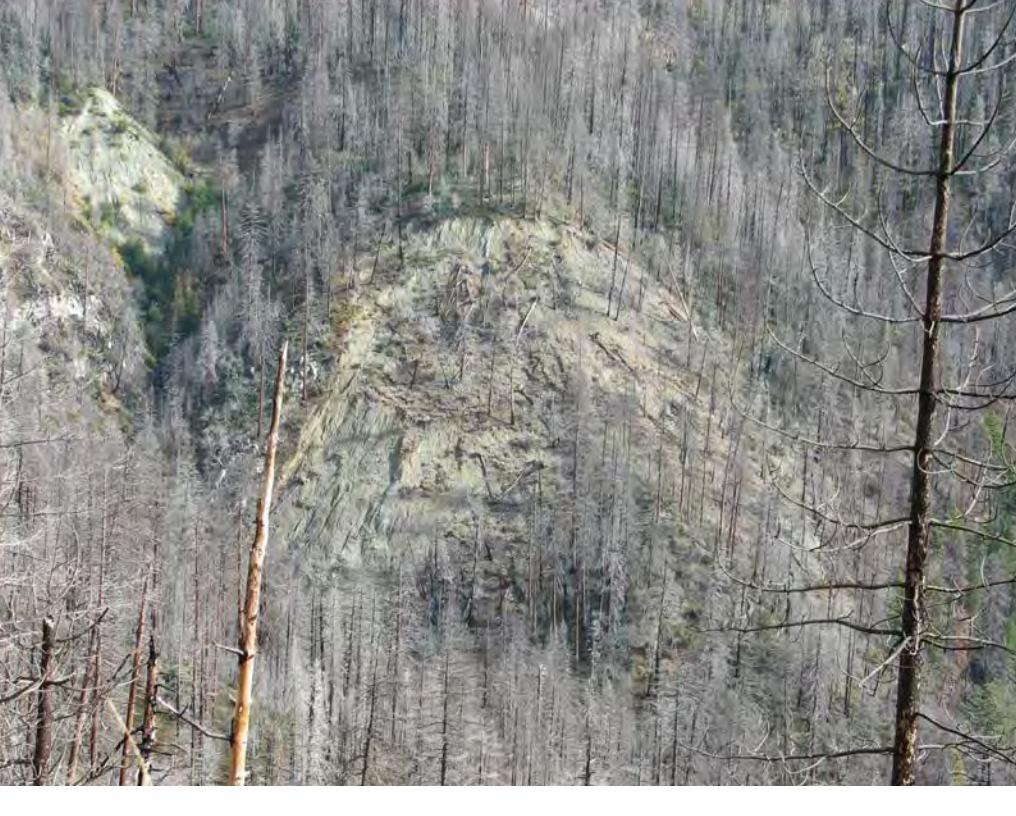
feet wide), producing shallow debris slides.

Panther #6 - First noticed in spring 2011, toe of older slide mobilized, forming raw scarps to 30 feet in height; Toe encroaching on Buckhorn Creek; In winter 2011-2012, little change other than shedding of sediment into stream by shallow debris slides at toe. Movement in head of slide on the order of a few feet.

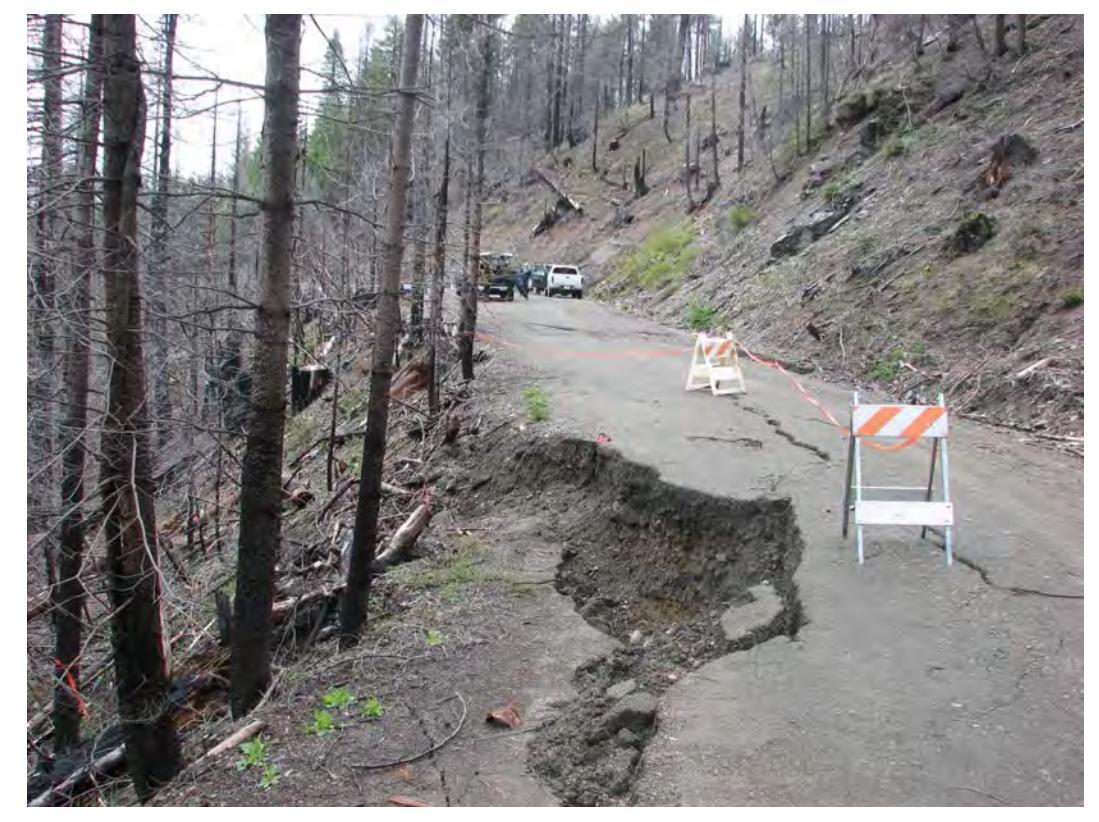
Trough #7 & #8 - Movement on #1 dropped the outside 1/3 of the road about 4 feet, in spring 2011, with cracks immediately above road ditch. Small debris slide (10' wide) on toe. Slide #8 dropped outside shoulder of the road a few inches in spring 2011, and exhibited 6 foot head scarps below the road. In winter 2011-2012, very minor movement on Trough #7, and virtually none on Trough #8.

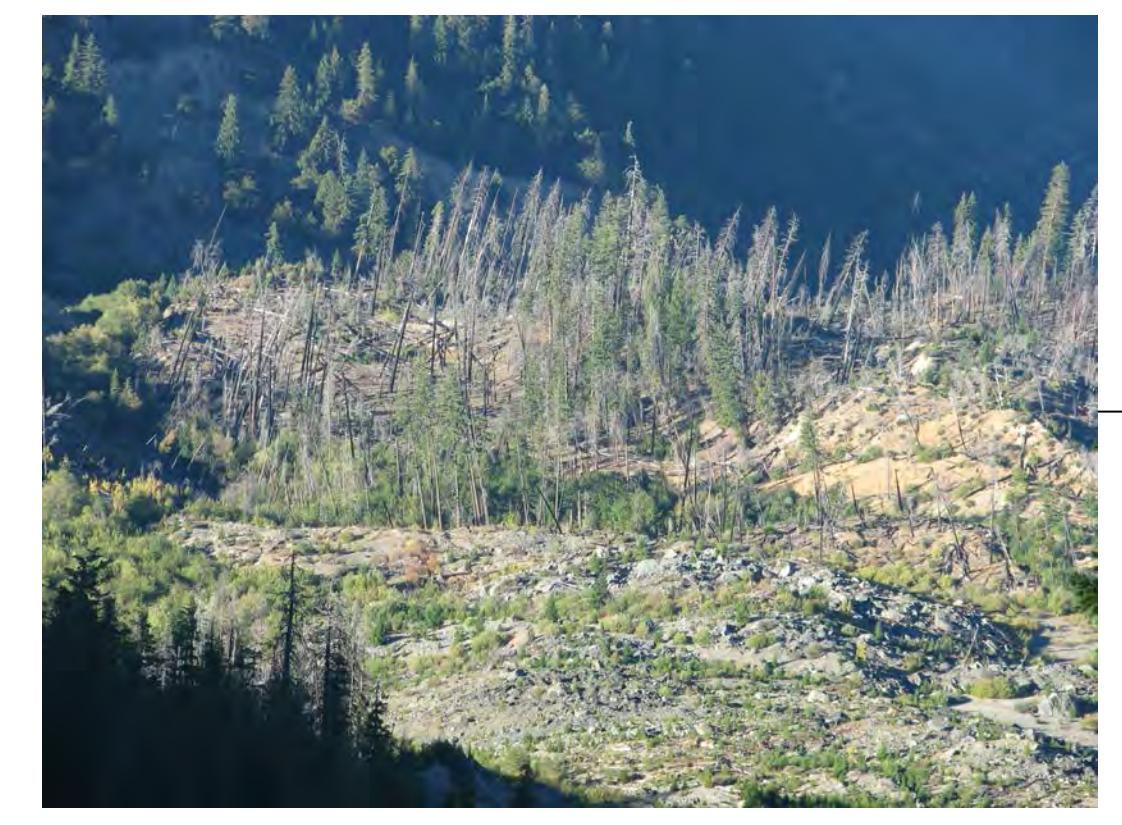
Iron Basin #9 - Huge slide, slope processes and response to fire likely different from the other slides examined due to difference of scale. First occurred in 1996, and field monitoring from 1998 through 2010 showed continued creep of the head of the slide (inches per year). Monitoring pins installed in summer 2010 revealed movement in the head of several inches in summer 2011, but virtually no movement in summer
