DeCoursey Off -Channel Pond

Monitoring Case Study

Mid Klamath Watershed Council

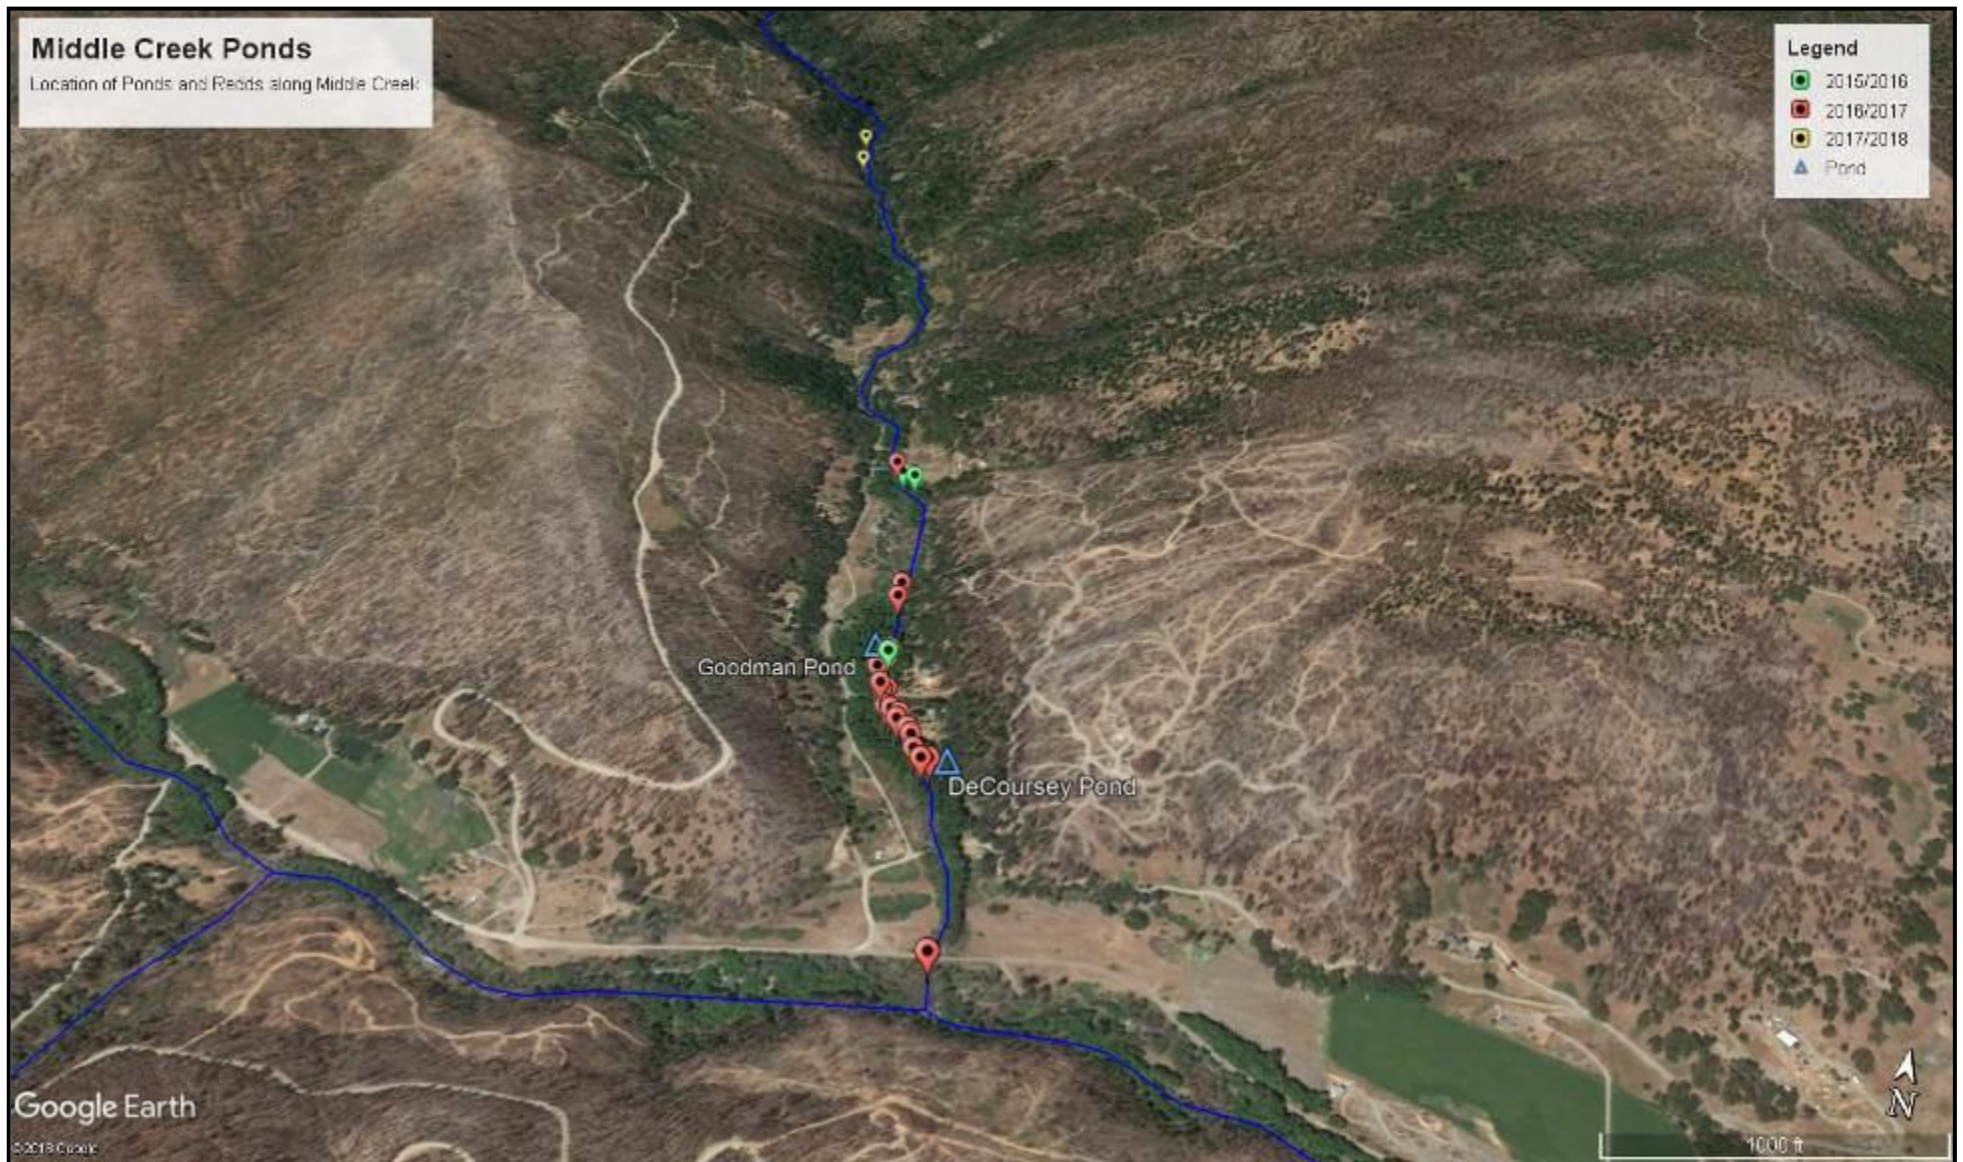
Figure 2: Topographic map of Middle Creek showing location of the two constructed off-channel ponds and three seasons of red locations. In 2016/2017 22 redds were recorded on Middle Creek. MKWC hypothesizes that the five year flood event recorded that year scoured away many of these redds base off of the lower fish counts recorded in the creek and ponds during the spring/summer of 2017.

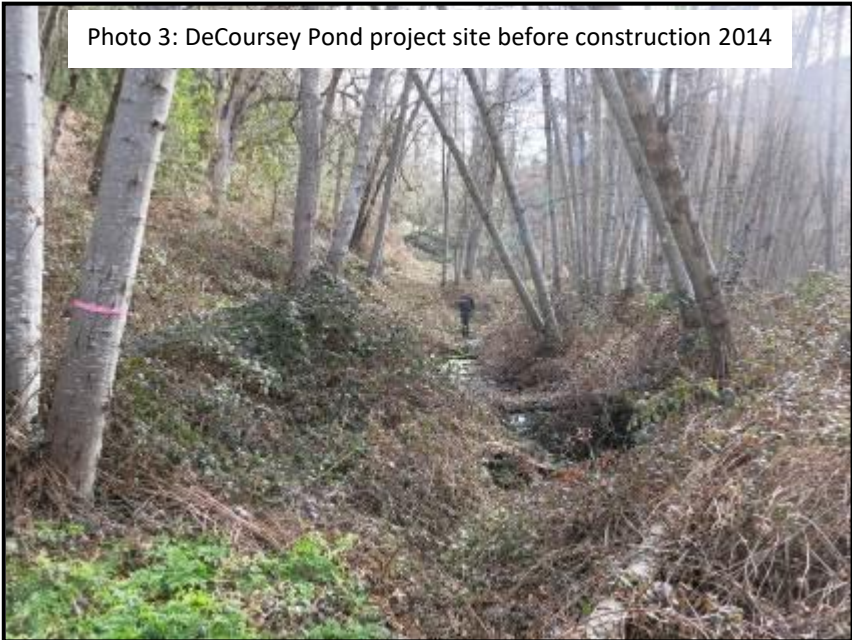
Photo 3: DeCoursey Pond project site before construction 2014

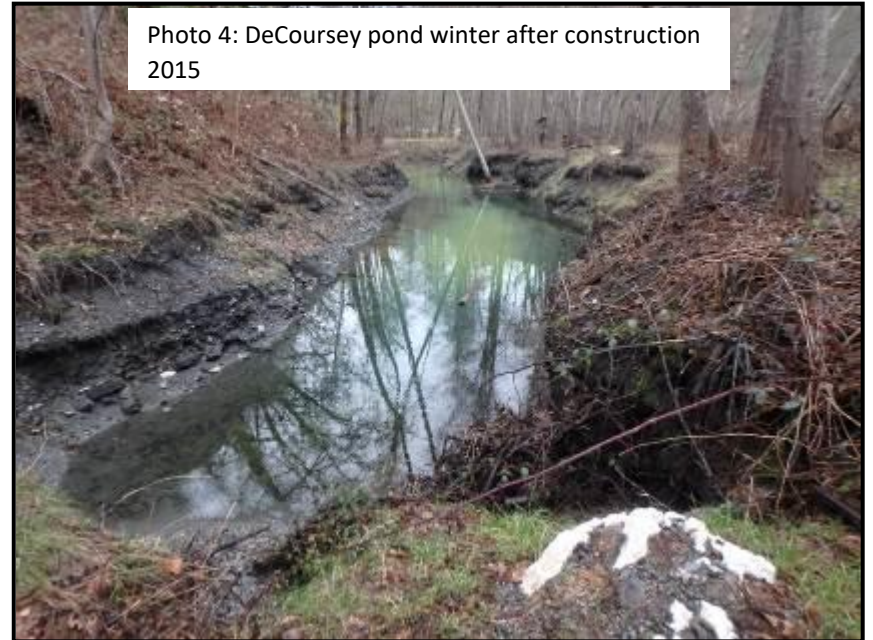
Photo 4: DeCoursey pond winter after construction 2015

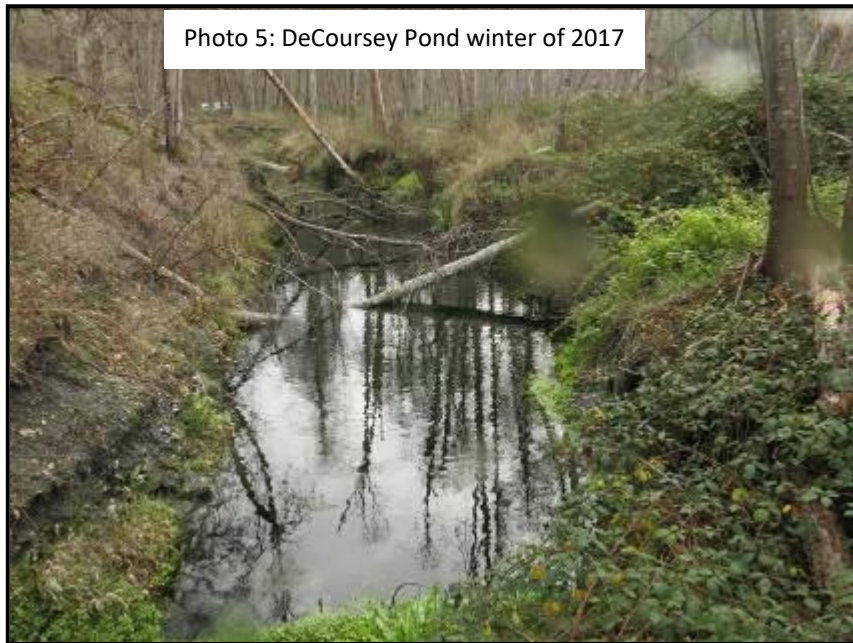
Photo 5: DeCoursey Pond winter of 2017

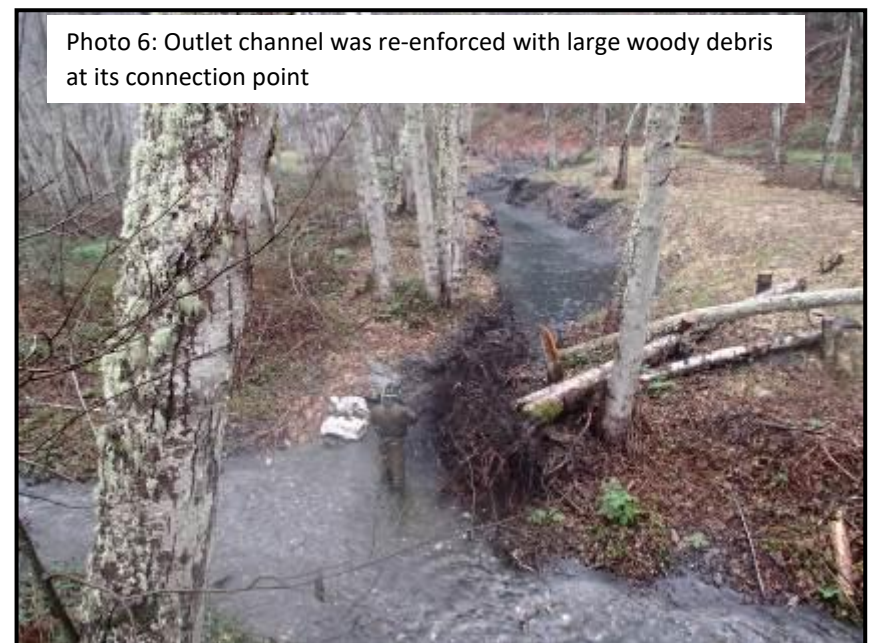
Photo 6: Outlet channel was re-enforced with large woody debris at its connection point

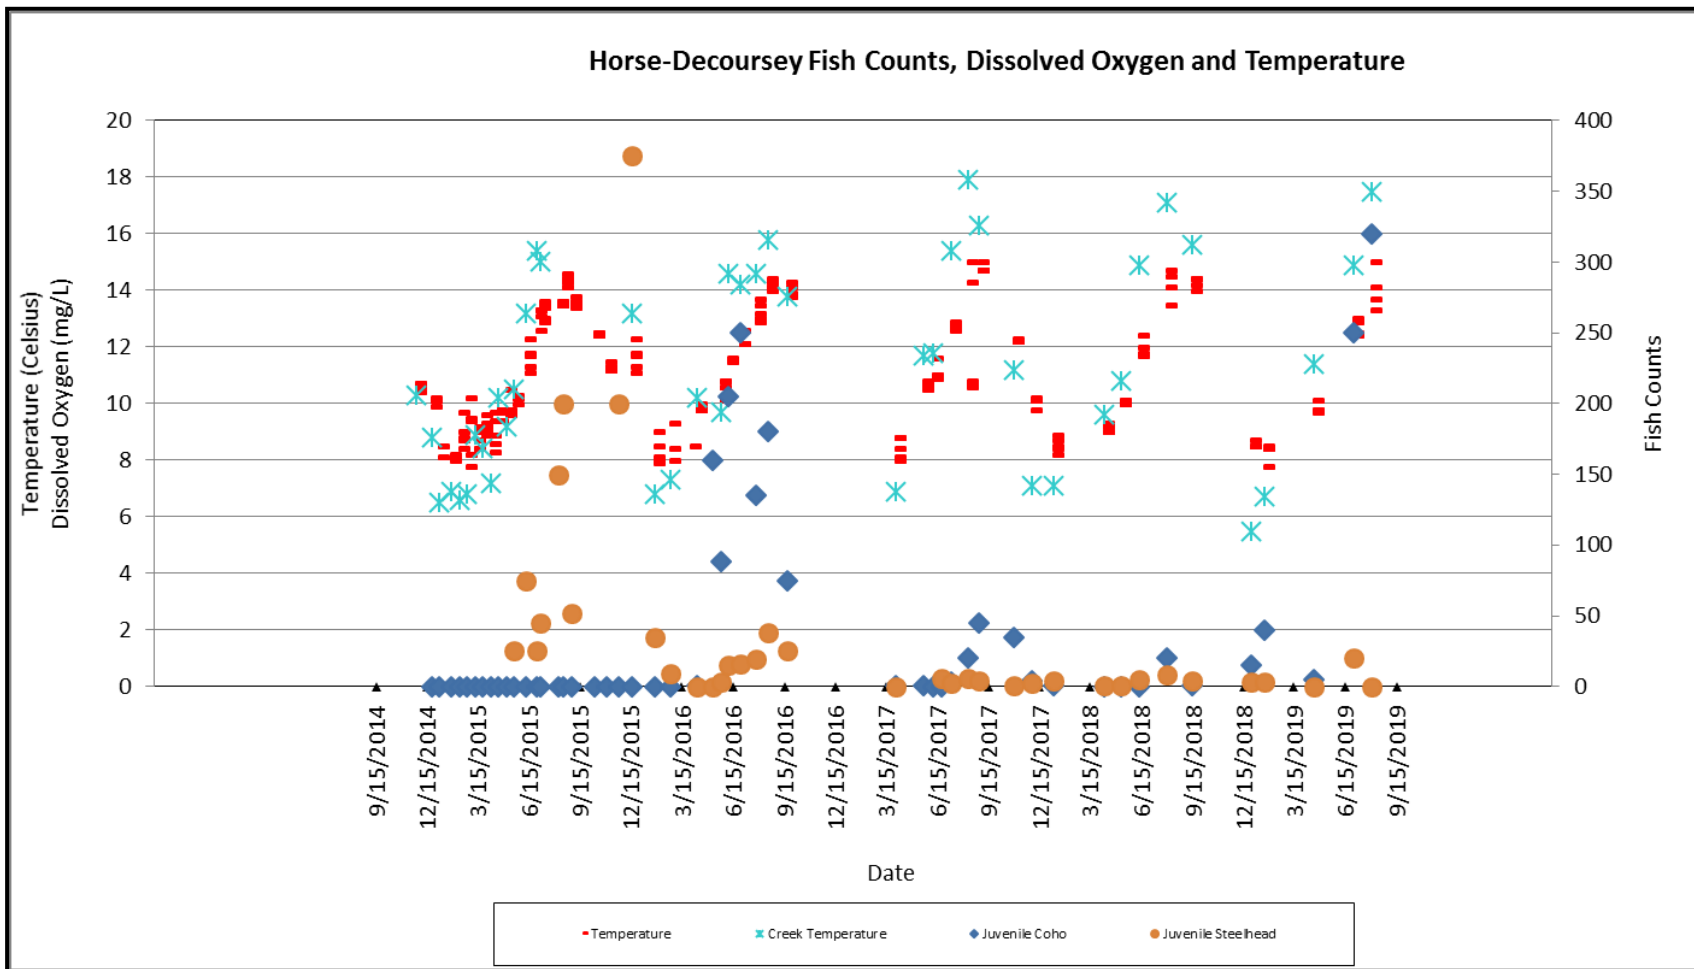
Figure 3: Spot temperature readings and ocular fish counts collected by MKWC during field visits to DeCoursey

DeCoursey O.C.P. has been found to provide optimal conditions for both summer and winter refuge for coho juveniles since we have been monitoring this feature in 2014. Like other constructed off-channel ponds MKWC has constructed, DeCoursey Pond provides extremely stable temperatures throughout the year, with a yearly fluctuation of around six degrees Celsius. This is likely attributed to the perennial ground water input to the pond and the riparian forest surrounding the feature. Low fish counts in the 2017 and 2018 years could be attributed to the vastly increased cover within the pond after the 2016 Gap Fire. Large amounts of wood within the pond have made it difficult to obtain accurate counts and we have now switched our protocols from ocular counts to presence/absence surveys due to the difficulty obtaining accurate survey data. We hypothesize that all of the fish using the DeCoursey Pond are natal to Middle Creek because of an old, undersized culvert crossing near the mouth of the creek. This culvert can be an adult barrier in low flow years and seems to be a barrier to upstream juvenile migration year round. This hypothesis is based off of the presence/absence counts collected by MWKC staff. Figure one illustrates a trend where young of the year are documented moving into the ponds in May and June followed by a large outmigration in the late fall with small numbers staying in the pond overwinter. Fish counts were collected by senior MKWC staff during snorkel surveys.

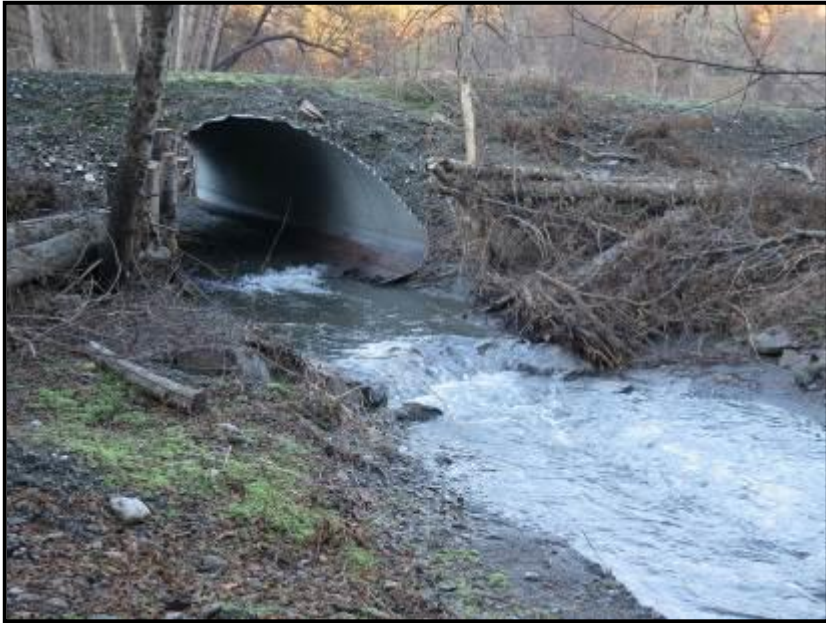
Photo 6: Culvert crossing on Middle Creek during high water event in December 2016

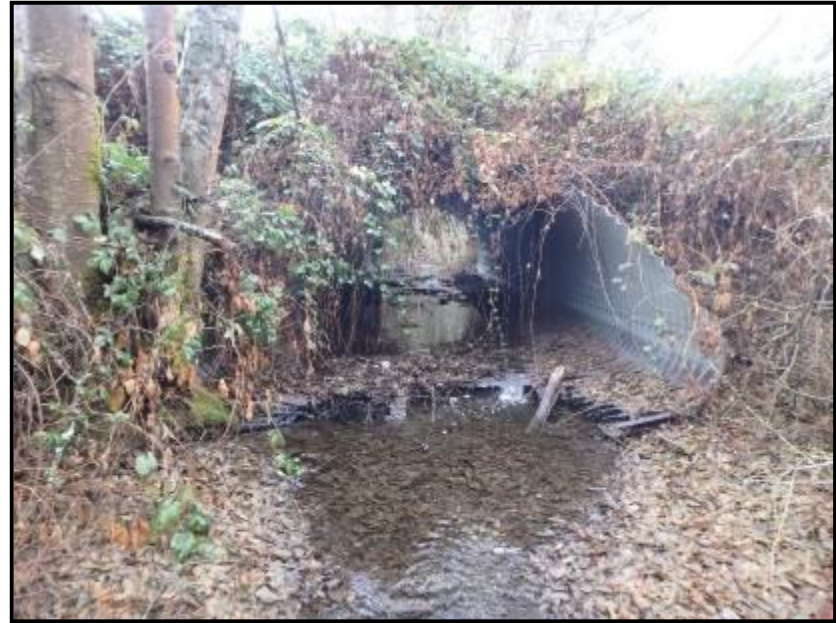
Photo 7: Culvert during low flows in December of 2015

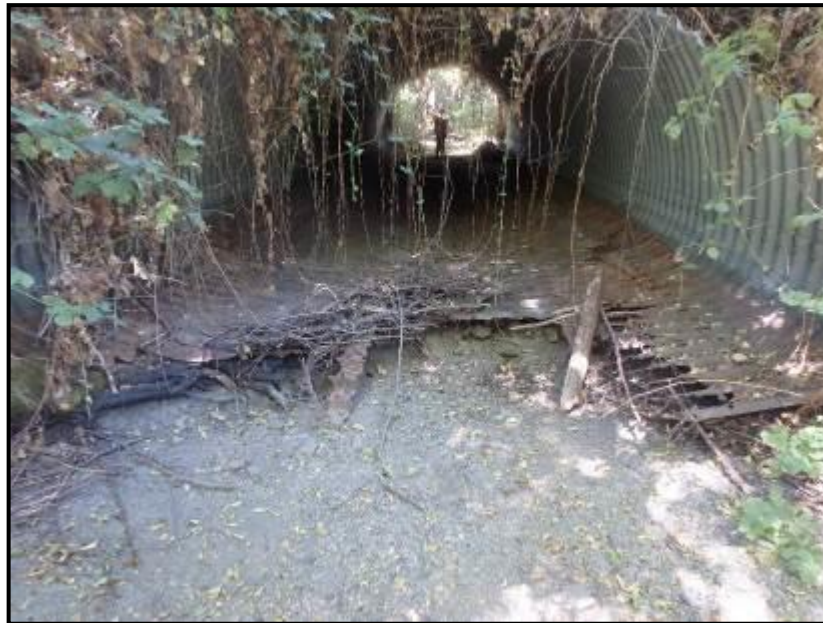
Photo 8: Dry creek channel in July of 2015

Despite having found abundant groundwater at this site in 2012 and 2013, and reports of perennial surface flow in Middle Creek from local residents, the summers of 2014 and 2015 both saw the lower one mile of Middle Creek dry up during the summer and early fall months. This was the first project MKWC constructed adjacent to a dry creek channel. The results of groundwater monitoring at the site throughout the summer of 2014 gave us confidence that the pond could be dug to a depth that would maintain an adequate amount of quality water throughout the driest seasons. The pond was dug approximately five feet deeper than designed to accommodate the historically low groundwater elevations, and though it did maintain the desired depth and quality of water throughout the summer of 2015, the extra depth significantly added to the amount of fill removed from the pond, and without increasing the footprint of the pond, the excavated edges became very steep and vulnerable to erosion. In hindsight, we would have altered the footprint of the pond, decreasing its length and increasing its width to maintain the original design's square footage while not sacrificing overhead canopy cover.

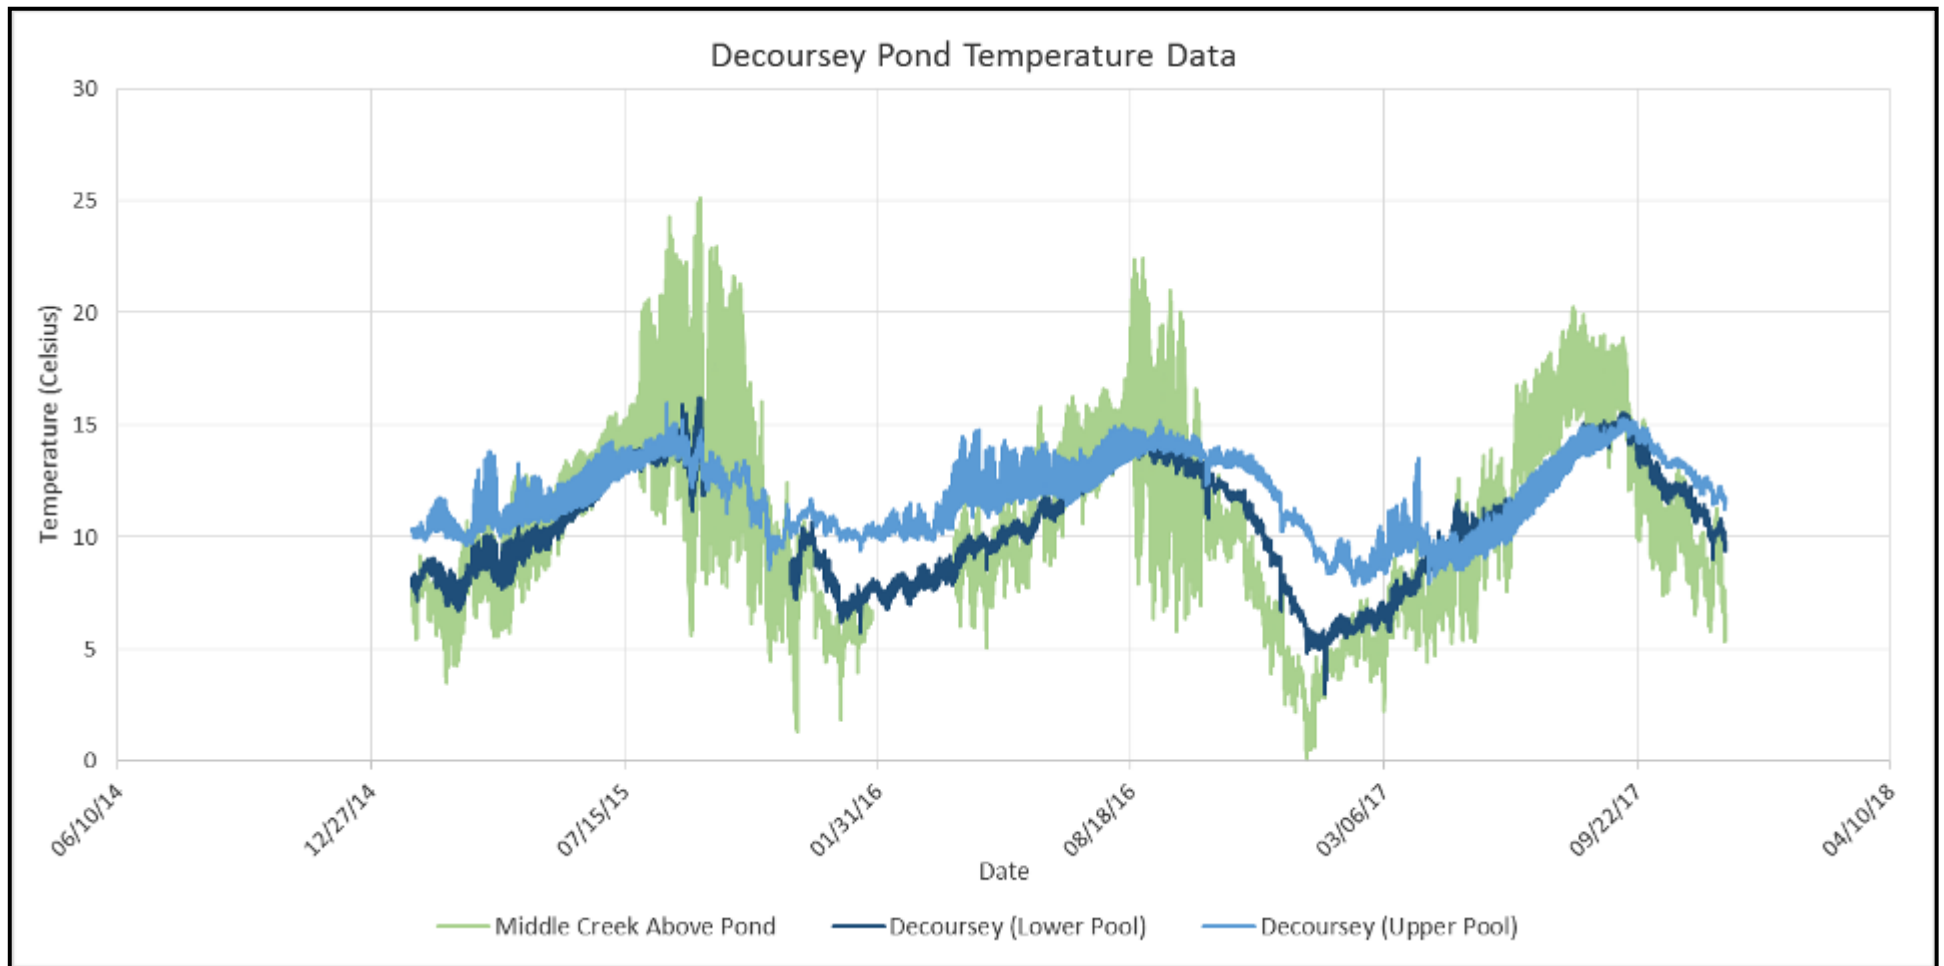
Figure 4: Temperature data collected by Hobo temperature logger deployed in the pond and creek. Loggers are set to take a reading once an hour. Two loggers are deployed in the pond, one in the lower pool which connects to the creek and one in the upper pool. One logger is deployed above the pond in Middle Creek. High spikes in creek temperature in 2015 and 2016 indicate the creek went subservice. The creek stayed connected during the summer of 2017.

DeCoursey Pond is heavily influenced by ground water which translates to very stable temperatures with small daily diel temperature fluctuations throughout the year (see figures). Two HOBO temperature loggers are deployed at the top (depth of 5 feet) and bottom of the pond (depth of 4.5 feet). Along with these two loggers, a U26 temperature and DO logger is deployed along the center line of the pond at a depth of 3.5 feet. The average daily temperature over three years of monitoring is 11.7 degrees Celsius with a three year minimum temperature of 2.98 degrees Celsius in the lower half of the pond and 7.89 degrees Celsius in the top half of the pond and a three year maximum temp of 15.29 degrees Celsius. The difference in temperatures at a depth of five feet compared to a depth of one foot is approximately .4 degrees Celsius during the summer (based off of three years of monitoring). This stable temperature regime provides excellent growth conditions for juvenile salmonids rearing in the pond throughout the year. This type of thermal stability is a common characteristic of habitats with strong groundwater connections.

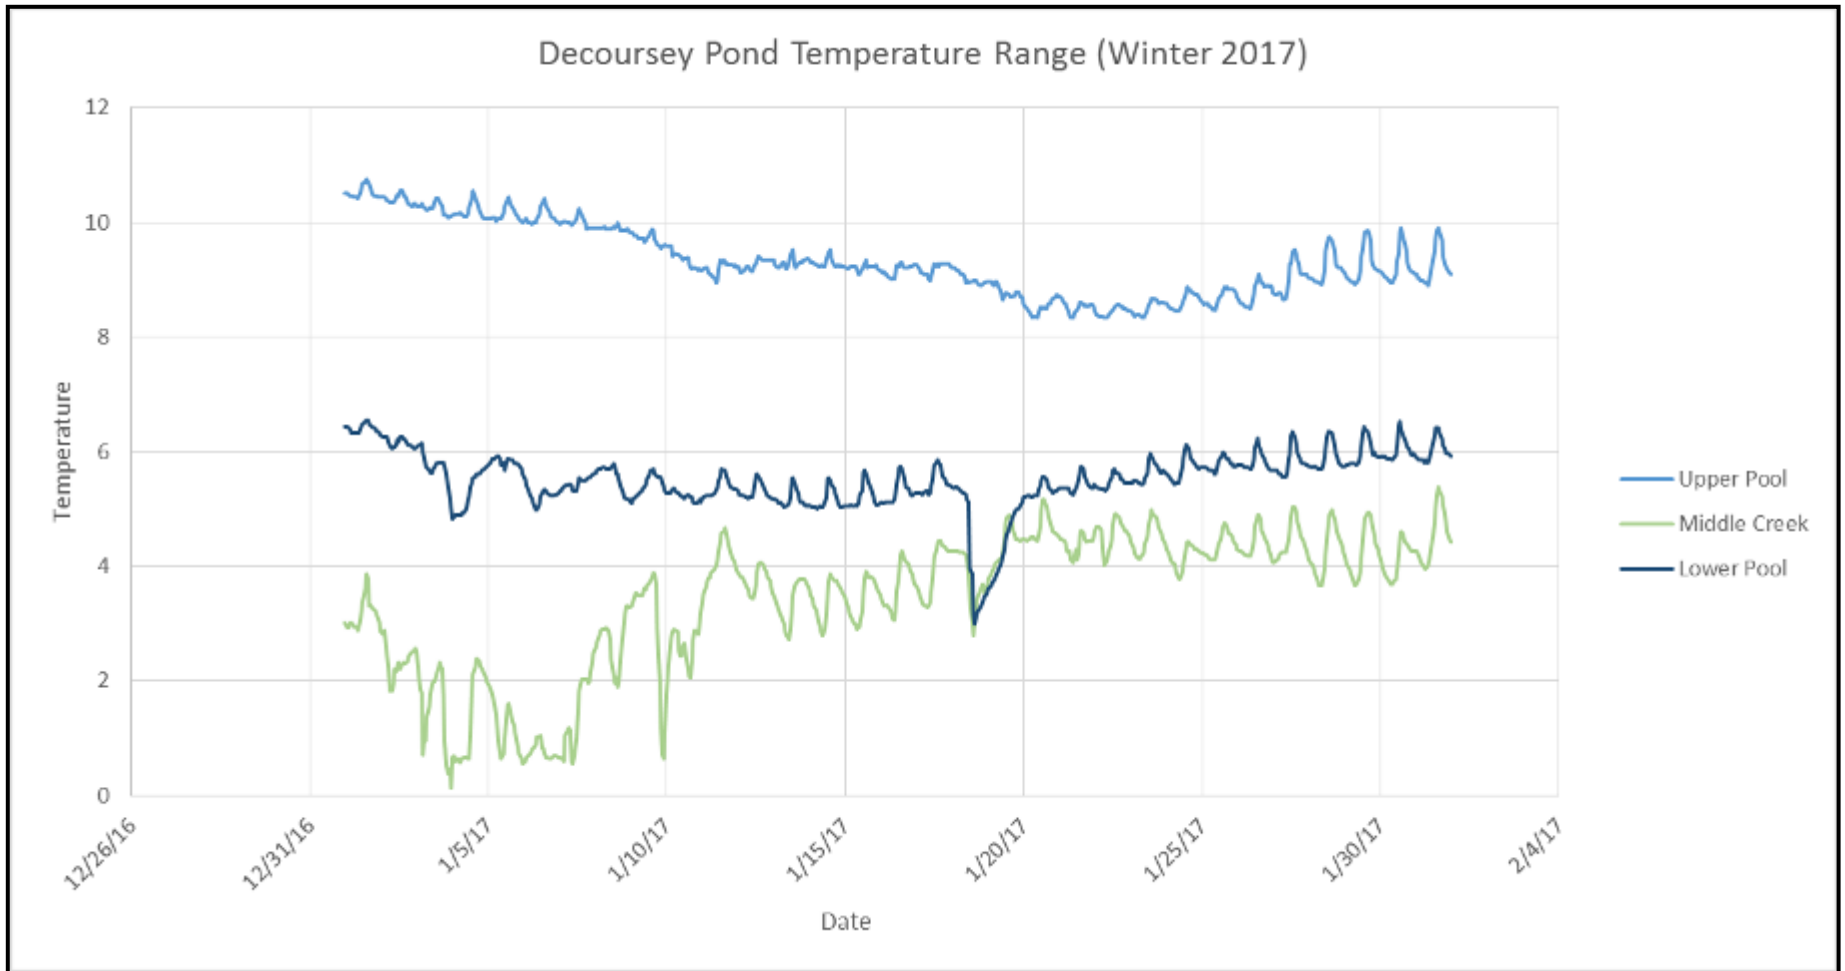
Figure 5: Monthly temperature snap shots collected by Hobo data loggers. Temperature in the pond are several degree warmer all winter than temperature in the adjacent creek. The upper pool of the pond is on average almost 4.5 degrees warmer/day than Middle Creek.

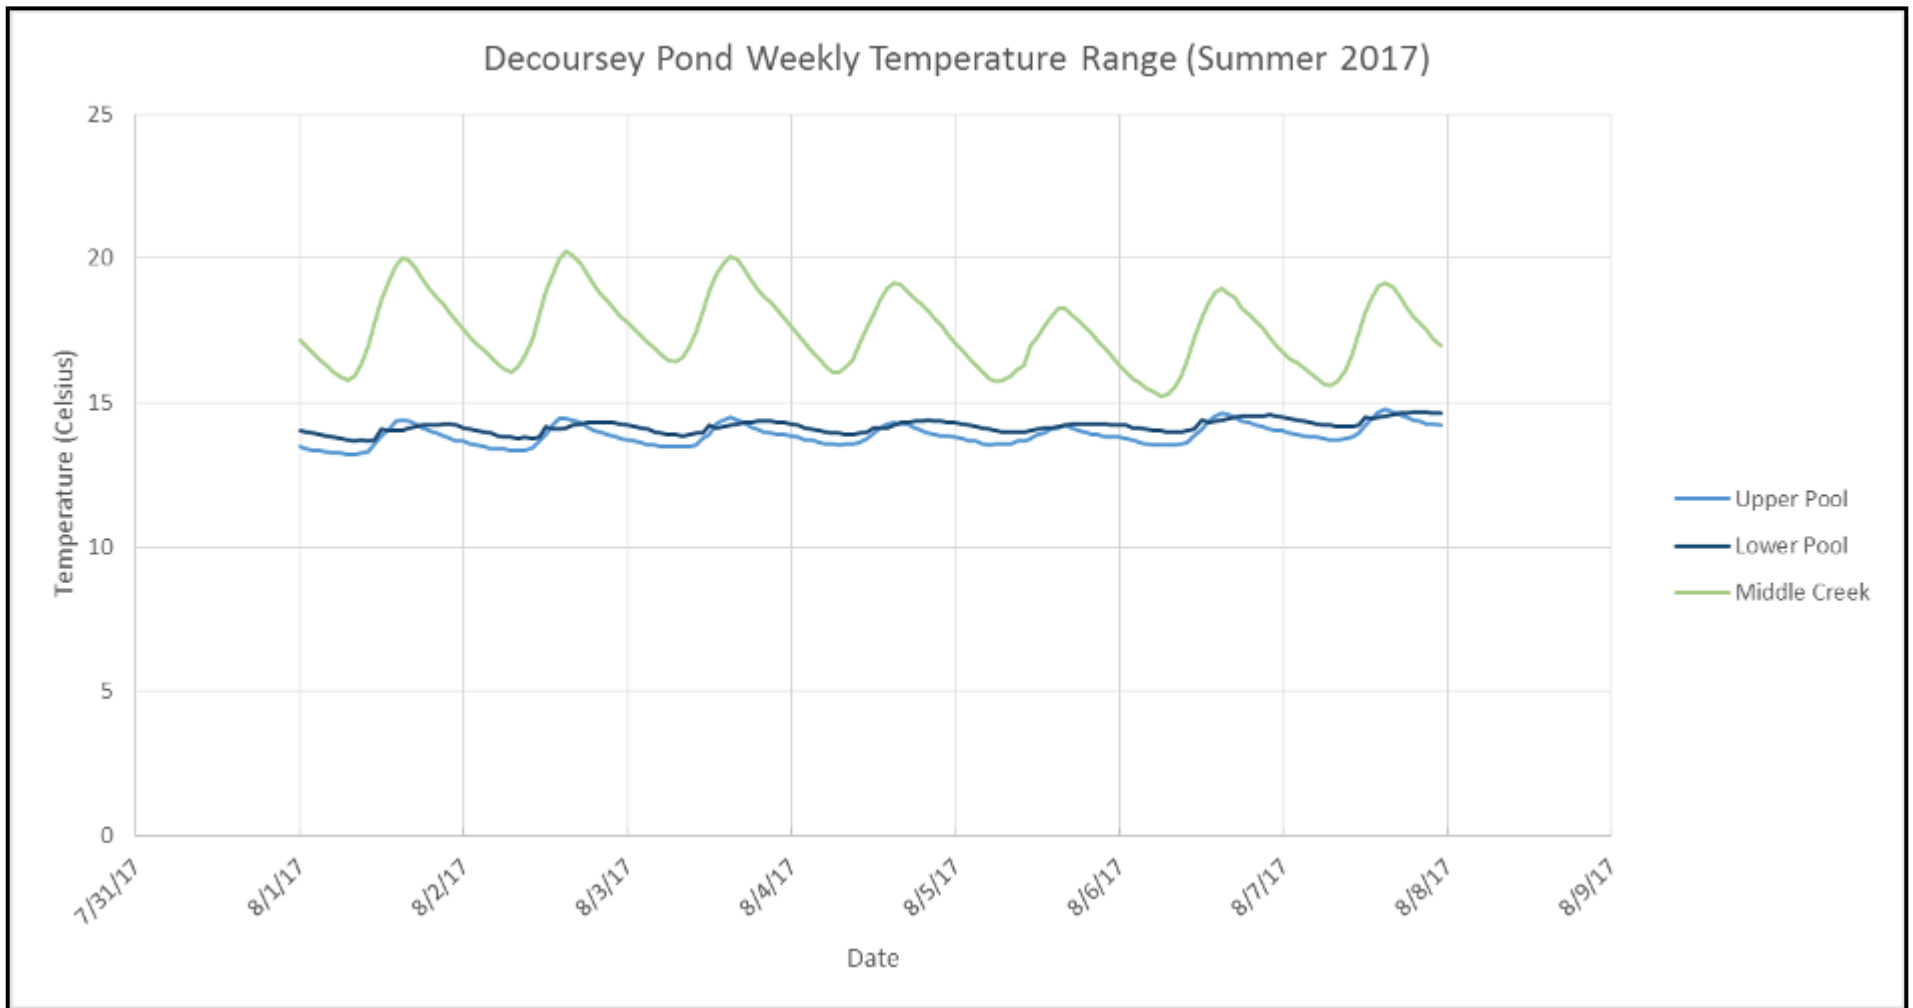
Figure 6: Weekly temperature fluctuation graph. DeCoursey pond had very little diel temperature change during hot summer months. Daily variation is approximately 1.5 degrees Celsius a day. This graph illustrates one of the hottest weeks of the year 2017 temperatures in the pond never peaked over 15 degrees Celsius, well below stressful levels for juvenile salmonids.

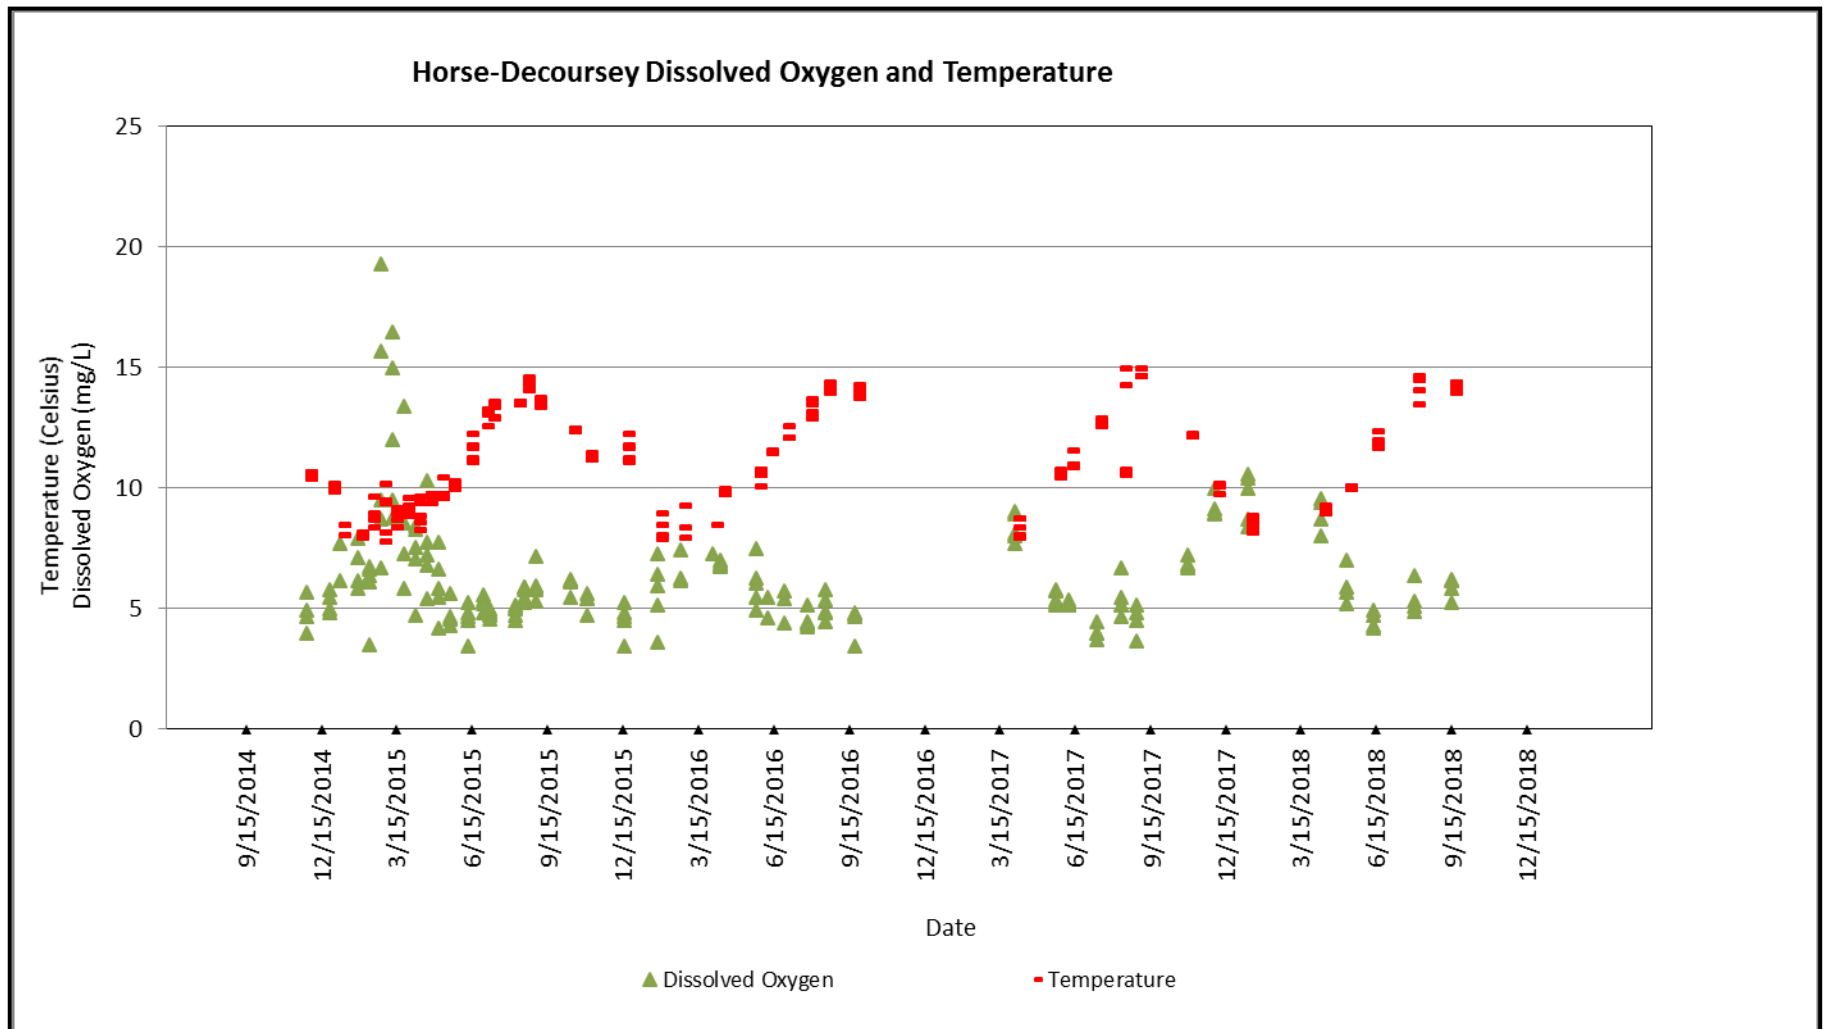
Figure 7: Temperature and dissolved oxygen readings taken with a handheld YSI during site visits by MKWC staff. Temperature and DO readings are well within suitable levels for juvenile salmonids.

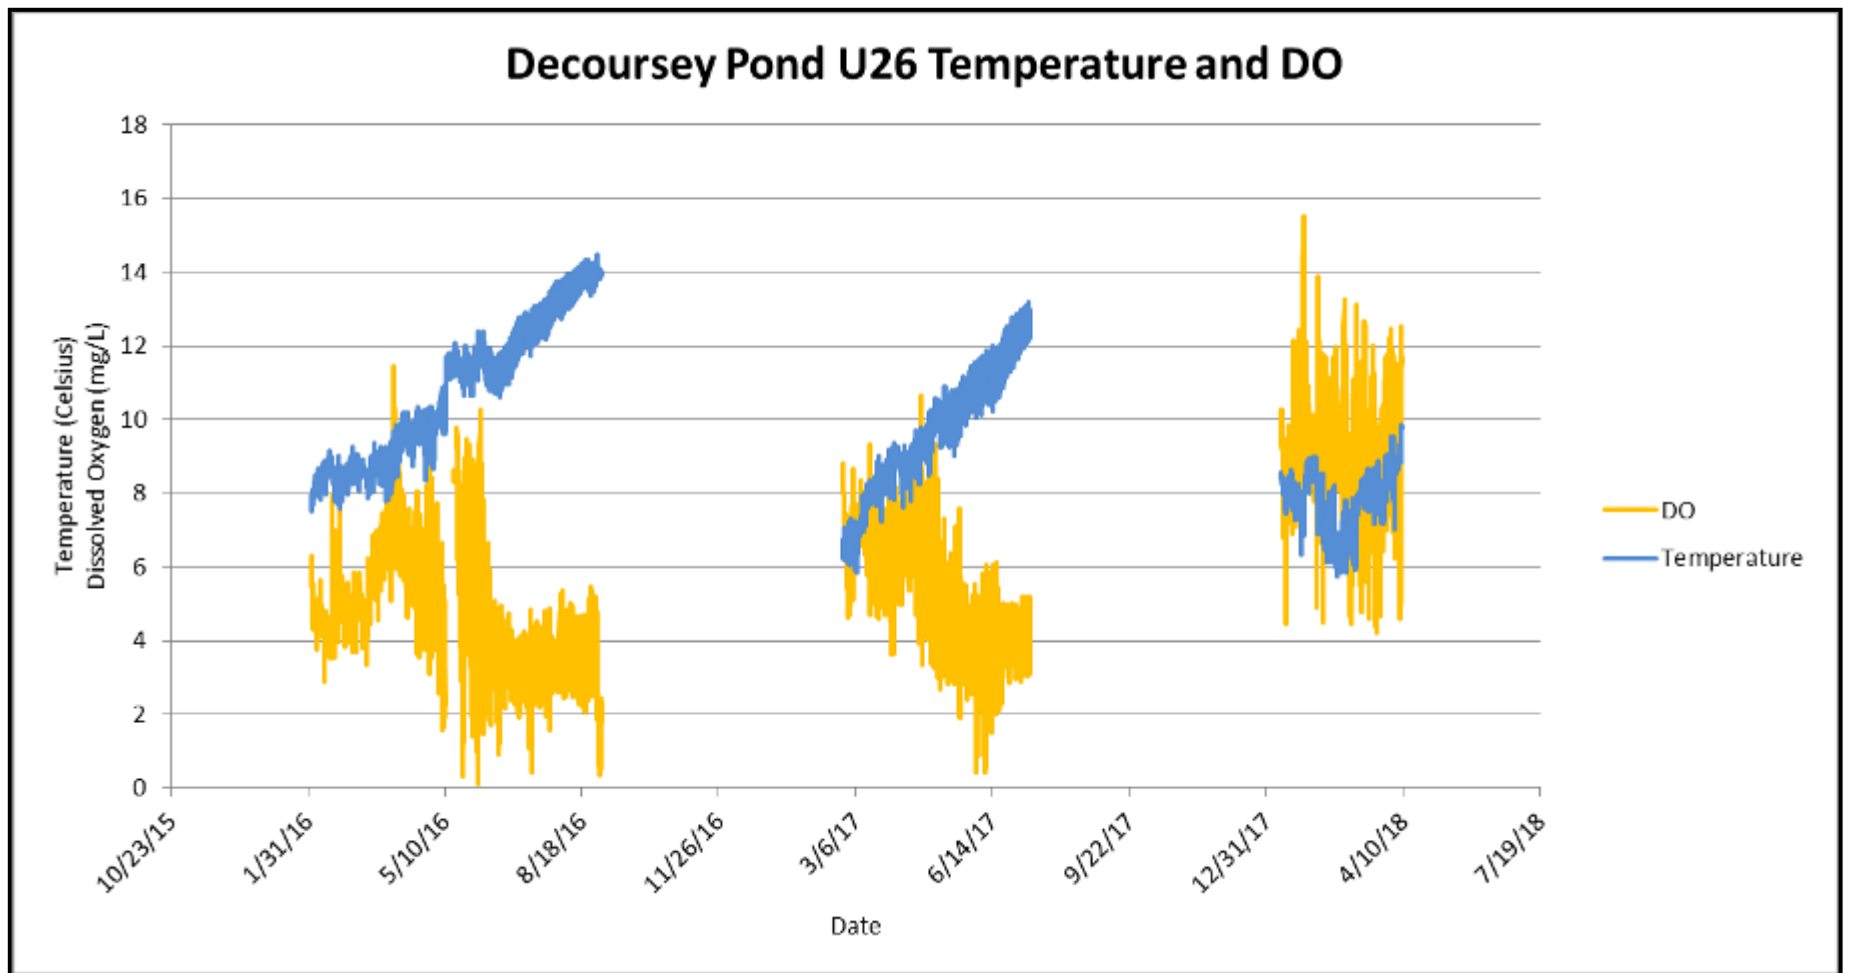
Figure 8: Temperature and DO readings taken with a U26 logger. Readings were taken every half hour for periods of up to six months. High readings of DO in spring of 2018 could be attributed to algal blooms that occurred during that time period. This can cause erratic DO levels within the pond during the growth and subsequent die off of algae.

Dissolved oxygen measurements were taken at the pond in several ways. An Onset U26 dissolved oxygen and temperature logger was deployed along the mid line of the pond at an approximate depth of three and a half feet deep. This logger recorded DO reading every half hour throughout the year to track DO trends (Figure 5 and 6). Spot readings were taken at various locations around the pond with a handheld YSI 550A temperature/dissolved oxygen meter. These readings were taken to measure DO and temperature readings at various depths throughout the pond to track physiological and biological differences within the habitat. As shown in Figure 4, 6 and 7, dissolved oxygen (DO) in the pond ranged from 1.15 mg/L to 15.82 mg/L over four years of monitoring. DO in the pond begins to stratify starting in the early summer months and tends to be more evenly mixed during the winter and spring months. Mean DO measurements in the pond are 4.92 throughout the four years of monitoring. According to the study by the California North Coast Regional Water Quality Board, DO ranges of 4 mg/L and over and temperatures of >18 degrees Celsius are ideal for optimum salmonid growth and health (Carter 2005). While May Pond drops below this threshold a few times a year, these events tend to be short lived and are commonly seen in slow water habitats during summer months. Even at low ranges of DO, juvenile coho were observed using the pond (Figure 5). By maintaining a connection with the creek, coho can move between the pond and creek to find what habitat they find most suitable. The following figures summarize the water quality sampling results for the DeCoursey Pond.

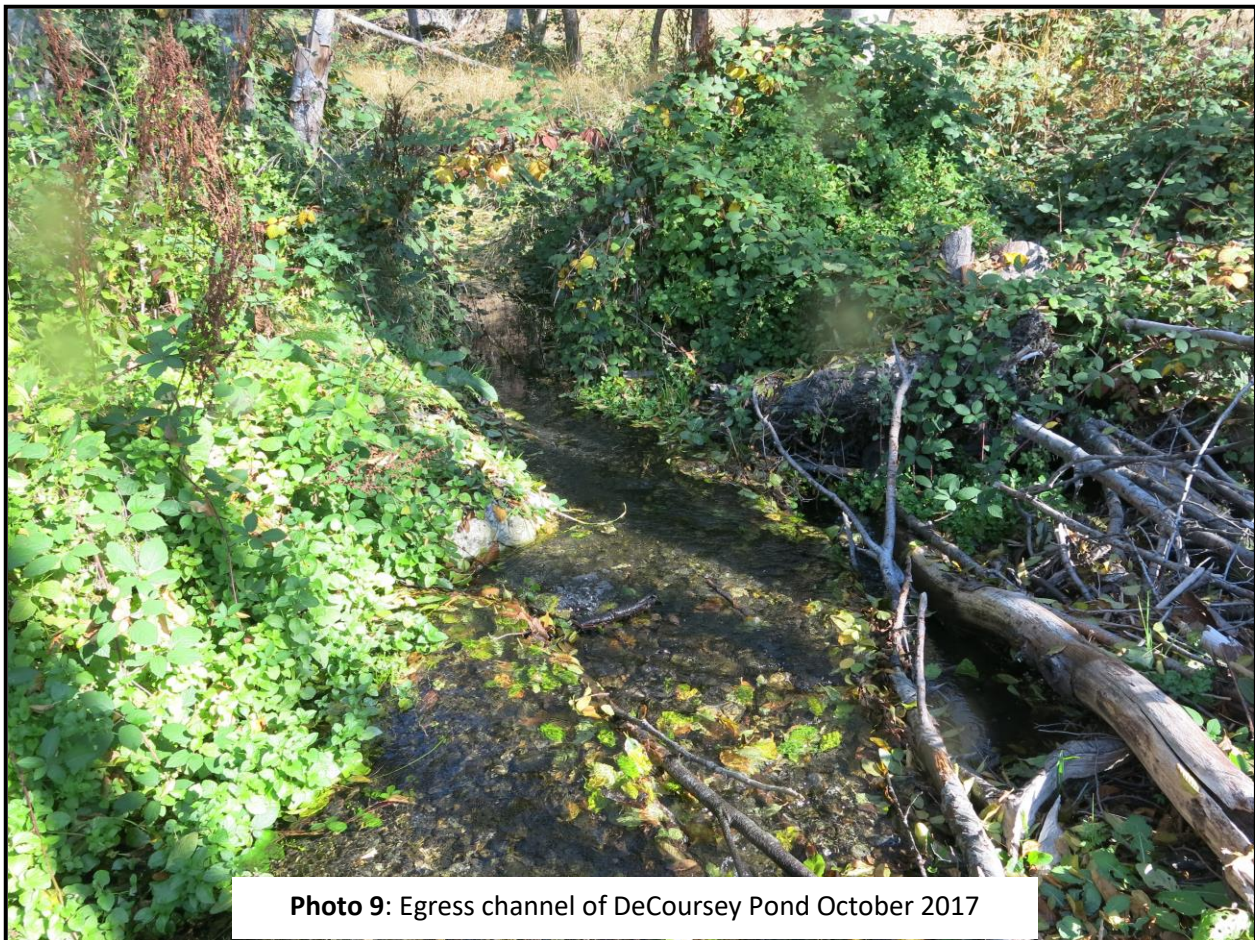
Photo 9: Egress channel of DeCoursey Pond October 2017

DeCoursey Pond has a perennial connection to Middle Creek. Little to no maintenance has been required to date due to the placement of a small root wad structure at the mouth of the creek. MKWC senior staff bolstered this root wad structure with slash and small logs in 2016 (see photos below). A minimum amount of work has helped to create a stable connection from the creek to the pond.

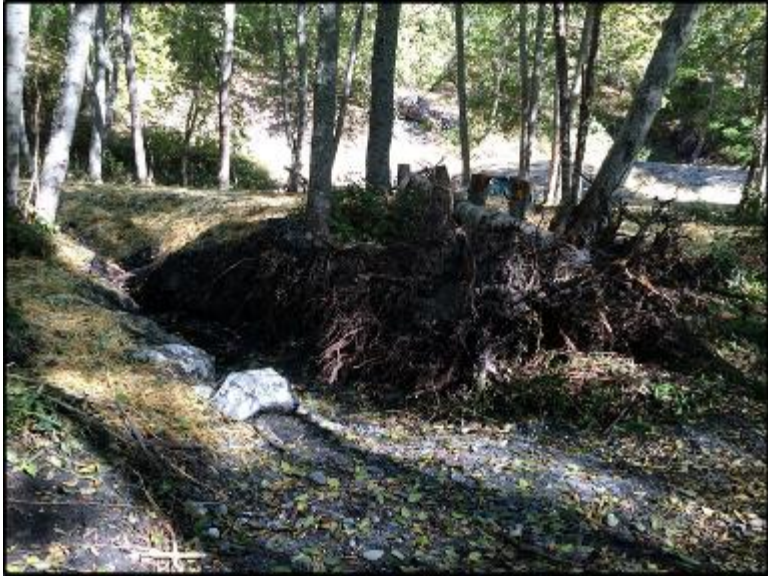
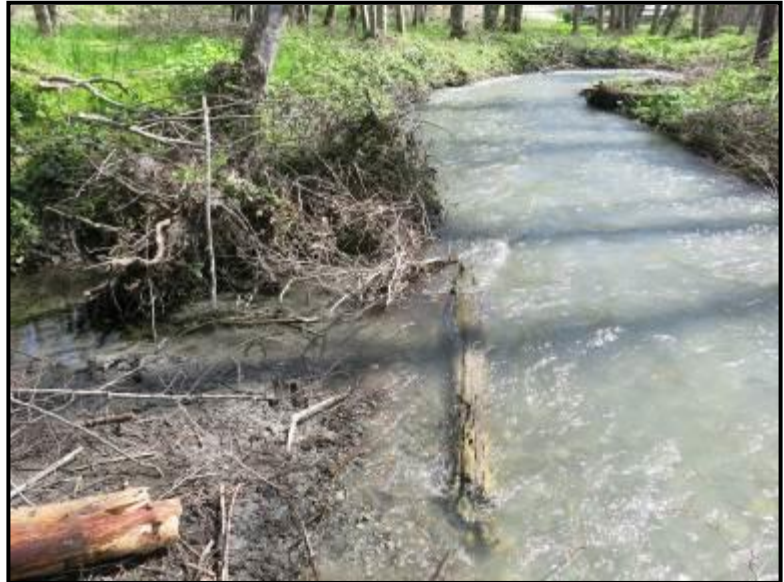
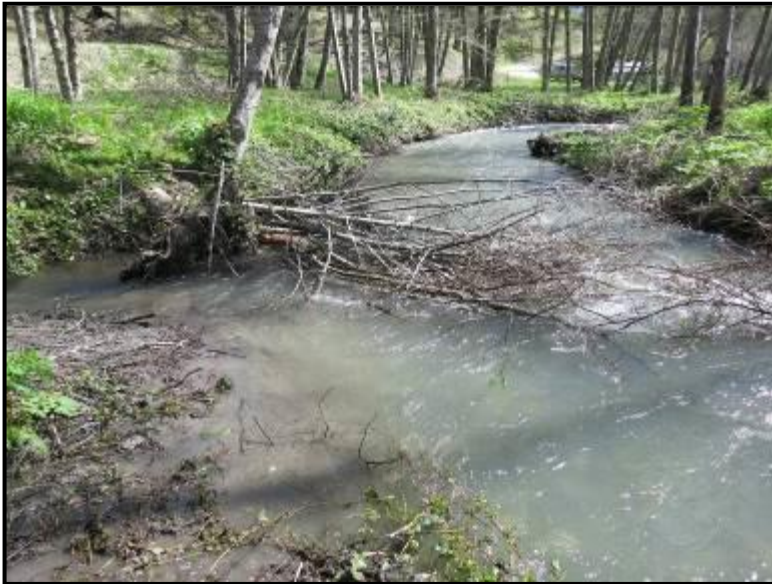
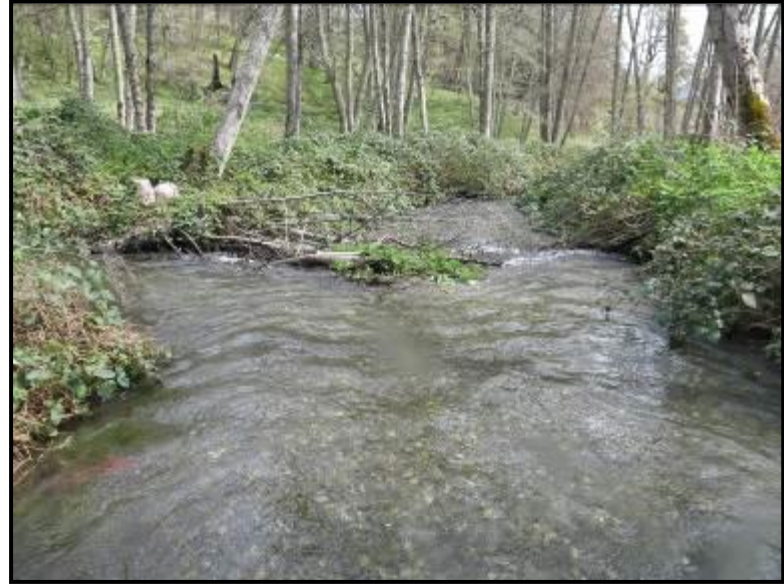
Photo 10: Photos of egress channel to DeCoursey Pond.
