Durazo Pond Monitoring Report

Durazo Off-Channel Pond Monitoring Report

By Mitzi Wickman, Charles Wickman, James Peterson and Will Harling

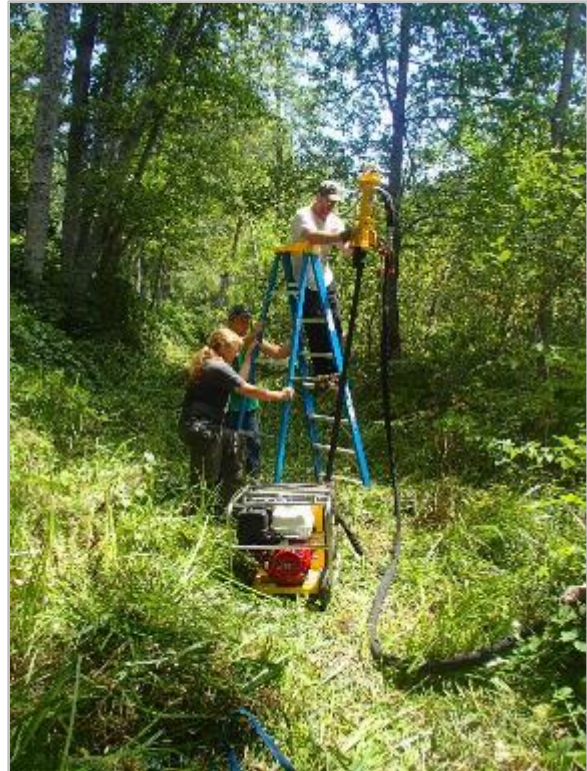
Image 1: MKWC Fisheries Staff installing ground water wells. Wells were used to monitor ground water levels throughout the year prior to construction.

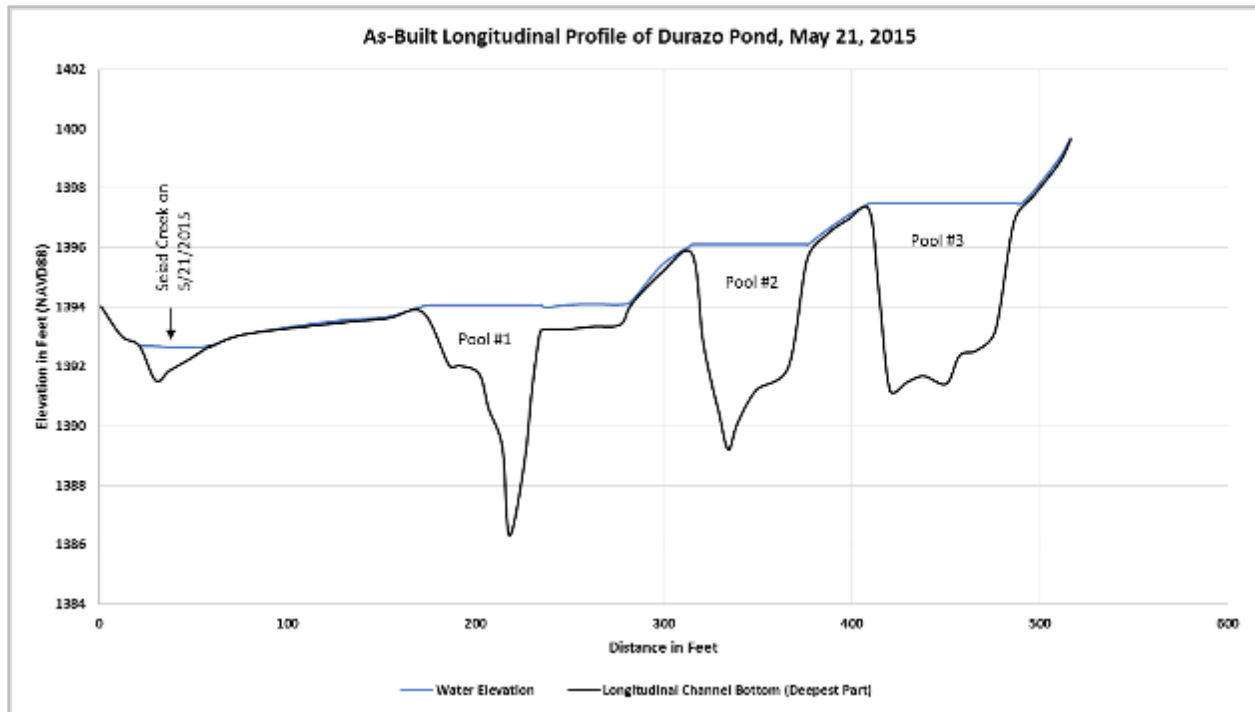
Figure 1: Longitudinal view through Durazo Pond the summer after completion.

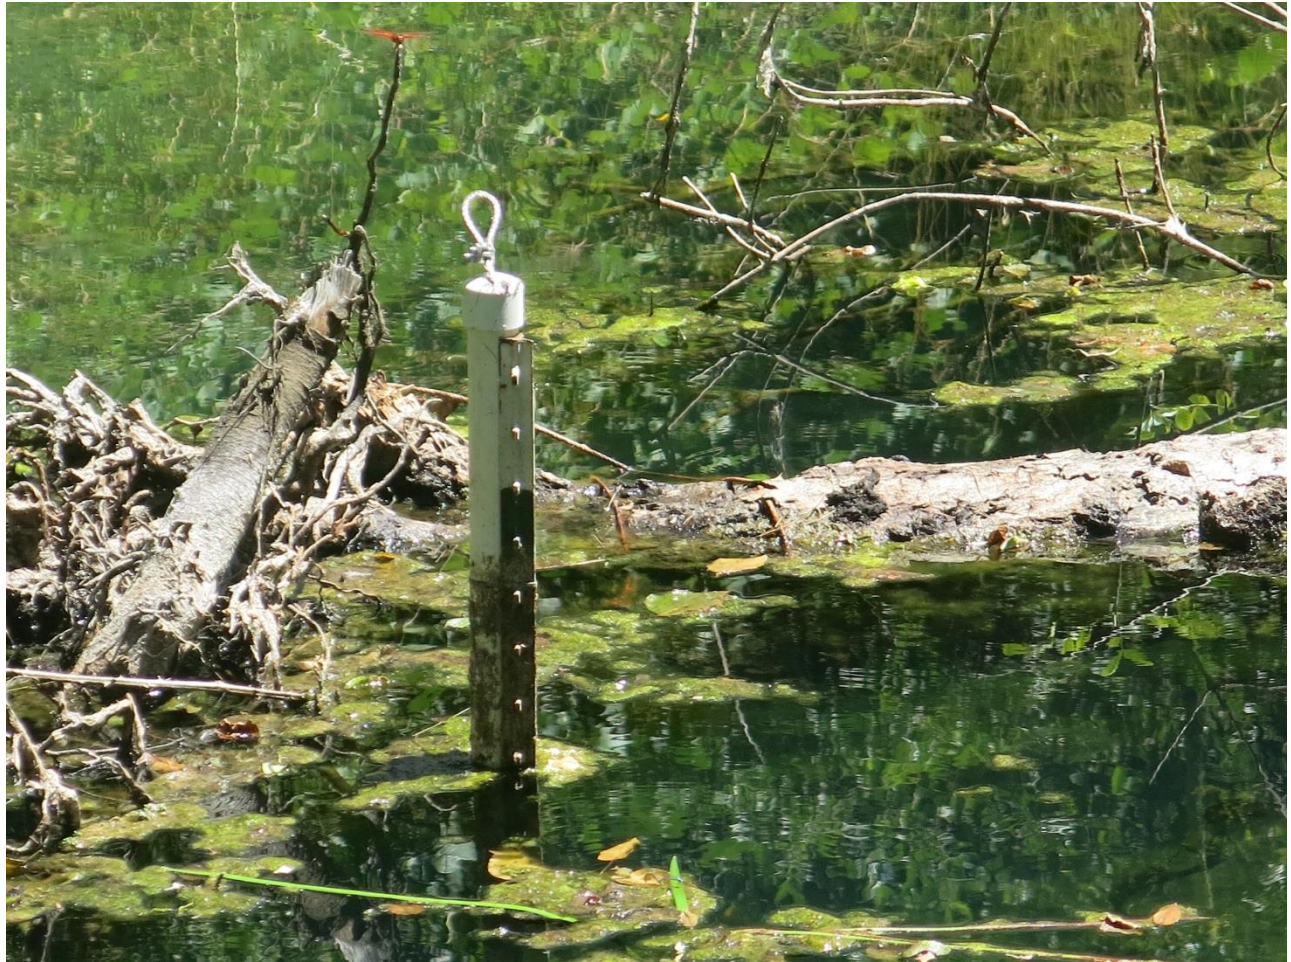
Photo: Water level logger well deployed in pool one of Durazo Pond. Photo was taken in July of 2016 and previous winter's high water mark can be seen on the pipe.

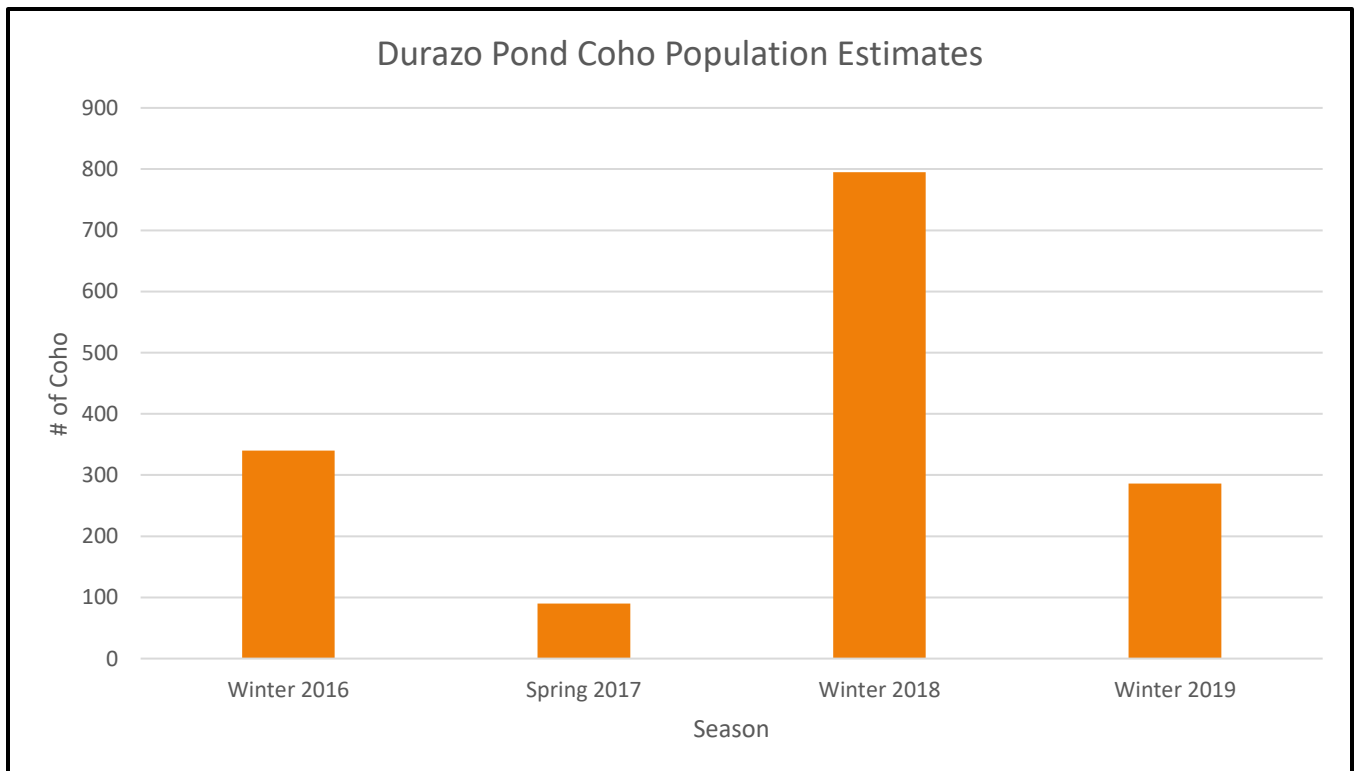
Figure 2: Preliminary Population estimates from KTFP Petersen mar/recapture tagging events. Winter 2016 and spring 2017 coho counts are based off of MKWC staff ocular snorkel counts.

Durazo O.C.P. provides both summer and winter refuge for coho juveniles. Coho have been seen utilizing all three pools of the pond throughout the year since the pond has been built. The Karuk Tribe Fisheries Program (KTFP) installed three stationary pit tag arrays at the outlet of the pond and within the first pool and second pool to monitor fish as they migrate in and out of the pond. Chinook, coho and steelhead have been seen using the pond, and on 2/24/16, MKWC fisheries staff dove the pond and estimated that there were approximately 340, one year old coho rearing within the three pools.

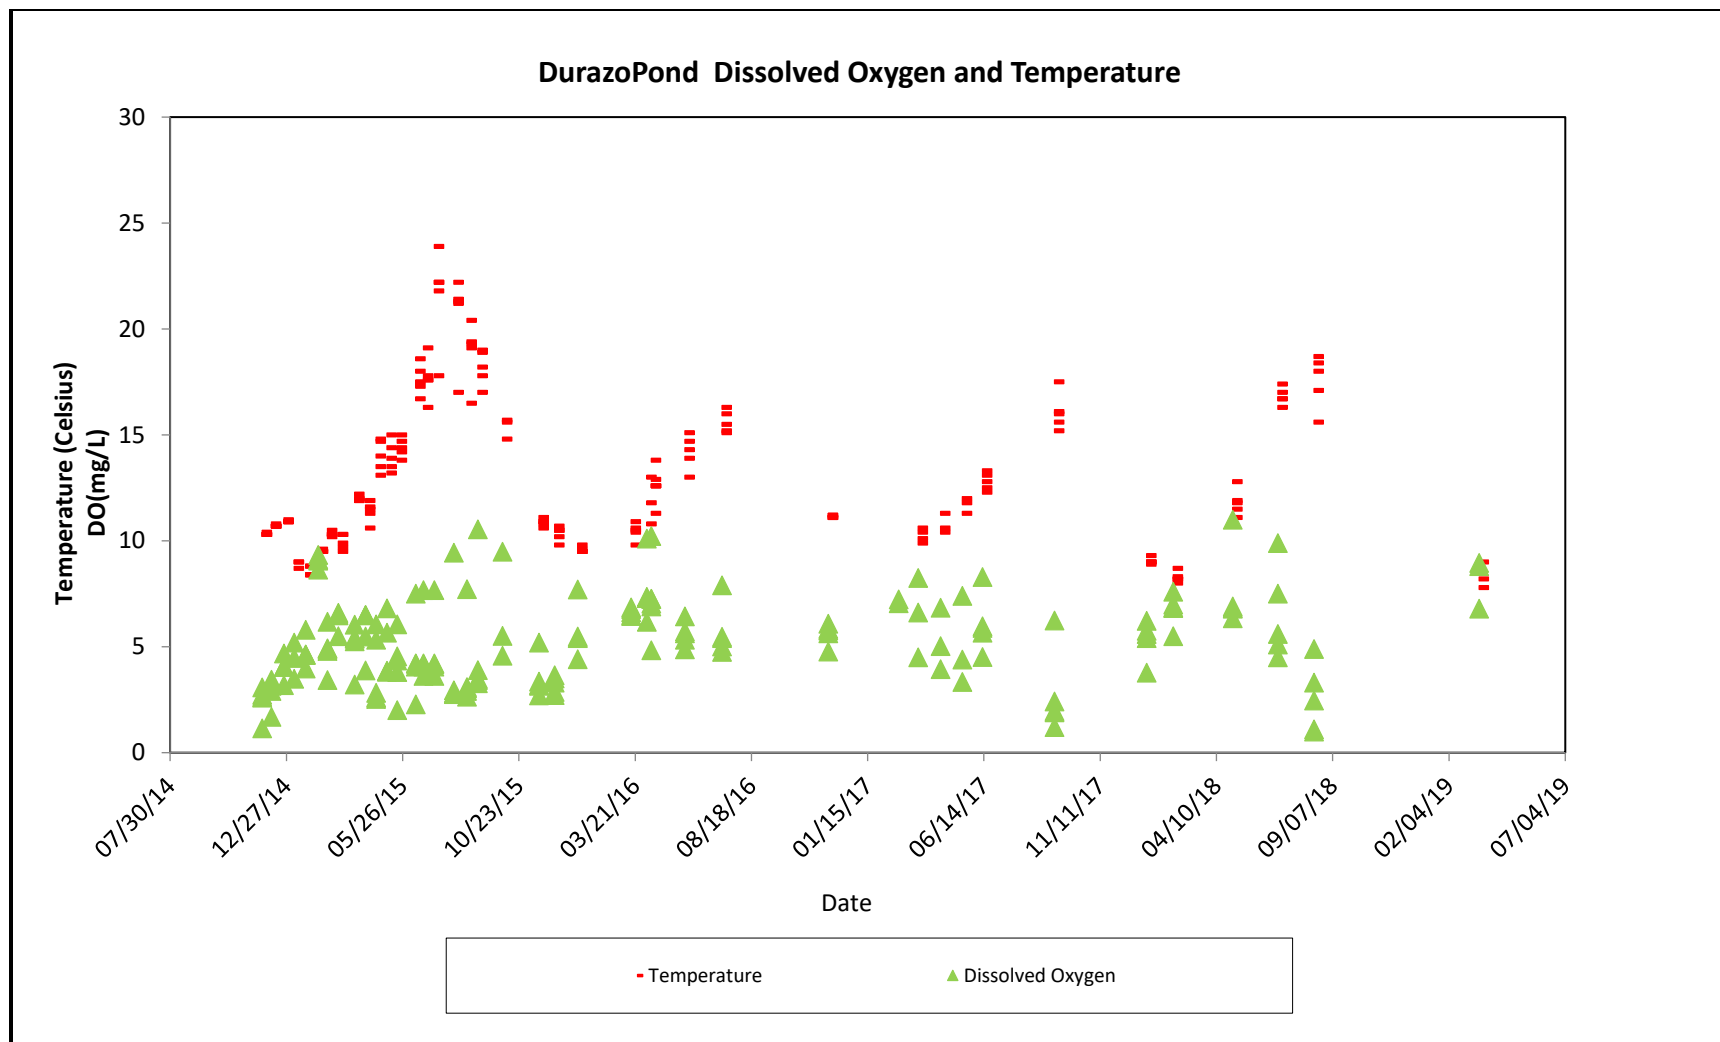
Figure 3: Dissolved oxygen and temperature readings from bi-weekly water quality visits. Readings were taken in each pool at varying depths to capture effects of stratification.

The following figures summarize the dissolved oxygen sampling results for the **Durazo** Pond. Much like the temperature identities of each pool of the pond, each pool shows its own unique dissolved oxygen profile. By having the pools of the pond tiered and connected by two low gradient riffles, the DO of the pools gradually increases from Pool #3 to Pool #1. Pool #3 has the lowest range of dissolved oxygen readings ranging from .57 mg/L to 6.34 mg/L. Pool #1 had a dissolved oxygen range of 4.46 mg/l to 13.26 mg/L. Overall average DO of the pond is 5.4 mg/L. Like many other slow water constructed habitats, Durazo Pond has more evenly mixed DO levels in all three pools during the winter months and then typically stratifies throughout the summer and early fall months. Average yearly DO for the pond is 5.4 mg/L. Even at lower Do levels juvenile coho were seen throughout the pond. Typically fish spread out to all three pools during the winter and spring and then move down into the lower pool for the summer.

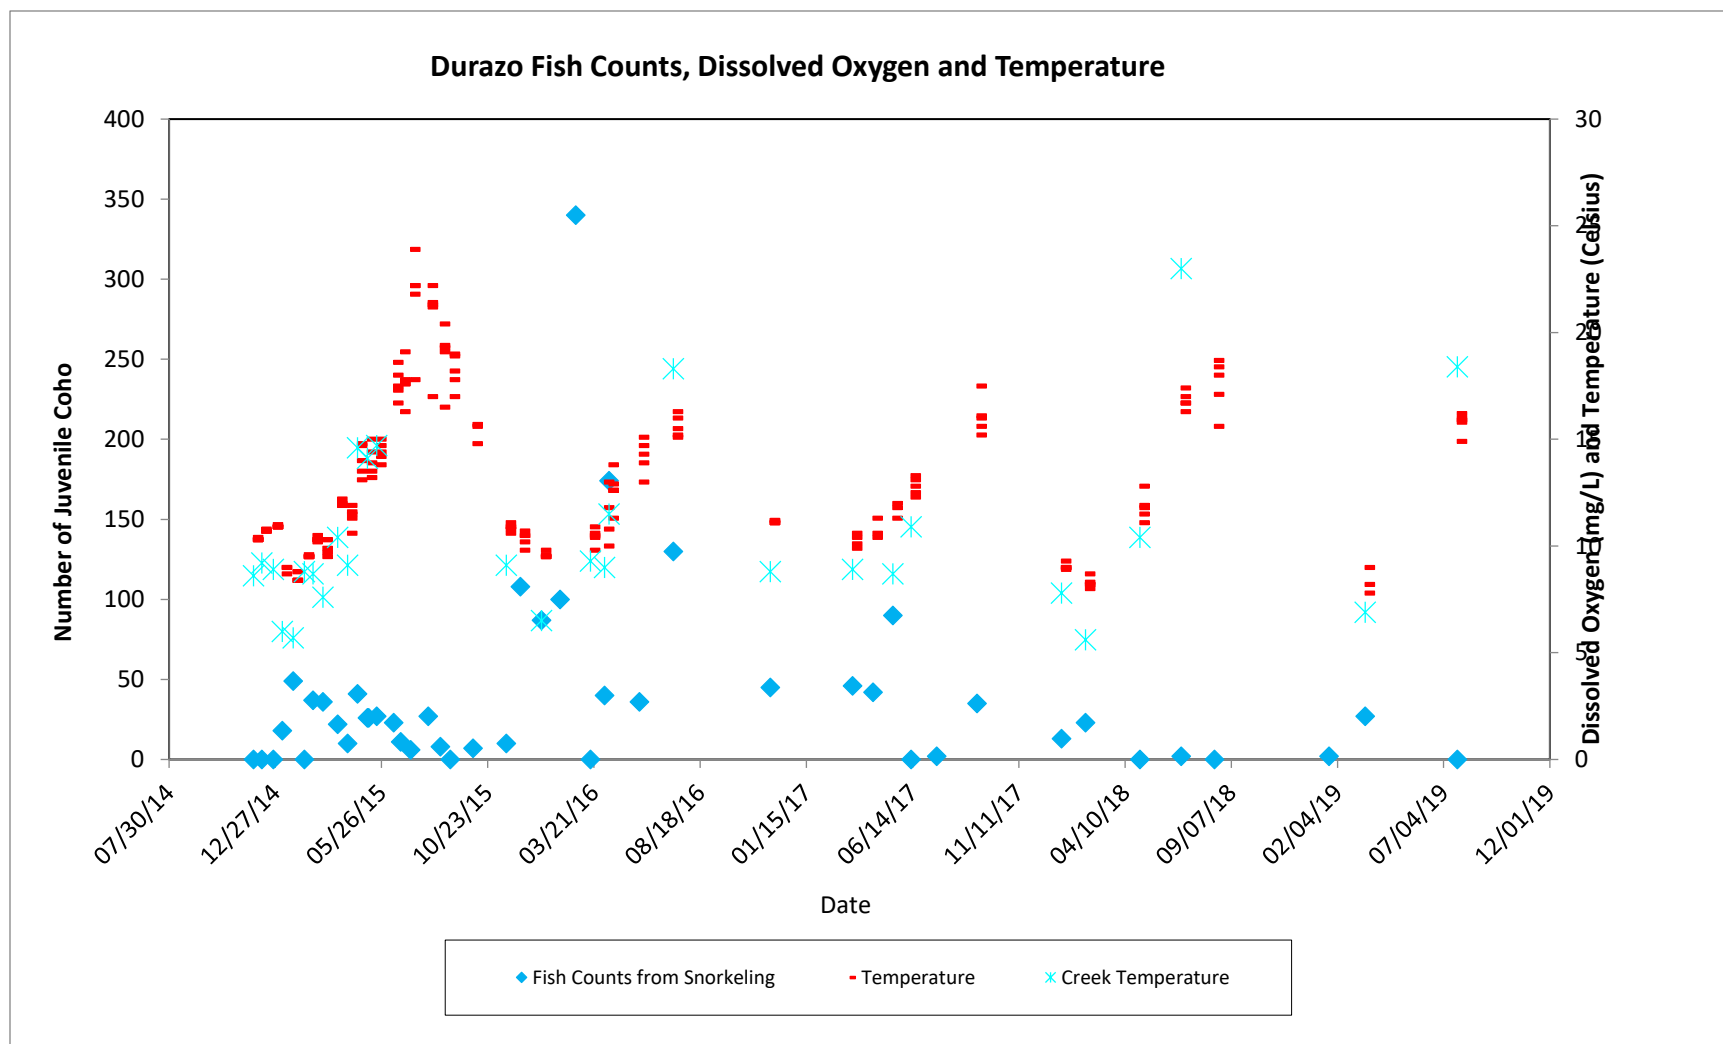
Figure 4: Temperature and ocular fish counts from bi-weekly water quality visits. Low fish count numbers can be attributed to a variety of factors including visibility, connectivity, and complex cover within the pond. For much of 2015, Durazo Pond was not connected to Seiad Creek because of the extreme lack of precipitation during the year. Fish that were able to migrate into the pond were able to rear in good conditions (temperature, DO), instead of becoming stranded in creek as it dried up in early June. In early February 2016, MKWC staff estimated over 300 juvenile coho using the pond, with approximately 100 in each of the three pools. As the pond has aged, ocular counts become more difficult as aquatic vegetation growth creates large areas of cover for fish.

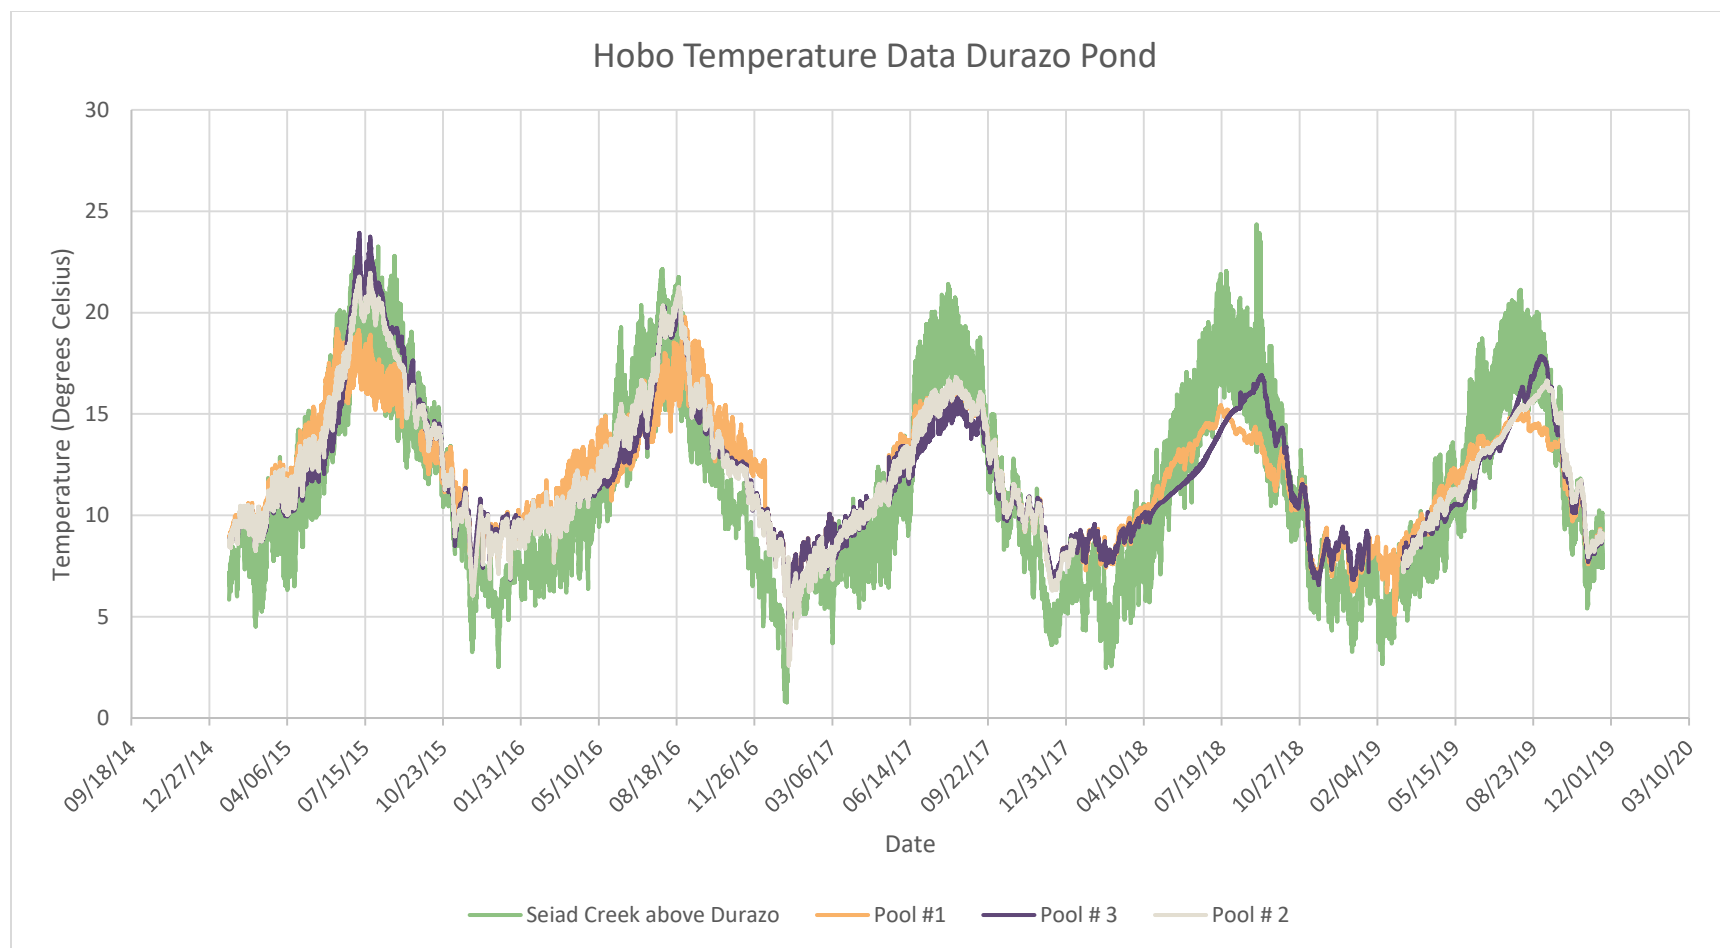
Figure 5: Hobo logger temperature data collected from Durazo Ponds since 2015. One logger was deployed in each pool at an average depth of five feet. The creek logger was placed in the creek ¼ mile upstream from Durazo Pond. Large spike in creek temperature in September 2018 is most likely caused by logger being out of the water.

Durazo Pond is made up of three distinct pools that are connected by two low gradient riffles. This design has shown that each pool has a slightly variable temperature profile from top to bottom. The uppermost pool (Pool #3) has an average winter temperature of 8.6 degrees Celsius and an average summer temperature of 16.9 degrees Celsius. The middle pool (Pool #2) has an average winter temperature of 8.14 degrees Celsius and an average summer temp of 17.21 degrees Celsius. The lowest pool which connects to Seiad Creek (Pool #1) has an average winter temperature of 8.6 degrees Celsius and an average summer temperature of 15.76 degrees Celsius. These averages are based on three years of temperature data for winter 2016-2018 and summer 2015-2017. As the ponds have aged and gone through several seasons of both low and high water, the average summer temperatures have steadily decreased. Temperatures in the pools of the pond stay well within optimal rearing temperatures for juvenile coho salmon. See figures 3-7 for more on temperatures.

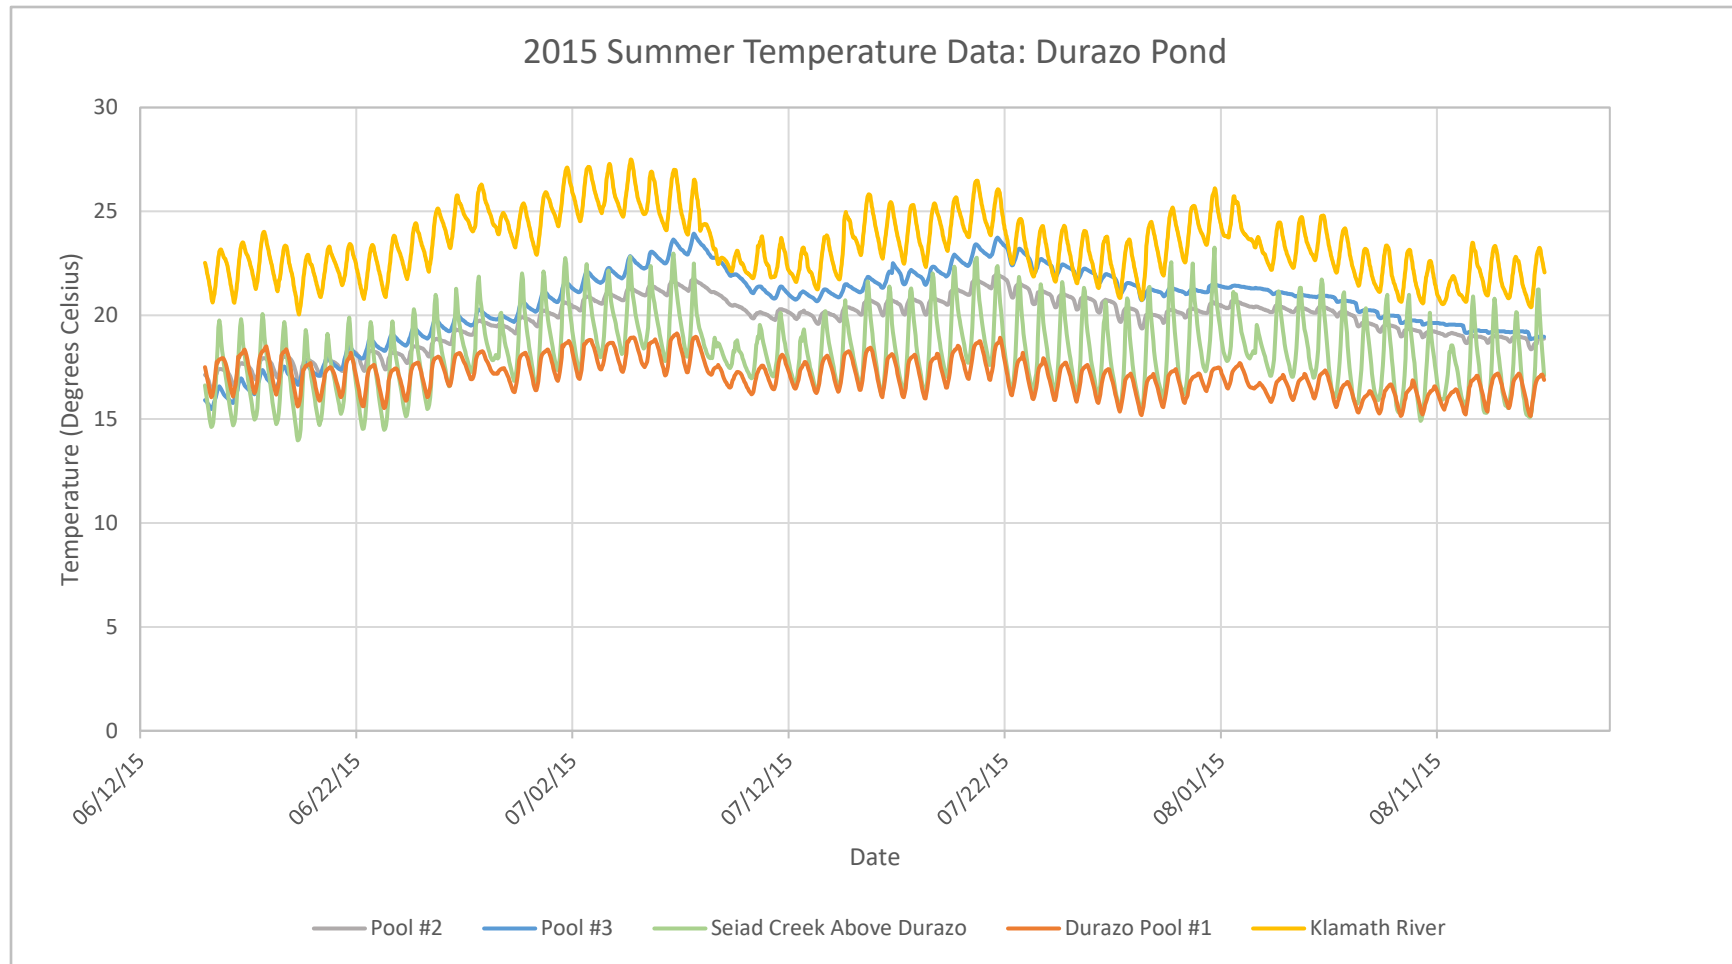
Figure 7: Hobo temperature data from the summer of 2015. The summer of 2015 was exceptionally hot and dry, and was the fifth year of California’s intensive drought. During its first year, Durazo Pond responded extremely well to these intense conditions. The lowest pool stayed within a healthy range for rearing juvenile coho. The upper two pools were disconnected from the lowest pool and no fish were seen in those pools all summer.

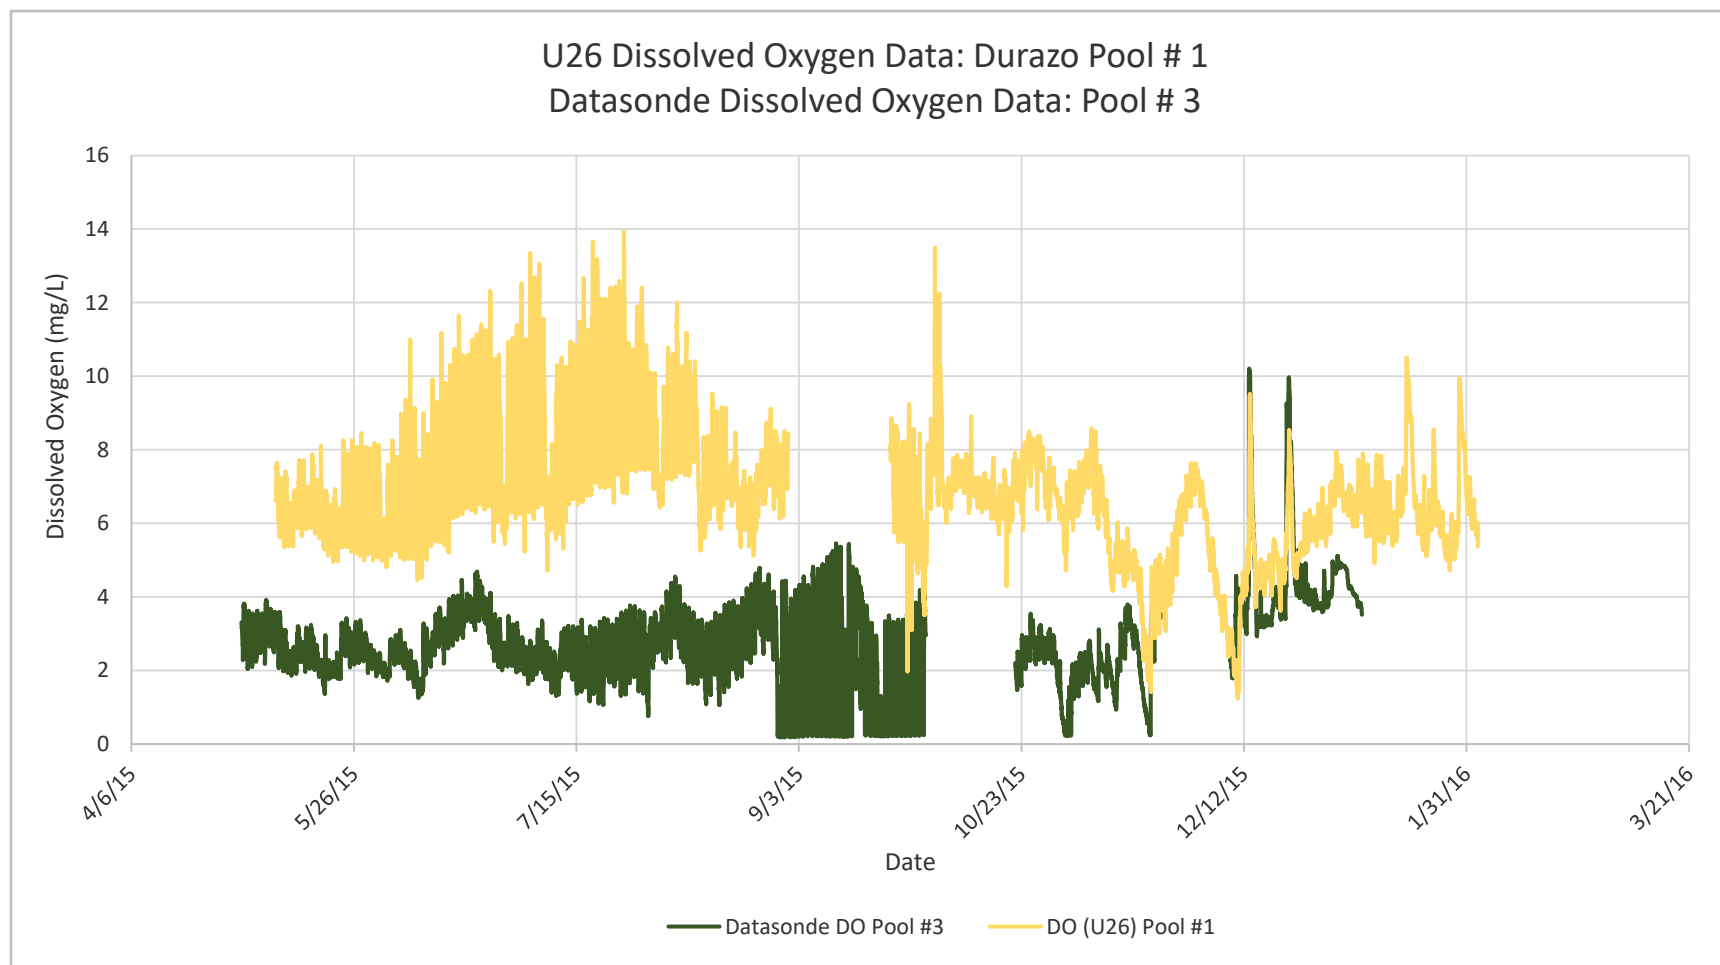
Figure 8: U26 and datasonde dissolved oxygen data from Durazo Pond. The datasonde was deployed in Pool #3 and the U26 was deployed in Pool #1. Each piece of equipment was deployed at a depth of 3.5 feet.

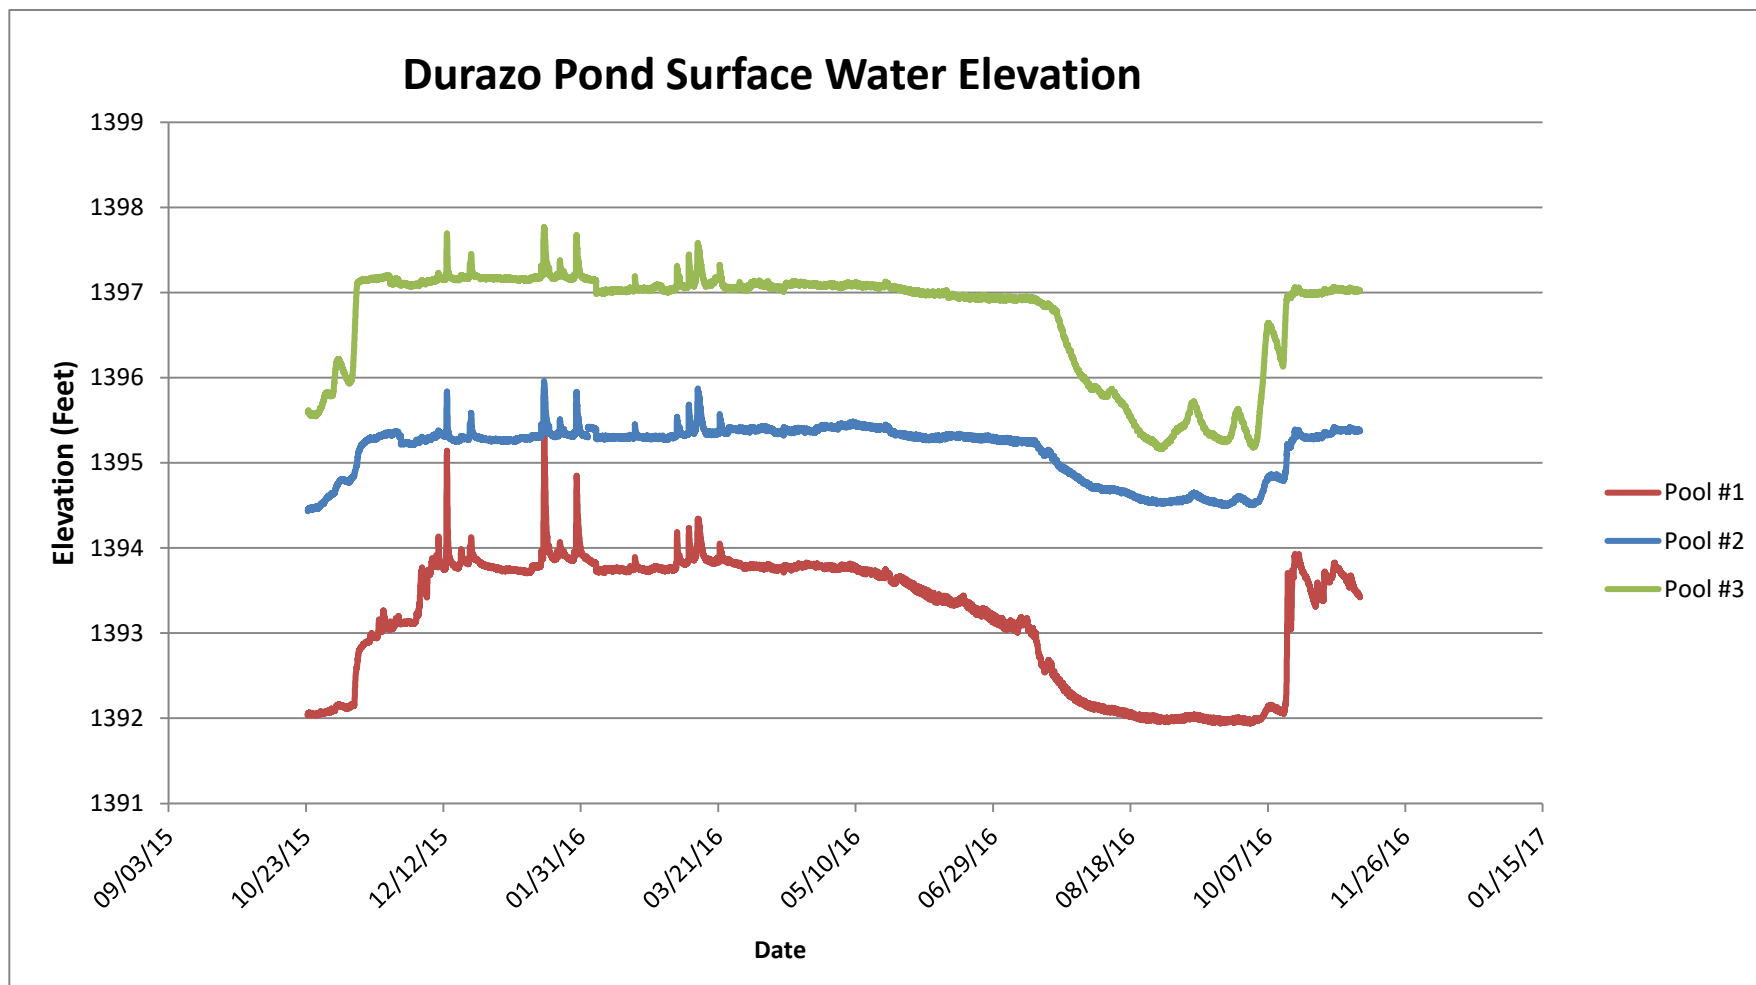
Figure 9: U-20 Onset water level logger data from Durazo Pond. One water level logger was installed in each of the three pools to allow MKWC staff to track water levels in the pond throughout the year.

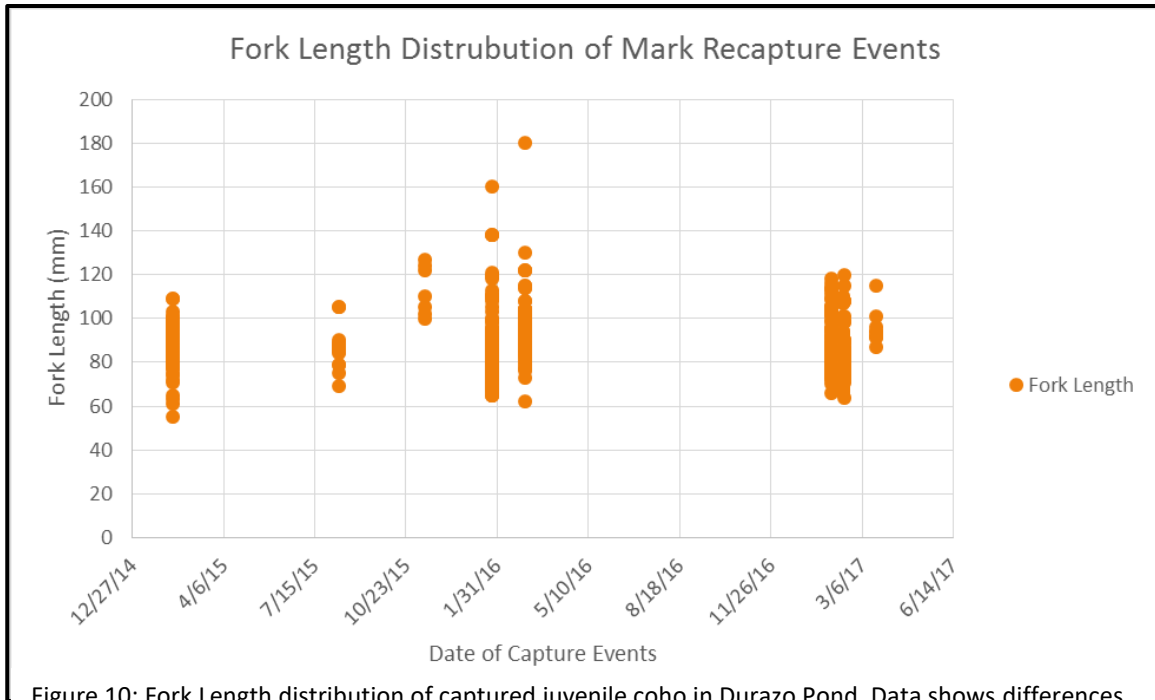
Figure 10: Fork Length distribution of captured juvenile coho in Durazo Pond. Data shows differences in eight capture events over three years. Capture data was collected by KTFP staff during mark recapture events.

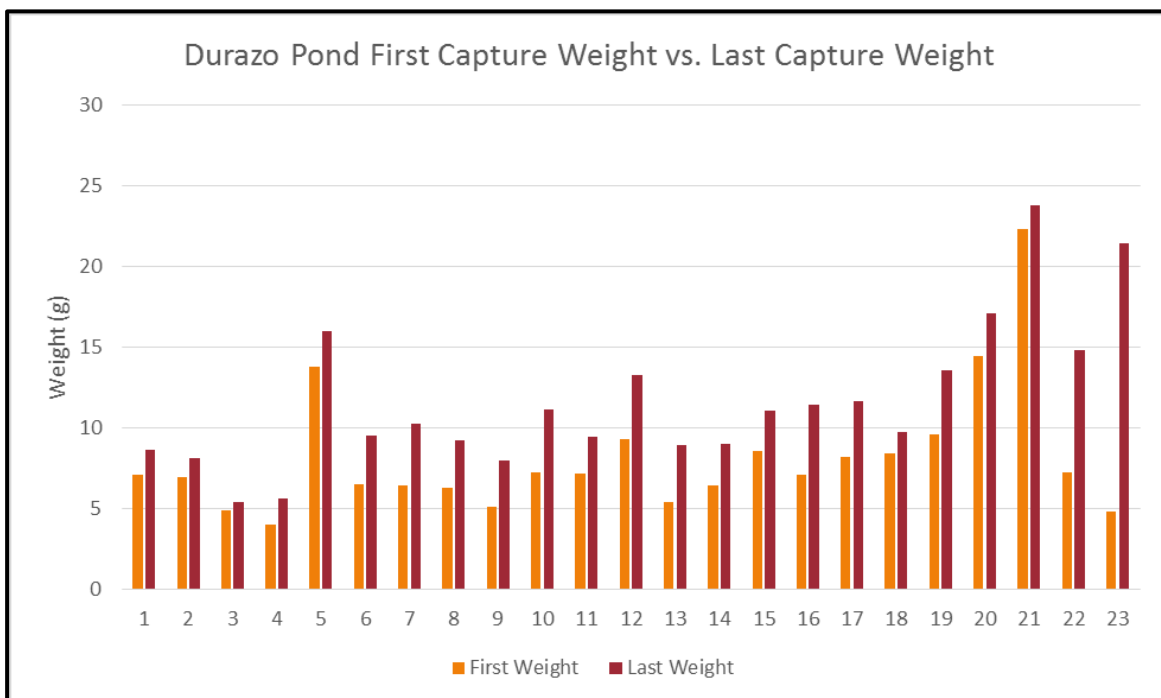
Figure 11: Growth comparison of tagged juvenile coho in Durazo Pond. MKWC staff identified 23 specific coho that had been tagged and recaptured at least once by KTFP staff. Average time between recapture events was 60 days with a minimum of 35 days between captures and a max of 276 between capture events. All recaptured fish showed positive growth over time.
