REACTIVATION OF DEEP-SEATED LANDSLIDES IN NORTHWESTERN CALIFORNIA AFTER WILDFIRES IN 2006 AND 2008 EP13D-0878

Abstract

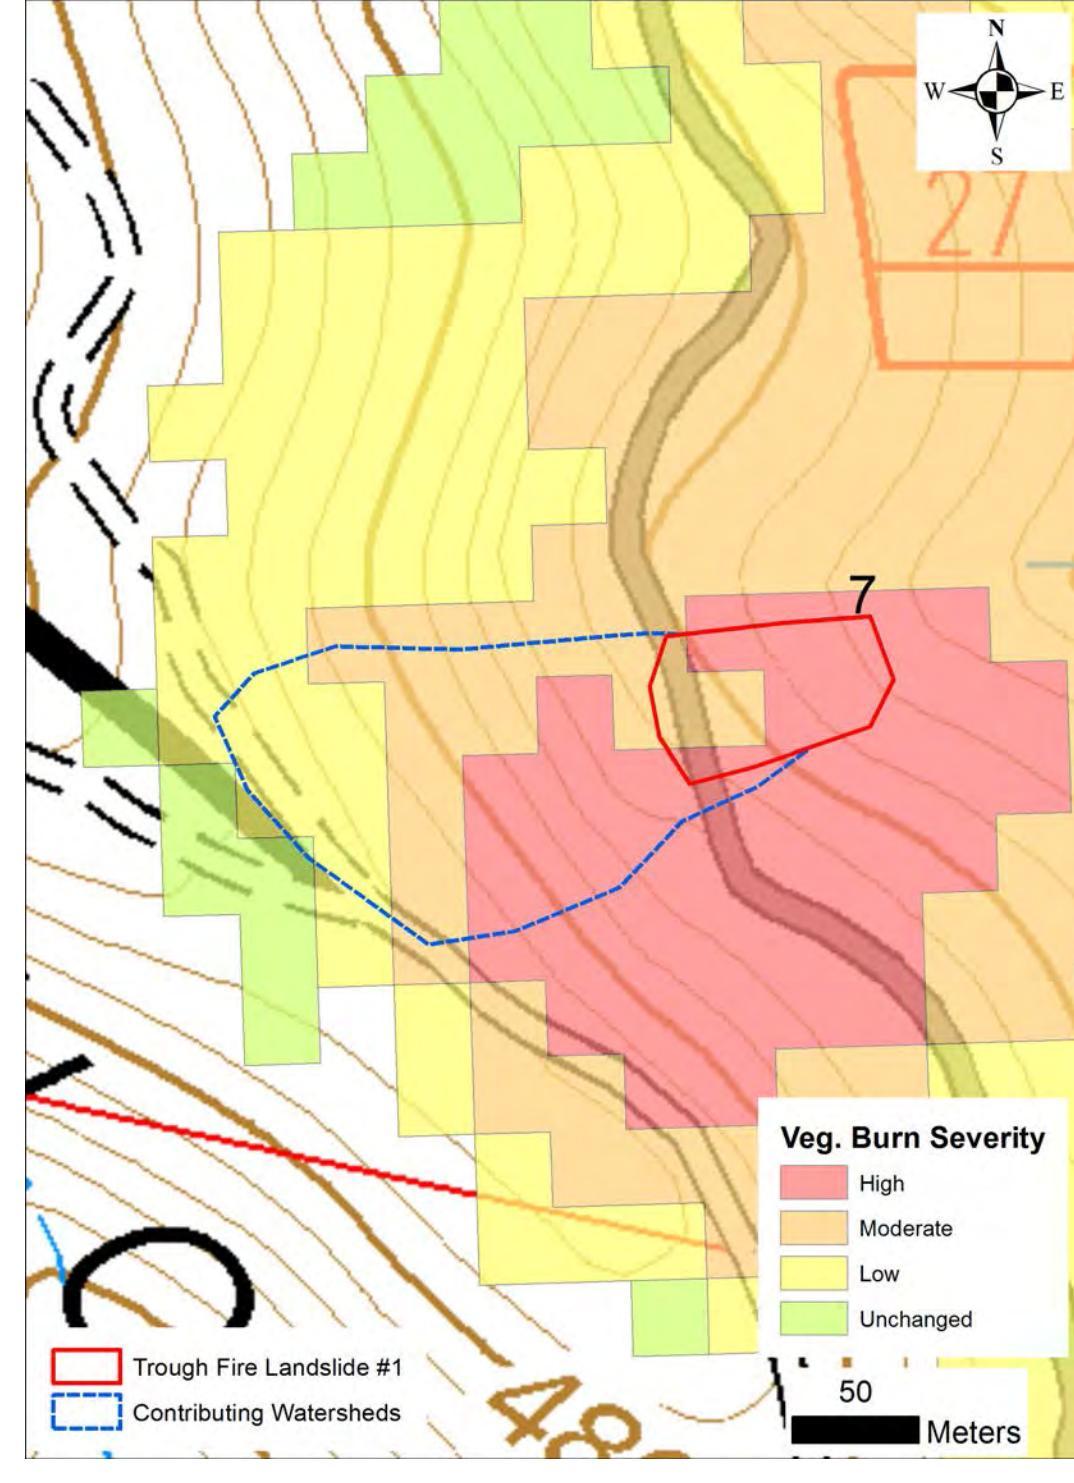
Map 5 Trough Fire: Slide #7 (1 acre)

Trough #7 & #8 - Movement on #1 dropped the outside 1/3 of the road about 4 feet, in spring 2011, with cracks immediately above road ditch. Small debris slide (10' wide) on toe. Slide #8 dropped outside shoulder of the road a few inches in spring 2011, and exhibited 6 foot head scarps below the road. In winter 2011-2012, very minor movement on Trough #7, and virtually none on Trough #8.
